## RECEIVER TANK BRACKET IMPROVEMENT

Prevost vehicles

On the vehicles affected by this bulletin, the condenser compartment wall may present fatigue cracks on or near the A/C receiver tank support. Follow these instructions to repair and improve the support.

| NOTICE TO SERVICE CENTERS | | |
|---|---|---|
| X3-45 Commuter<br>Model Year : 2014 - 2016 | From 2PCG33495EC735590 up to<br>4RKG33491G9737299 incl. | From 2490 up to<br>2789, incl. |

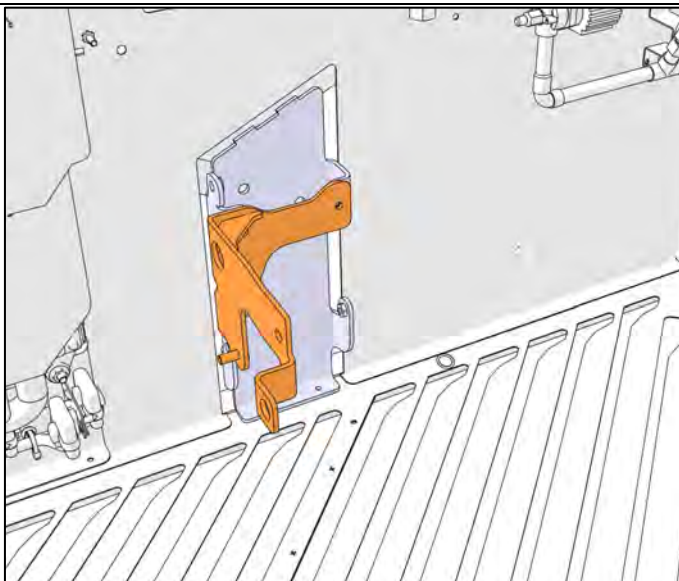
Figure 14: New fuel pro bracket

30. If a fuel pro unit was present on the vehicle, install new bracket 030018 at the same time

**Tighten to 17lb-ft**

Add torque seal mark

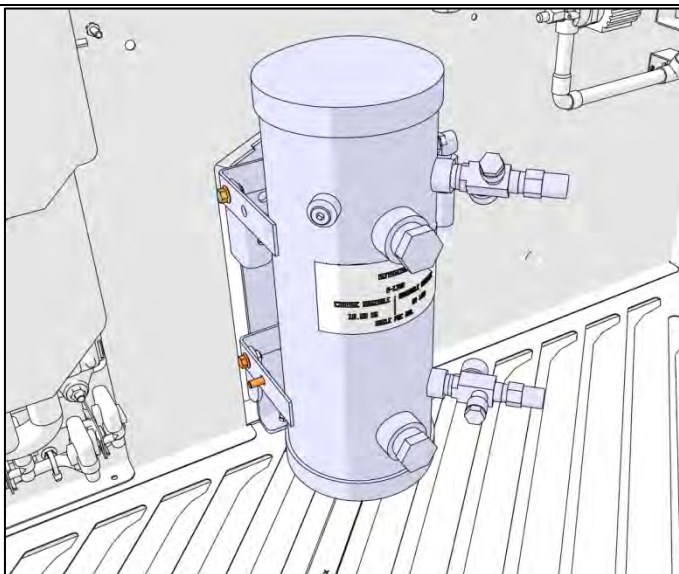
Figure 15: Receiver tank installation

31. Install the receiver tank on the new support.

**Tighten to 17lb-ft**

Add torque seal mark

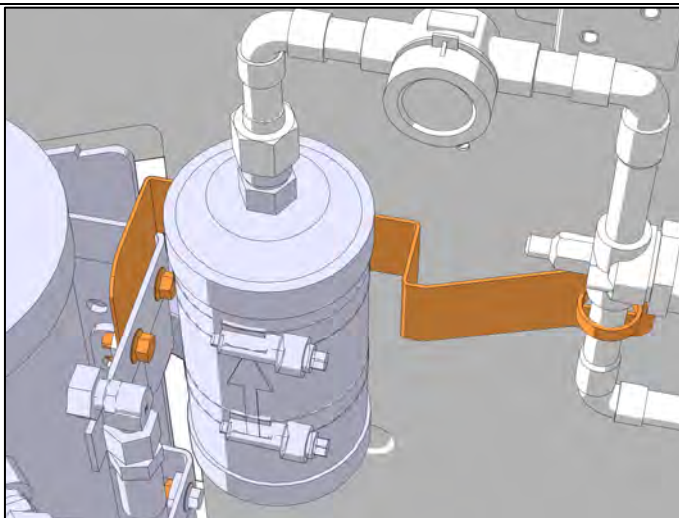
Figure 16: Filter dryer bracket.

32. Install the filter dryer bracket.
33. Install previously removed screws 5001780 and cable tie 504016, 5/16"x 14 1/2".

**Tighten to 17lb-ft**

Add torque seal mark

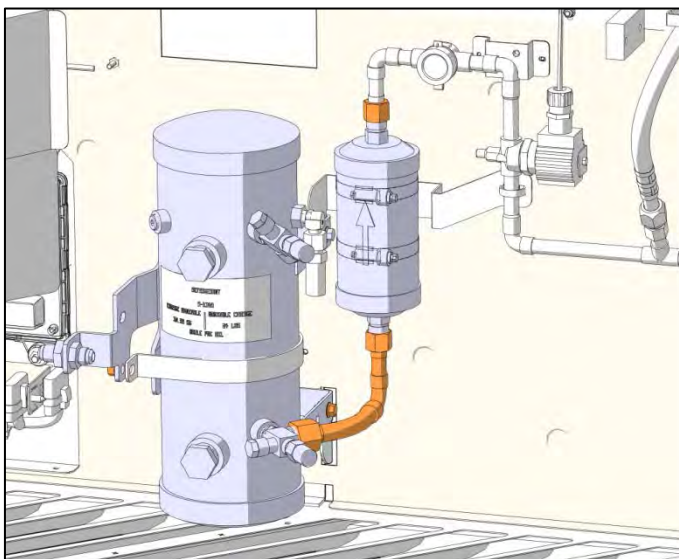
Figure 17: Piping

34. Install piping between receiver tank and dryer filter.
35. Tighten according to Appendix D
36. Apply torque seal on each tightened fitting.

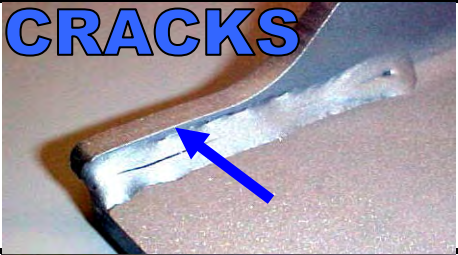
| MAJOR DEFECTS | | | | |
|---|---|---|---|---|
| <b>CRACKS</b><br> | NONE | NONE | NONE | <b>Gouge or grind</b> to sound metal at craked locations <b>and reweld.</b><br><br>Contact the welding technician. |

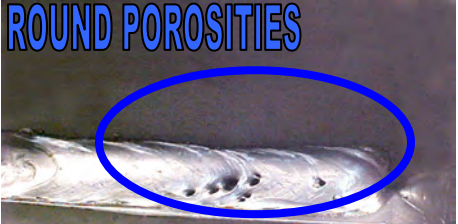
| MAJOR DEFECTS | | | | |
|---|---|---|---|---|
| <b>ROUND POROSITIES</b><br> | NONE | NONE | NONE | <b>Gouge or grind</b> to sound metal <b>and reweld.</b><br><br>Contact the welding technician. |

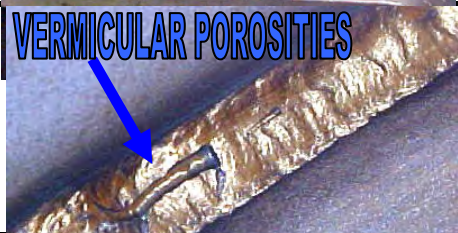
| MAJOR DEFECTS | | | | |
|---|---|---|---|---|
| <b>VERMICULAR POROSITIES</b><br> | NONE | NONE | NONE | <b>Gouge or grind</b> to sound metal <b>and reweld.</b><br><br>Contact the welding technician. |

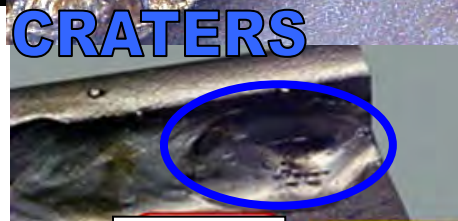
| MAJOR DEFECTS | | | | |
|---|---|---|---|---|
| <b>CRATERS</b><br><br><div data-bbox="175 1390 344 1495"> FOR THICKNESSES LESS THEN 3.2MM </div> | No unfilled crater allowed. | | Hole accepted at the end of the seam if diameter less than <b>0.5 mm.</b><br><br><b>No unfilled crater allowed.</b> | <b>Fill with welding</b><br><br>Note : If presence of cracks in the crater, grind and weld |

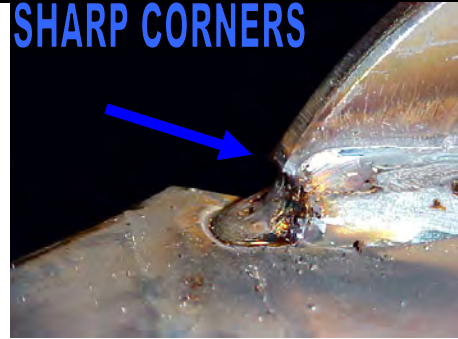
| MAJOR DEFECTS | | | | |
|---|---|---|---|---|
| <b>SHARP CORNERS</b><br> | NONE | NONE | NONE | <b>Grind</b> to eliminate stress concentration or <b>hammering</b> to remove the sharp corner.<br><br><b>Reweld if possible.</b> |

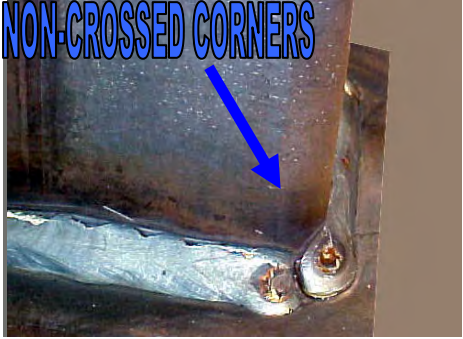
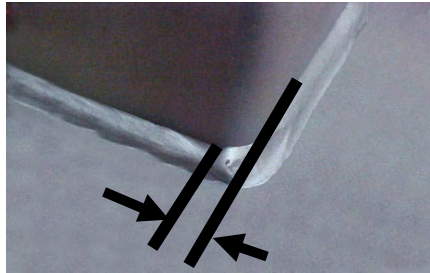
| TITRE: WELD INSPECTION | | | NO: IT750004A | | |
|---|---|---|---|---|--|
| <div>NON-CROSSED CORNERS</div> <br> | <p>Unless otherwise stated on the shop drawing, all welded joints must be so to cross the corners</p> <p>Visually check that :</p> <p>Minimum covering : <b>3 mm</b></p> <p>Desirable covering : <b>5 mm</b></p> | | | <b>Add weld.</b> | |

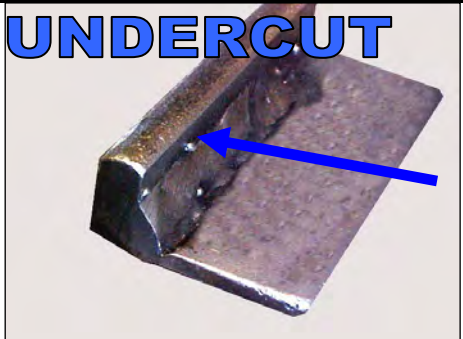
| TITRE: WELD INSPECTION | | | NO: IT750004A | | |
|---|---|---|---|---|--|
| <div>UNDERCUT</div> <br><br> <p>Jauge a profil</p> <p>Check the depth using the profile gauge.</p> | NONE | Max. depth :<br><b>0.5 mm</b><br><b>Max. 10% of weld length</b> | Max. depth :<br>NONE | <b>Grind if required (MAX 10% of material thickness)</b><br><br>Make an <b>additional weld seam</b> , adhering to the weld profile.<br><b>DOWNWARD WELDING is forbidden with FCAW et MCAW processes.</b> | |

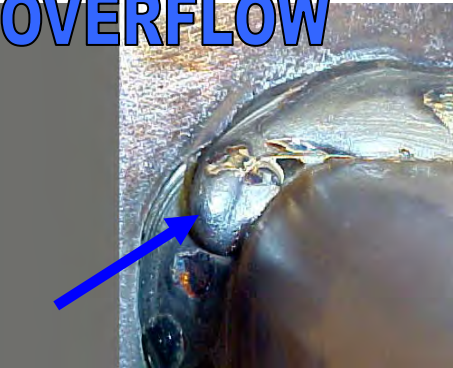
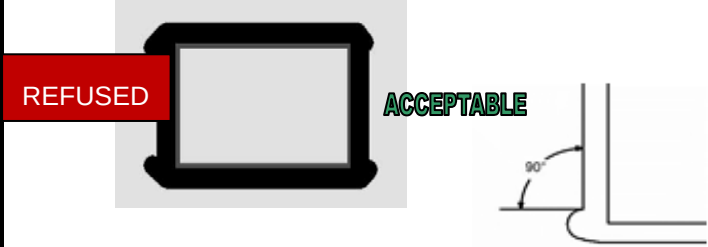
| TYPE OF DISCONTINUITY | MATERIAL THICKNESS | | | RÉPARATION |
|---|---|---|---|---|
| <div>OVERFLOW</div> | <div>NO overflow having a less than 90 degree angle.</div> <div></div> | | | Grind or weld. |

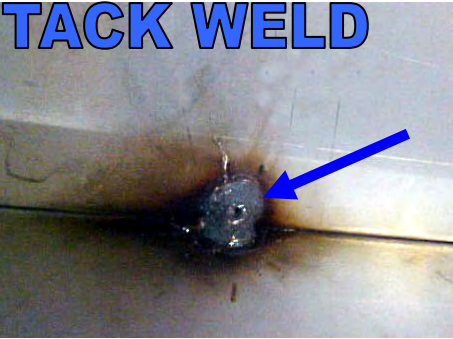
| TYPE OF DISCONTINUITY | MATERIAL THICKNESS | | | RÉPARATION |
|---|---|---|---|---|
| <div>TACK WELD</div> | NONE | NONE | NONE | <div>Grind or fuse with bead, minimum length : 10 mm.</div> <div>Blend with weld bead.</div> |

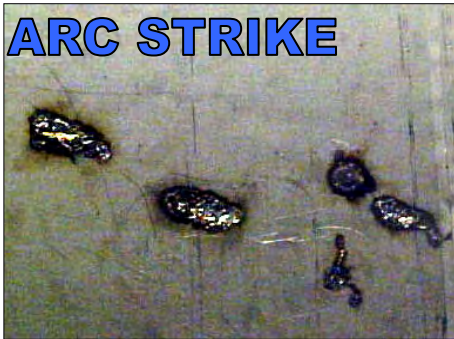
| TITRE: WELD INSPECTION | | NO: IT750004A | | |
|---|---|---|---|---|
| | NONE | NONE | NONE | Grind |

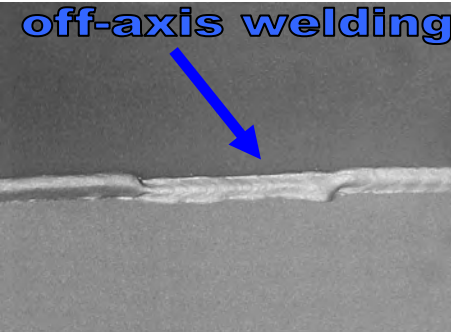
| TITRE: WELD INSPECTION | | NO: IT750004A | | |
|---|---|---|---|---|
| | <p>For a skewed weld to be acceptable, it should not exceed the following criterias:</p> <p>Max. length: 10 % of weld length</p> <p>Max. skew distance. : 1.5 mm</p> <p>Not to be located at the end of the weld seam: (12 mm)</p> | | | Grind and reweld |

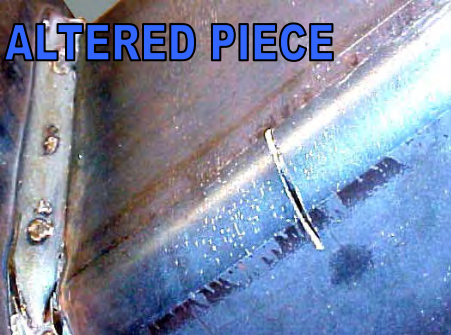
| TITRE: WELD INSPECTION | | NO: IT750004A | | |
|---|---|---|---|---|
| | No cut line, cracks or other defects on parts. | | | <p>The repair must meet the quality criterias.</p> <p>Contact the welding technician to see if the repair is possible, to be analyzed for exemption request.</p> |

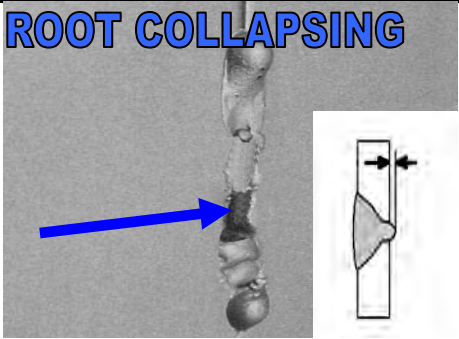
| <div><div>ROOT COLLAPSING</div></div> | | <p>The extra thickness of the collapse should not exceed 2 mm.</p> <p>Note : Repair if presence of porosity or undercut.</p> | <p>Excessive thickness :</p> <p>Grind</p> <p>Porosity or undercut:</p> <p>Grind and weld</p> |

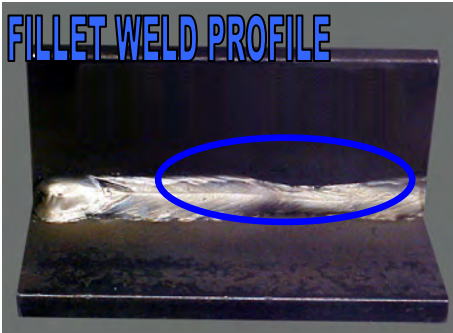
| DIMENSIONAL INSPECTION OF WELDS | | | | |
|---|---|---|---|---|
| <b>FILLET WELD PROFILE</b><br><br><br> | <b>Visually check and control with a dimensionnal gauge to make sure that weld profile is acceptable.</b> | | | <b>Weld or grind as required.</b> |
| | <b>The dimension of a continous fillet weld may be 2 mm less than required without correction if it is present on less than 10% of weld length.</b> | | As noted on drawing. | |

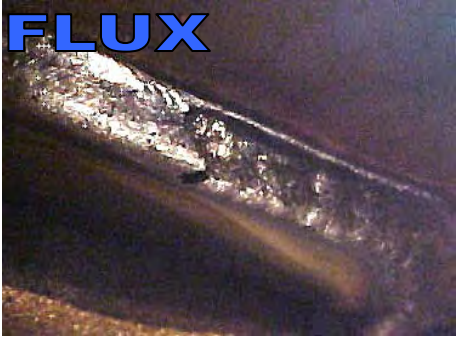
| MINOR DEFECTS | | | | |
|---|---|---|---|---|
| | NONE | NONE | NONE | Remove with a flux hammer |

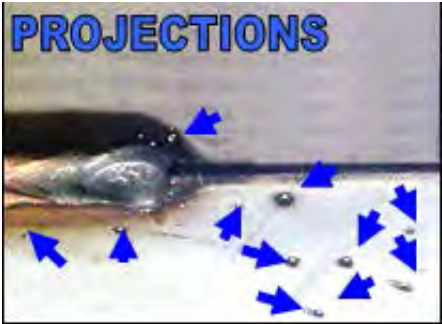
| MINOR DEFECTS | | | | |
|---|---|---|---|---|
| <br><br> | Remove <b>projections which do not fit the acceptable profile.</b><br><br>For carbon and stainless steels,<br><b>non adhesive projections are not permitted.</b><br><br>Maximum projections allowed without repair:<br><b>6 projections per 625 mm<sup>2</sup> (1 po<sup>2</sup>)</b> | | | Grind. |

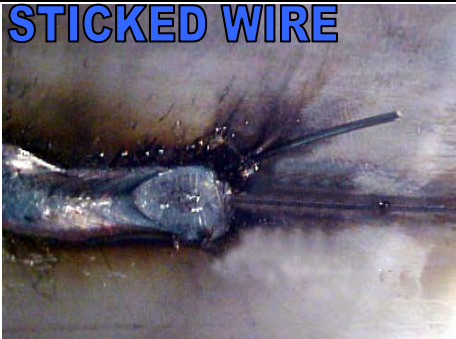
| MINOR DEFECTS | | | | |
|---|---|---|---|---|
| | NONE | NONE | NONE | Remove |
