# Special Bulletin

# SP18-304 A

## SLIDING DOOR ADJUSTMENT AND HARDWARE REPLACEMENT

Prevost vehicles

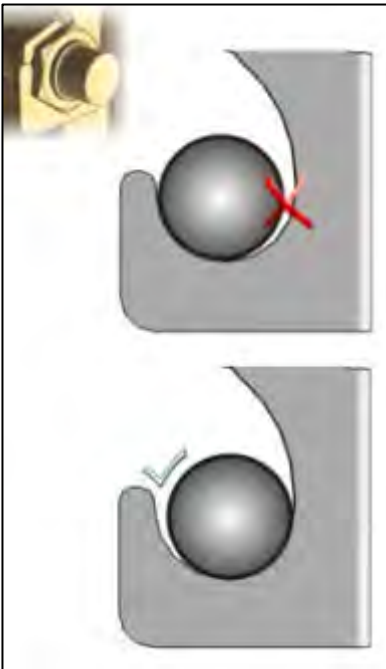
Figure 16

17. Check dimension (Figure 17) and position of proximity switch in support opening (Figure 16)

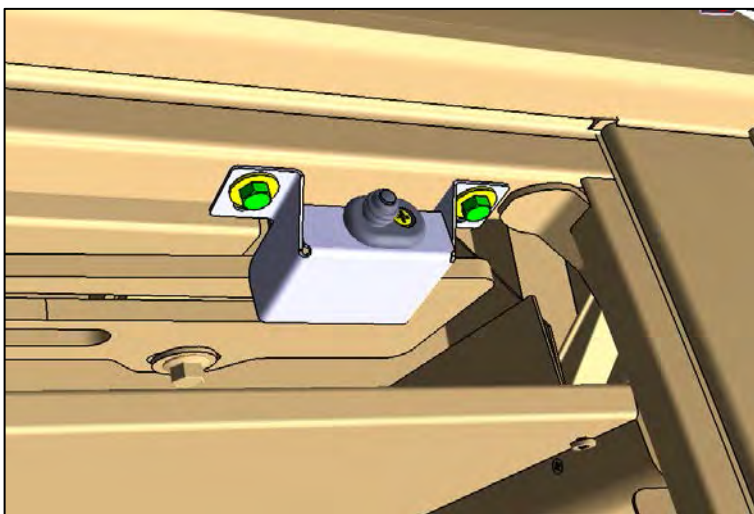
Figure 20

21. Check torque seal on the door switch support.

If broken, tighten to **7lb-ft**

Re-apply torque seal mark.

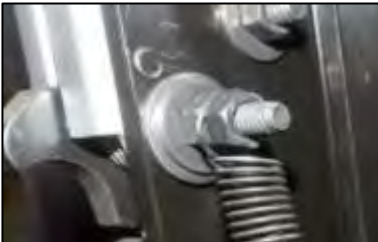
Figure 36

47. At lever spring anchor location, inspect torque seal. (Figure 36, Figure 37)

48. If broken, tighten to **7 lb-ft**

49. Apply torque seal mark.

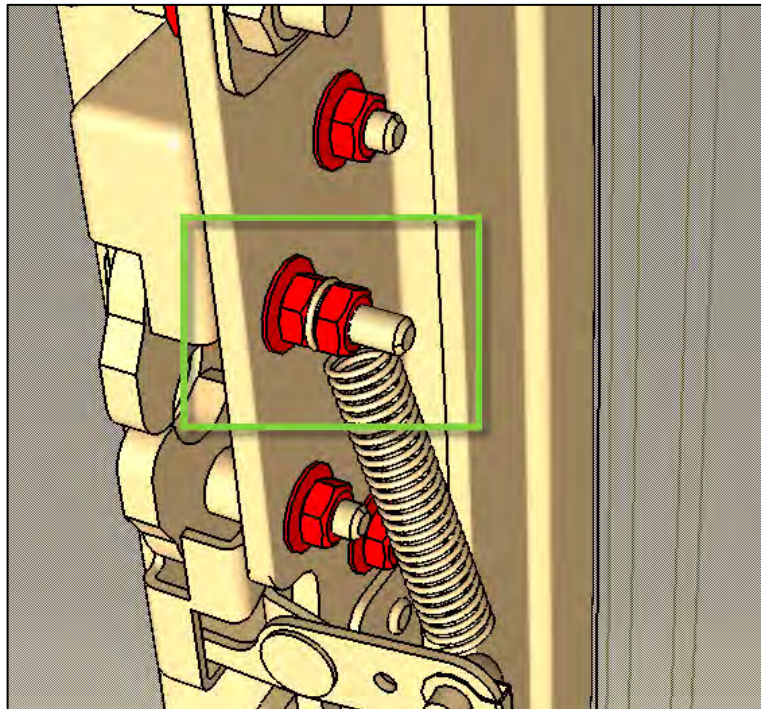
Figure 37

50. At the remaining three locations inspect torque seal. (Figure 37)

51. If broken tighten to **7 lb-ft\***

*\*Note- Inner nuts need #10 crowfoot adapter to torque properly*

52. Apply Torque seal mark

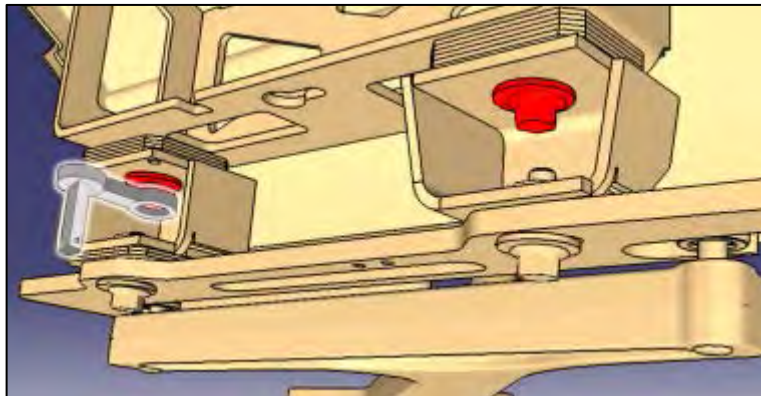
Figure 41

61. Inspect torque seal. (Figure 41)

62.If torque seal is broken,  
tighten to **34 lb-ft**

(Specific torque+2lb-ft)

Use a **torque extension** and a  
vertical **socket extension**. (See  
RECOMMENDED TOOLS)  
(Figure 42).

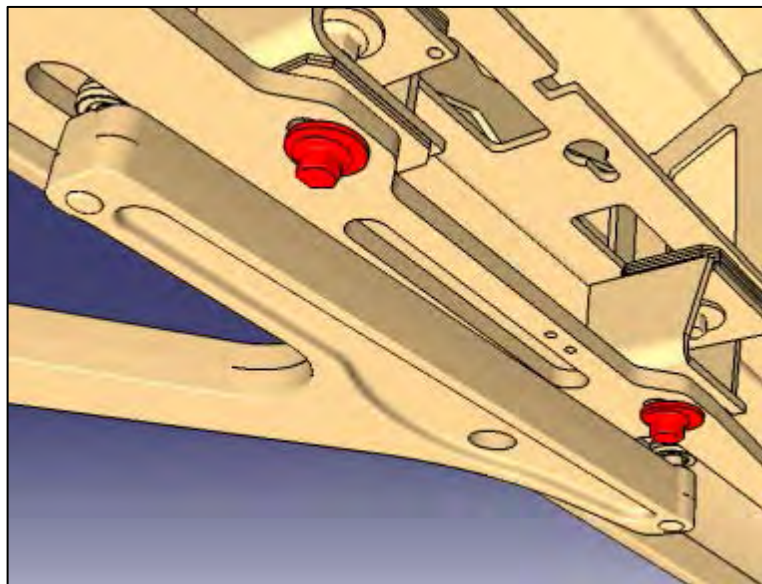
Figure 44

65.If inspection reveals  
adjustment is OK, check  
torque seal. (Figure 44).

66.If broken, tighten screws to  
**32 lb-ft**.

67.Add torque seal mark.

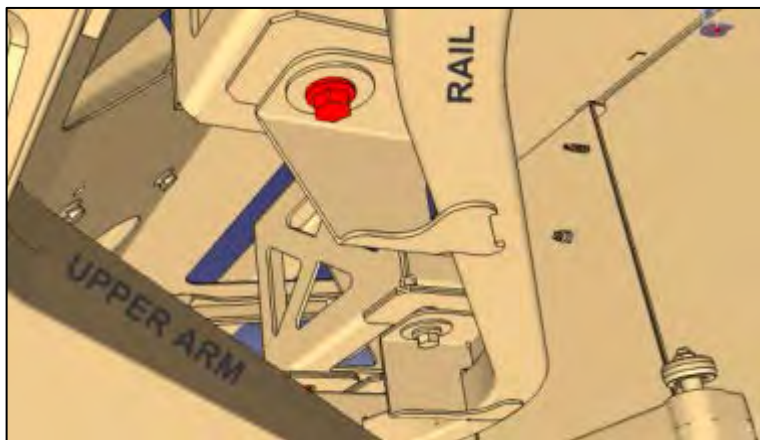
Figure 60

- 85. Check torque seal.
- 86. If seal is broken, Tighten to **16 lb-ft**
- 87. Apply torque seal mark.

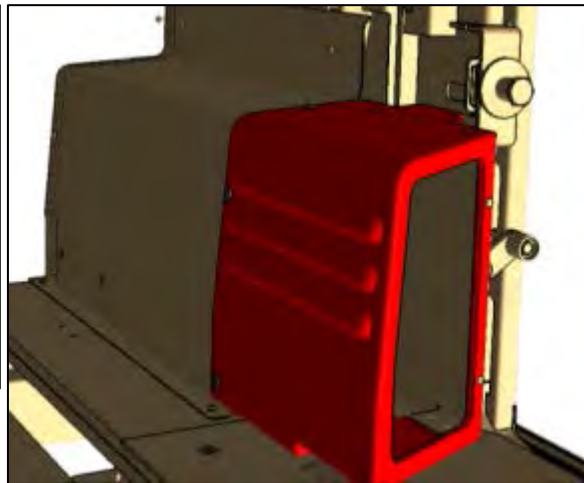
Figure 62: Careful not to squeeze cables and tubes.
