SERVICE CAMPAIGN BULLETIN

NTB18-051

VOLUNTARY SERVICE CAMPAIGN 2013-2017 SENTRA; ECM REPROGRAM

CAMPAIGN ID #s: PM827 and PC633
APPLIED VEHICLES: 2013-2017 Sentra (B17)
APPLIED ENGINE: MRA8DE (non-turbo)

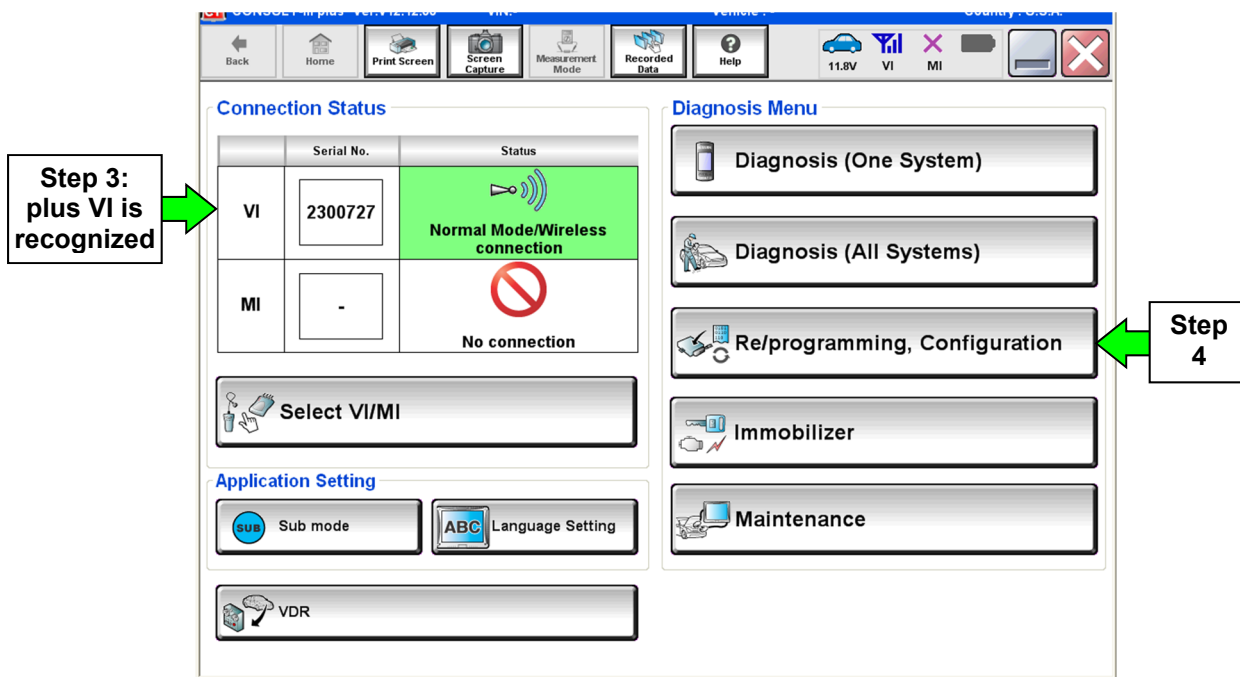
Figure 1

1. Connect the CONSULT PC to the vehicle to begin the reprogramming procedure.
- 2 Start C-III plus.
3. Wait for the plus VI to be recognized/connected.
 - The serial number will display when the plus VI is recognized/connected.
4. Select **Re/programming, Configuration**.

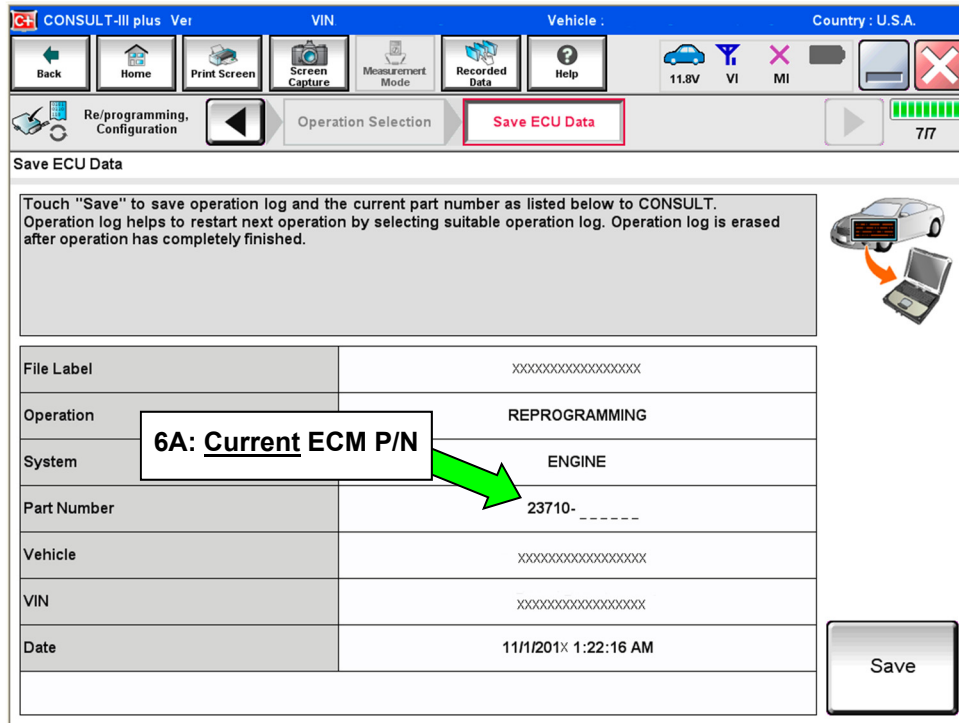
Figure 2

6. When you get to the screen shown in Figure 2, confirm this bulletin applies as follows.
- A. Find the ECM **Part Number** and write it on the repair order.

NOTE: This is the current ECM Part Number (P/N).

- B. Compare the P/N you wrote down to the numbers in the **Current ECM Part Number** column in **Table A** on the next page.
- If there is a match, continue with the reprogramming procedure.
 - If there is not a match, reprogramming is not needed. Proceed to page 12, **CLAIMS INFORMATION**, "Reprogramming Not Needed".

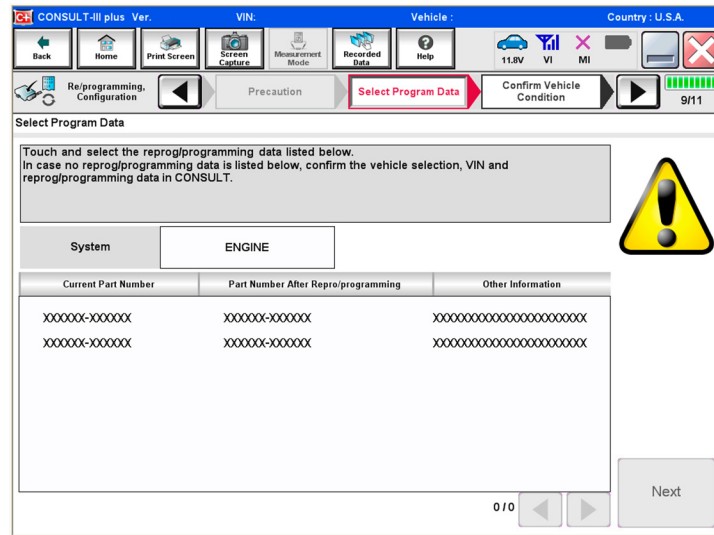
- In some cases, more than one new P/N for reprogramming is available.
 - In this case, the screen in Figure 3 displays.
 - Select and use the reprogramming option that **does not** have the message “Caution! Use ONLY with NTBXX-XXX”.
- If you get this screen and it is blank (no reprogramming listed), it means there is no reprogramming available for this vehicle.

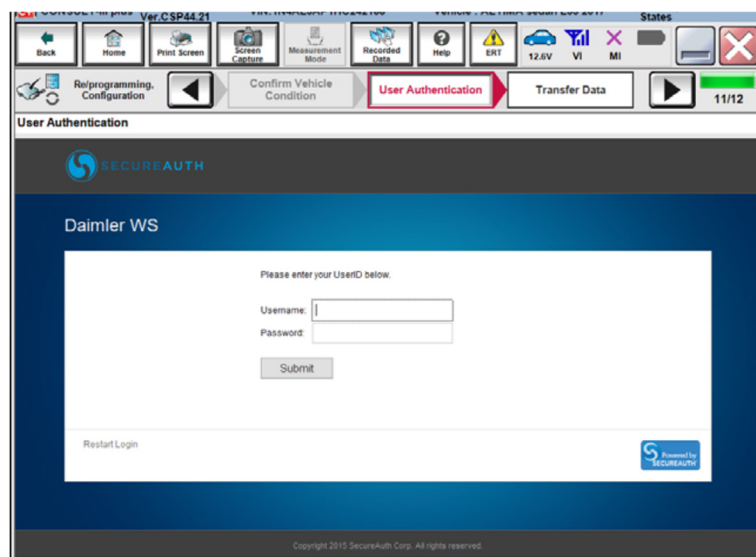
Figure 4

- Before reprogramming will start, you will be required to enter your User Name and Password.
 - The CONSULT PC must be connected to the Internet (Wi-Fi or cable).
 - If you do not know your User Name and Password, contact your Service Manager.

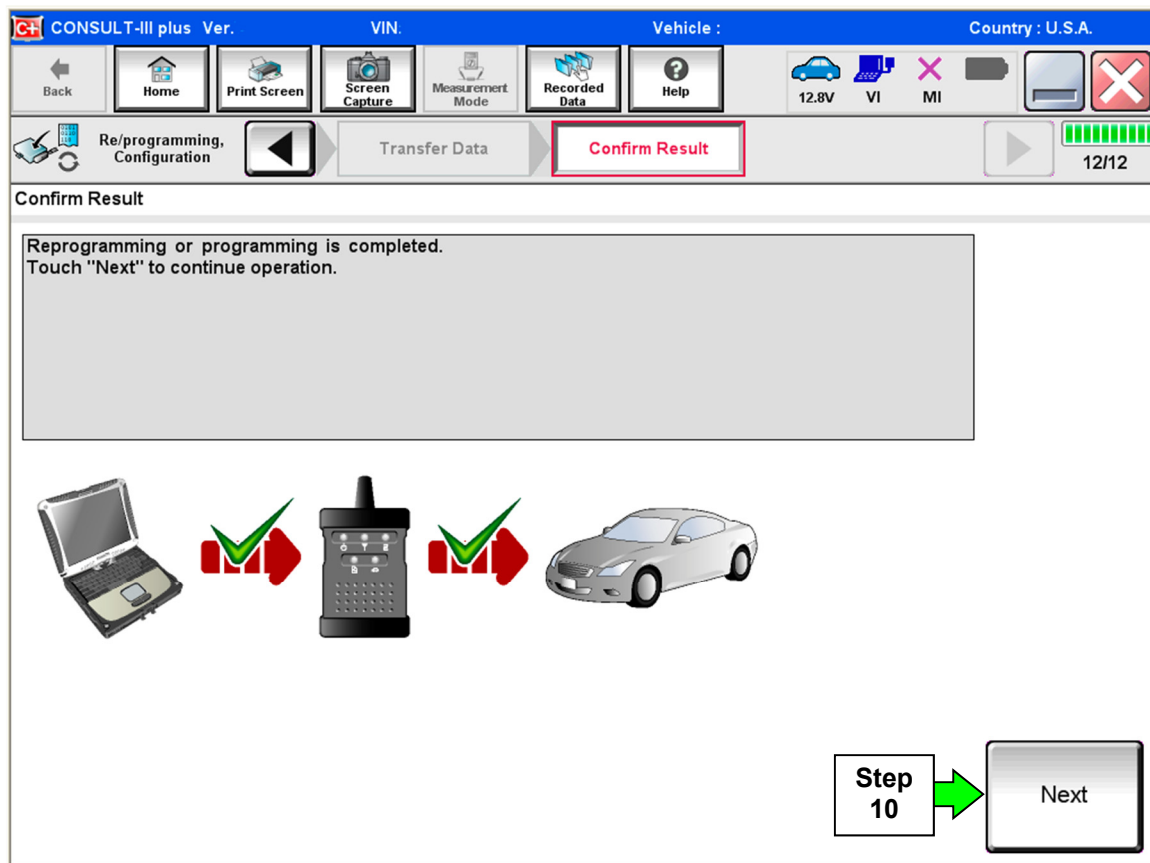
8. When the screen in Figure 5 displays, reprogramming is complete.

NOTE: If the screen in Figure 5 does not display (indicating that reprogramming did not complete), refer to the information on page 9.

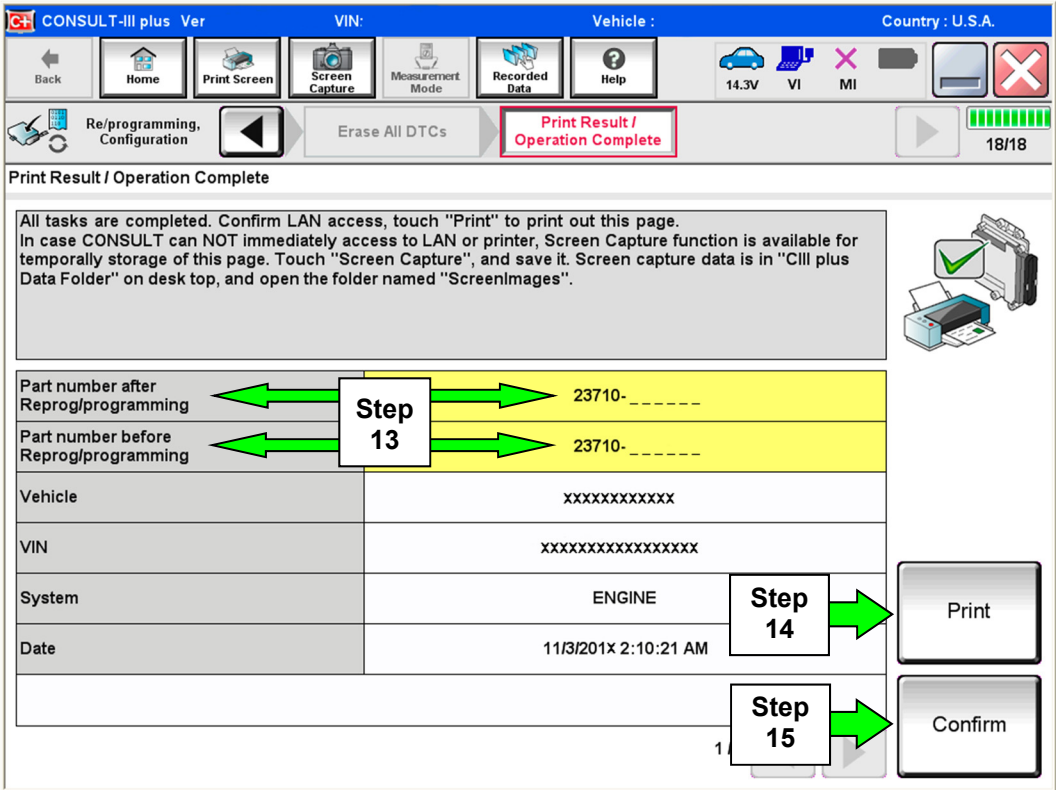
- 12. When the entire reprogramming process is complete, the screen in Figure 8 will display.
- 13. Verify the before and after part numbers are different.
- 14. Print a copy of this screen (Figure 8) and attach it to the repair order for warranty documentation.
- 15. Select **Confirm**.
