## SERVICE BULLETIN

**APPLICABILITY:** 2014-17MY Forester Turbo **NUMBER:** 07-136-18  
**SUBJECT:** New Alternator Assembly to Address Engine Vibration at Idle and False DTCs P0300, P0301, P0302, P0303 and P0304 **DATE:** 07/18/18

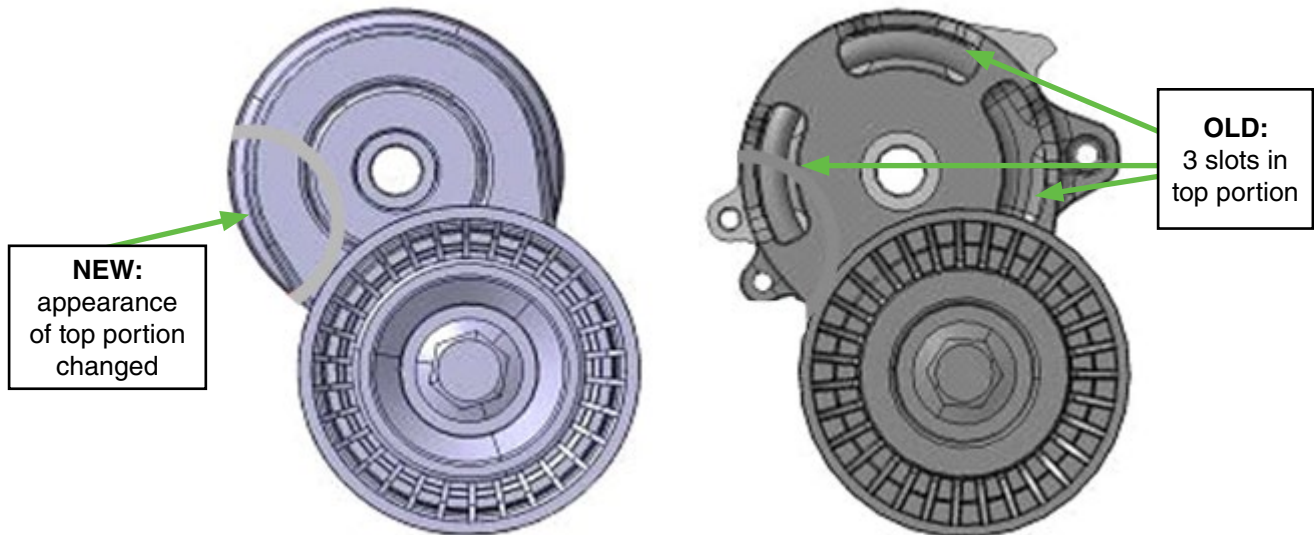
Resonance and / or oscillation between the alternator, drive belt and belt tensioner may cause the knock sensor to falsely identify a misfire condition and cause the engine misfire DTC(s) to set. To ensure a proper diagnosis, always determine the root cause of any misfire DTC BEFORE attempting any repairs. Refer to the procedure below for how to diagnose this condition:

- If a Battery Current value of more than +/- 3A is confirmed AND the roughness monitor value for the cylinder(s) setting the DTC keeps increasing, replace the alternator assembly, v belt and tensioner assembly **as a set** with the new parts listed in the table above.
