SERVICE BULLETIN

APPLICABILITY: 2015-2018MY Legacy and Outback NUMBER: 12-246-18

SUBJECT: "Popping" or "Snapping" Sound When

Opening the Sunroof

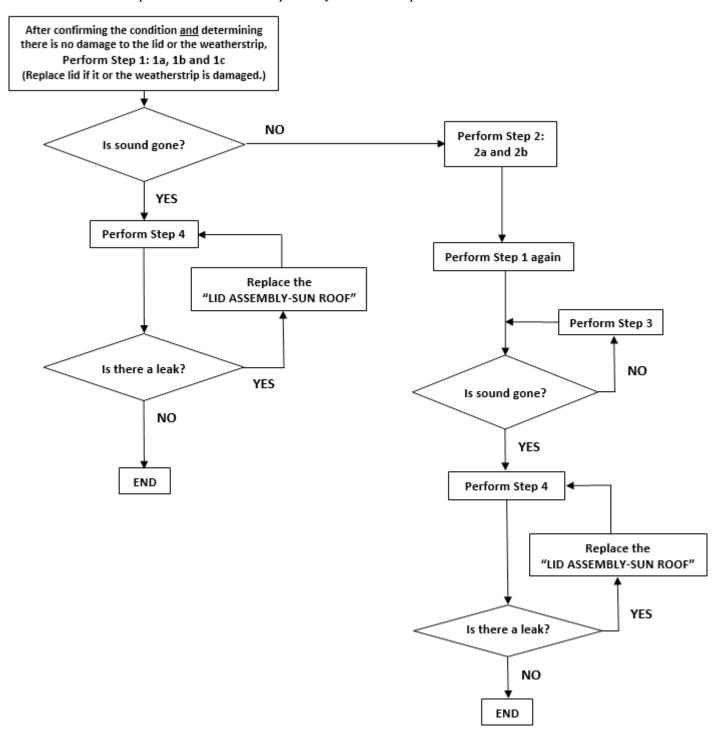
A flow chart is provided below to help clarify the service procedure.

Step 1: Adjust the lid forward to reduce chances of the weatherstrip sticking or catching the edge of the sunroof opening in the roof panel or the sunroof frame. This can cause the snapping sound and / or damage to the weatherstrip / seal..
