SERVICE BULLETIN

APPLICABILITY: 2017-18MY Impreza
 2018MY Crosstrek
 2018MY Legacy and Outback
 2018MY BRZ

NUMBER: 15-211-17R
DATE: 06/13/17
REVISED: 07/25/18

SUBJECT: Reprogramming File Availability for Additional Optimization of Harman Gen 3 Audio and Navigation Head Units

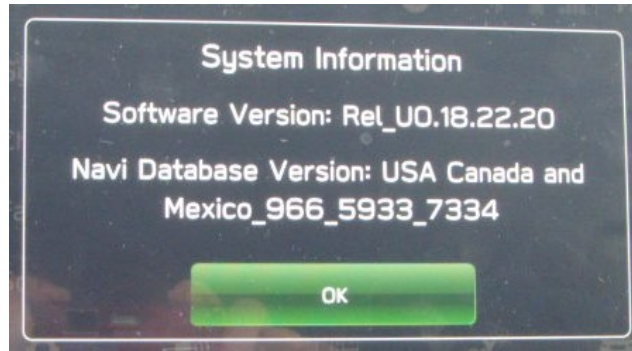
- Confirm the current Software Version ID. If the Current Version is **Rel_U0.18.22.20** STOP as this latest update has already been installed.

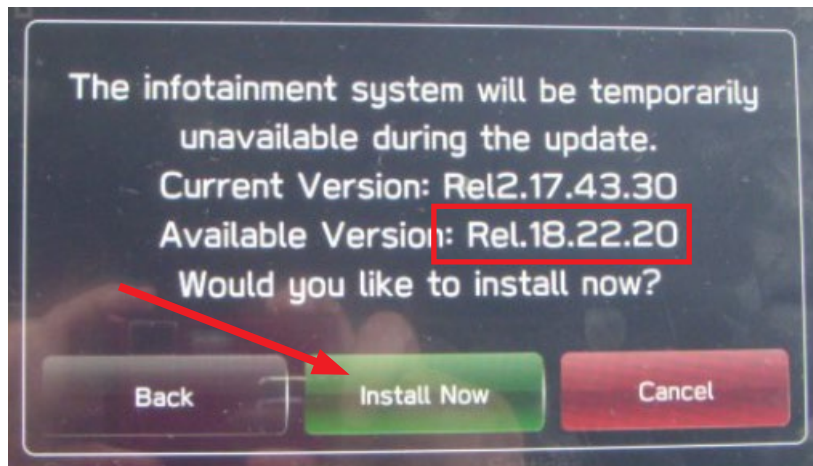
- The current and available software version information will be displayed. The Available Version I.D should be **Rel.18.22.20**.

NOTE: The displayed Available Version as shown below does not show the 2 after Rel. This is normal.

- After confirming the Available Version, press “Install Now” to start the reprogramming process. The screen will go blank (black) for a brief period after installation begins.
- Each of the updates (Base, Mid and High) should take less than 10 minutes to install.

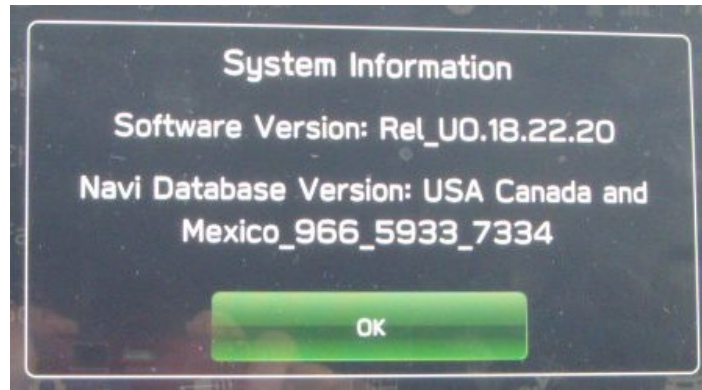
- Confirm Software Version is now “**Rel_U0.18.22.20**”.
