Subject: ENGINE NO START AND / OR REAR VIEW MONITOR DISPLAY IS BLURRY DUE TO AFTERMARKET ELECTRICAL DEVICE	M-Tips No.: MT-007/18
	Last Issued: 07/20/2018

APPLICABLE MODEL(S)/VINS

2014-**2018** Mazda3
 2014-2018 Mazda6
 2016-**2019** CX-3
 2013-2018 CX-5
 2016-2018 CX-9
 2016-2019 MX-5

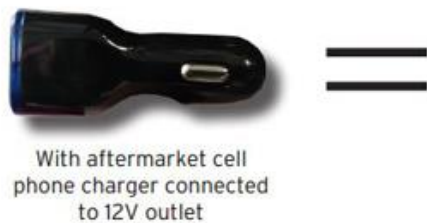
Example 2

Rear View Monitor Display is Blurry:

Blurry Display

Warranty Compliance Note: Repairs for this concern are not covered under Mazda's warranty policy. Advise the customer not to use the aftermarket device that is causing the concern.
