# Service Campaign Bulletin

Campaign No. 2018040008, June 2018

SUBJECT: **Model A205, Model Year 2018**  
**Check Luggage Cover**

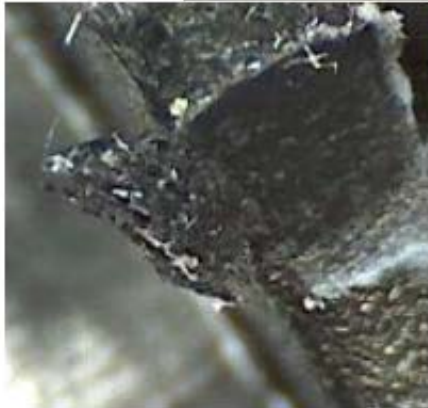
Figure 7 (NOT OK)

**i** Rib of housing may not be damaged **(figure 7)**.

- a. All test conditions **OK**:  
**Assemble** in reverse order and **end measure**.
- b. Heat-sealing of magnetic pocket **not OK**:  
Carry out **work procedure A**.
- c. Rib of housing below plunger **not OK**:  
Carry out **work procedure A**.
- d. Cable set **not OK**:  
Perform **work procedures B and C**.
- e. Position of flat-wire connectors **not OK**:  
**Carry out work procedure C**.

1. Replace partially electric trunk luggage cover.
