## Technical Information Bulletin

### E191

PACCAR MX-13 EPA2017 MY2017 Engine Brake Rocker Inspection

8/7/2018

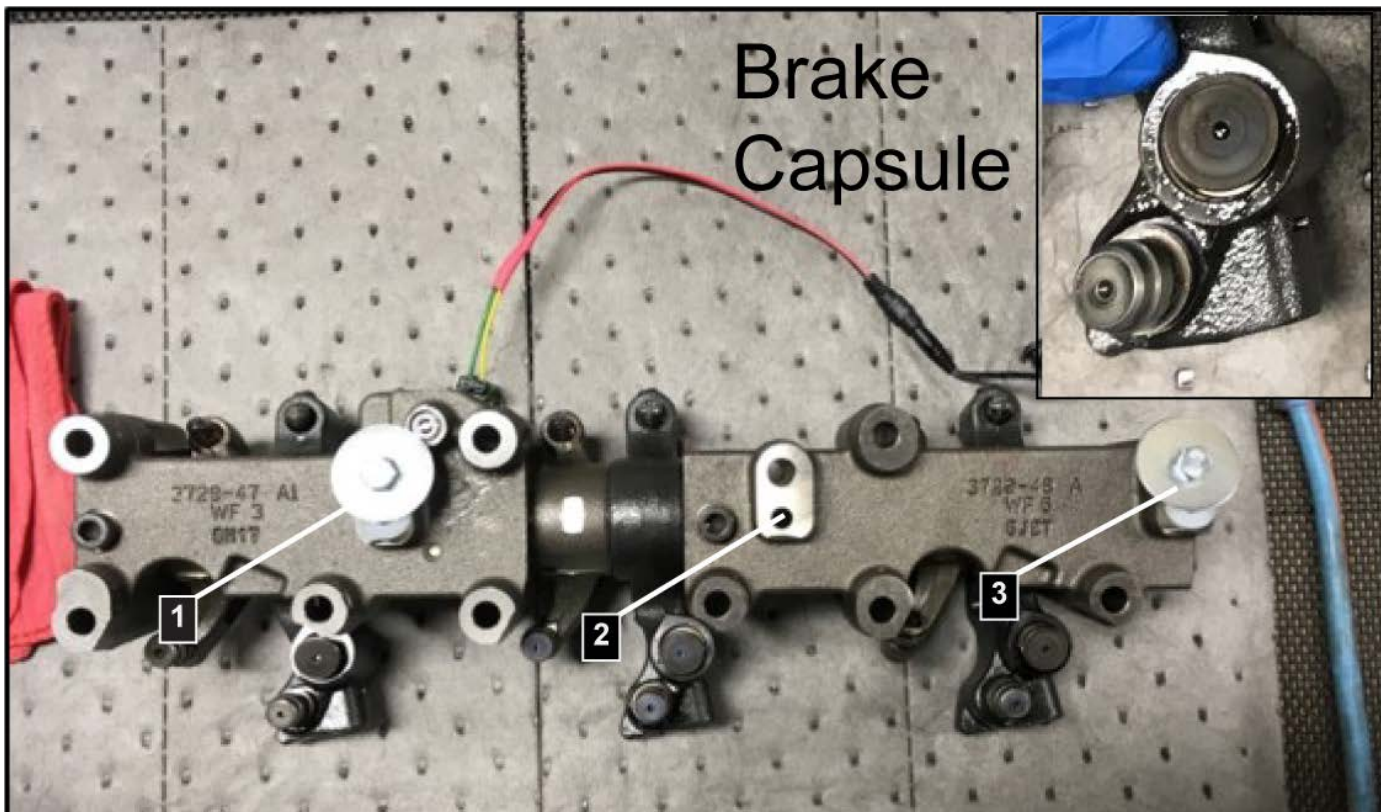
**i** NOTE

Oil hole (2) is left open to supply air.

4. Connect the 12-volt power source and supplied jumper wire to the Oil Control Valve (OCV). Connect the power source to a 120V source. A distinct click will be heard from the OCV when power is applied to it.
5. Place clean shop rags over the plugged oil holes (1 & 3 in the image above) to capture any potential oil spray during the procedure.
6. Place shop rags underneath the brake capsule foot to be removed.
