## FIELD INSPECTION INSTRUCTIONS

For Kenworth Outboard Sliding Fifth Wheels

## Technical Information Bulletin

JOST 5<sup>th</sup> Wheel Outboard Slider Clearance Inspection

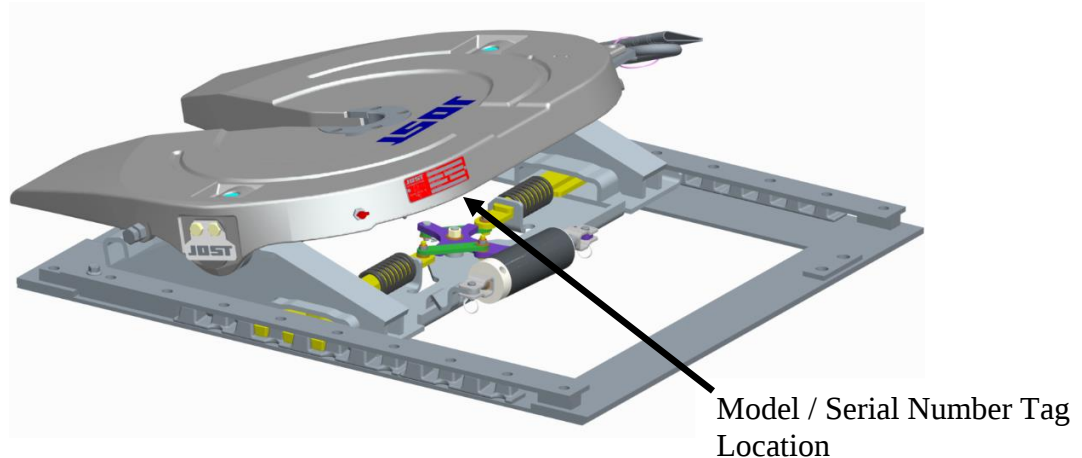
Jost International has concluded a possibility exists that a production unit built containing a prototype component has been shipped to Kenworth Chillicothe. This single **(1)** unit has an incorrectly sized slider bracket that is easily detectable following the procedure on page two.

#### Model Number

37USA-A8PX12

37USB-A8PX12

37USB-A8PX16

37USB-A8PX24

If inspection does result in finding the (1) unit in question, DO NOT use the tractor. Please call 800-253-5105 to order a replacement bracket. Jost replacement procedure LT JSK37-13 will be provided.
