## SERVICE BULLETIN

**APPLICABILITY:** 2014-2018MY Forester

**NUMBER:** 12-204-16R

**SUBJECT:** Pop, Click, Creak Sounds from the Rear Body Area

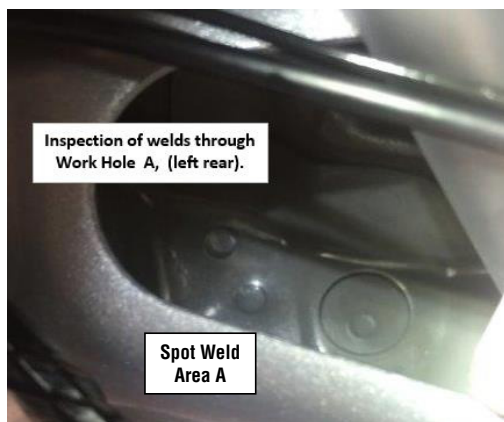
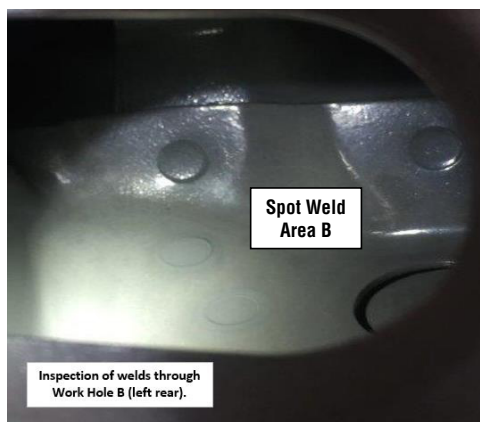
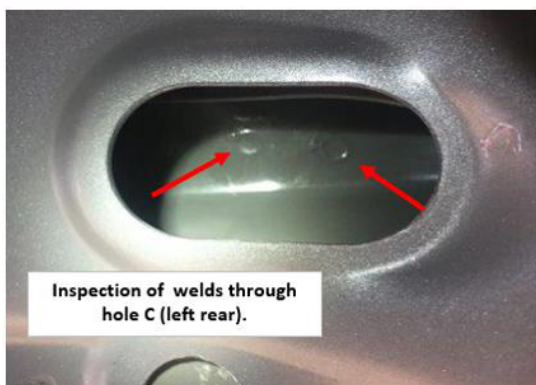
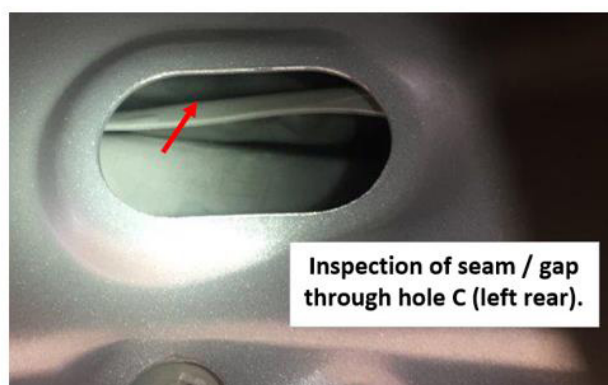
Use the reference photos provided below to help with identification of the areas described throughout the service procedure steps. **NOTE:** In order to better show the described weld and seam areas, the orientations of these photos may differ in comparison to how they actually appear on the vehicle.

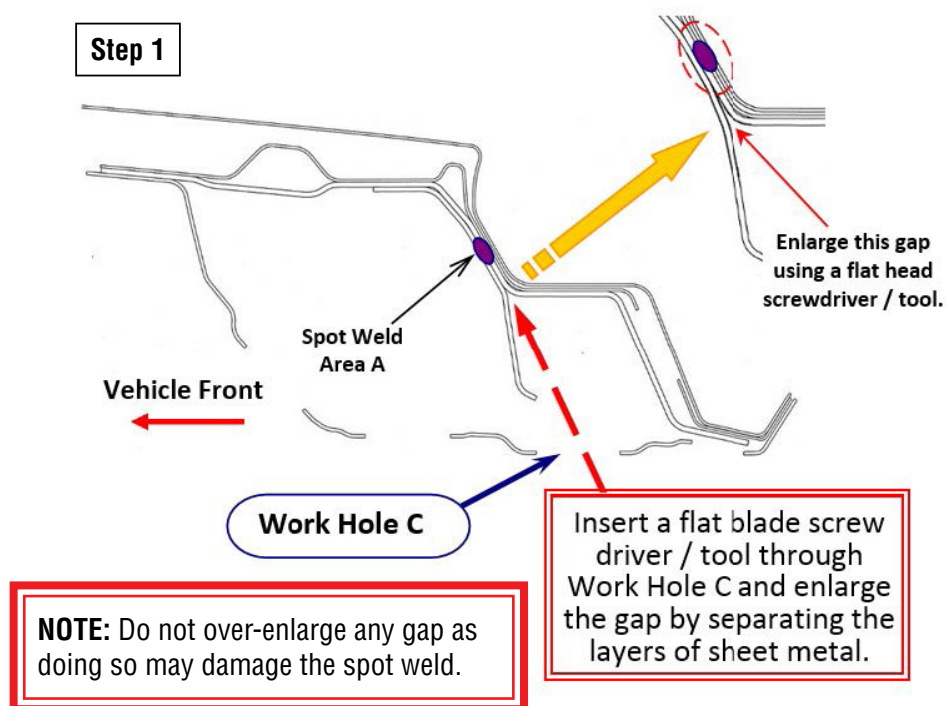
Photo shows weld spatter between layers of sheet metal.

**NOTE:** It is **VERY IMPORTANT** to perform each (without skipping over any) of the **STEPS (1-4)** as outlined below before proceeding to **STEP 5** (welding repairs).
