Technical product information

Topic	Bentayga W12 - Bentley dynamic ride system fault displayed in Driver Instrument Panel
Market area	Bentley: worldwide (2WBE),Hongkong-Macau (5HK)
Brand	Bentley
Transaction No.	2051553/1
Level	EH
Status	Approval
Release date

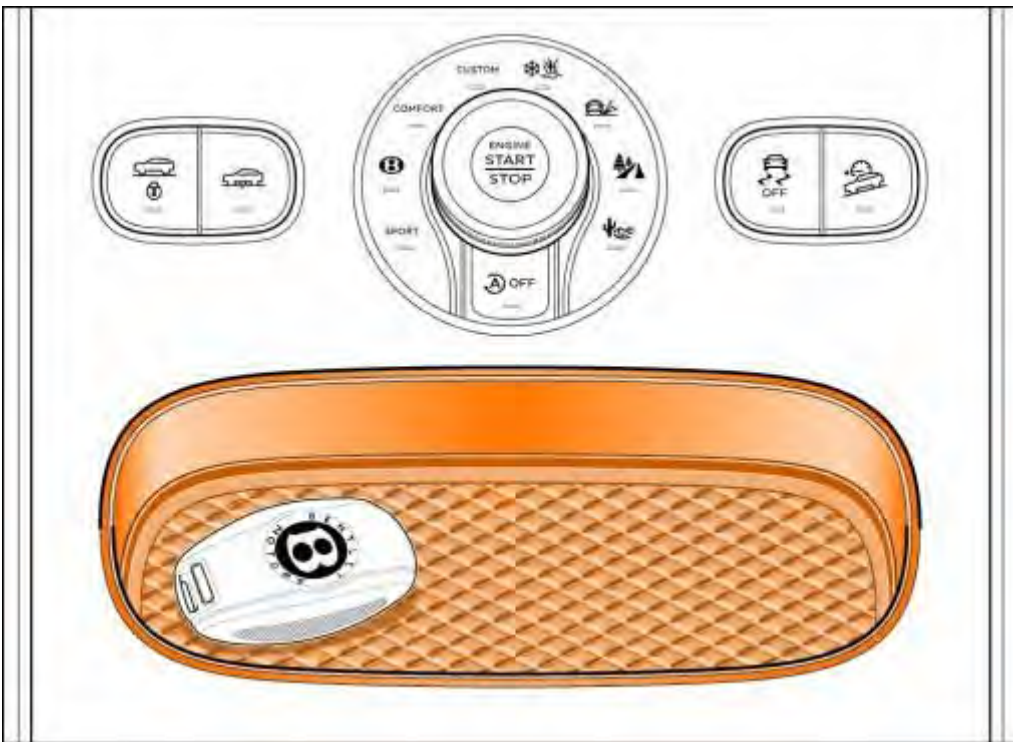
Figure 1

2. Ensure the ignition key is located in the remote control key reader and switch on the ignition (see Figure 1)
3. Connect the Bentley approved diagnostic tool to the vehicle On Board Diagnostic (OBD) socket. NOTE: The process is Initiated via Bentley diagnostic tool (VAS 6150C or similar) using a hard wire connection to the vehicle OBD socket, Bluetooth connections should not be used
Your Bentley diagnostic tester must be loaded with Bentley Brand Diagnostic Data Version 2.24.7 or higher
4. From the diagnostic tool main desktop select Off board Diagnostic Information System
5. Select – Start diagnosis
6. Select – Model / Engine
7. Select guided fault finding to check and clear the vehicle of any fault codes. NOTE: At this stage when requested to make a Target/Actual comparison do not perform this action select NO

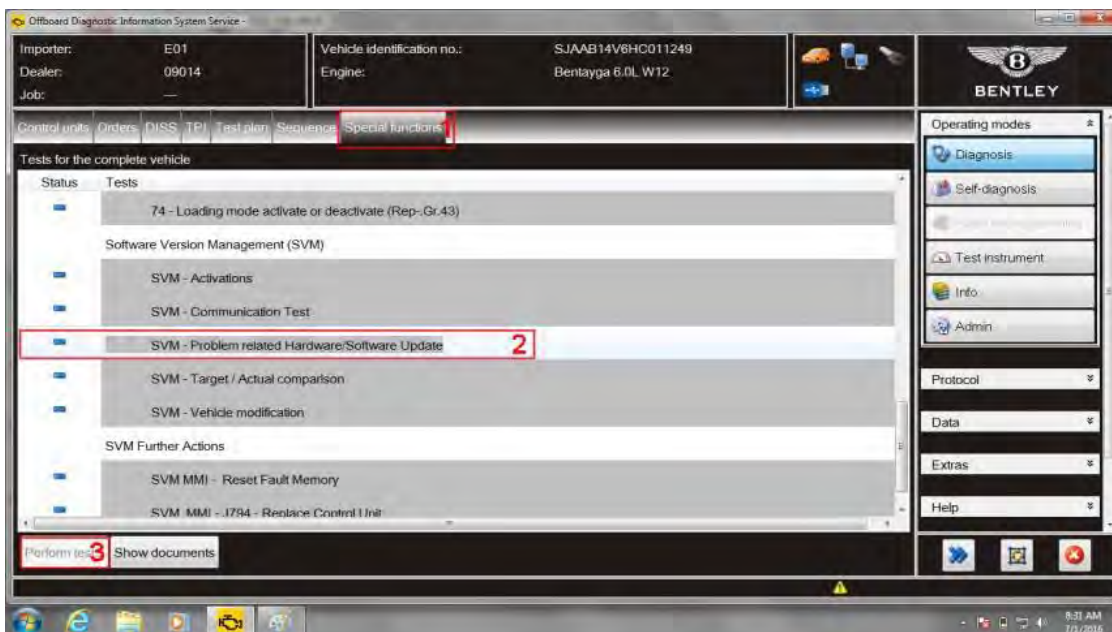
Figure 2

8. Referring to Figure 2, Select Specialfunctions (1), Select SVM – Problem related Hardware/Software Update (2), Select Perform test (3)

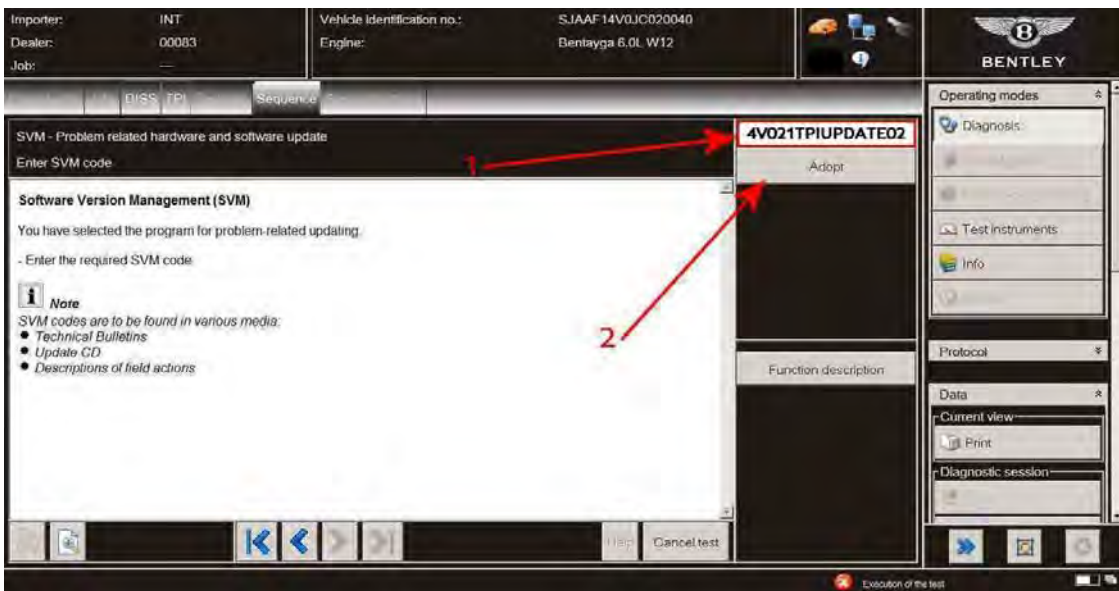
Figure 3

9. Referring to Figure 3, at the SVM screen (1) enter the specific SVM code 4V021TPIUPDATE02 and then select Adopt (2)

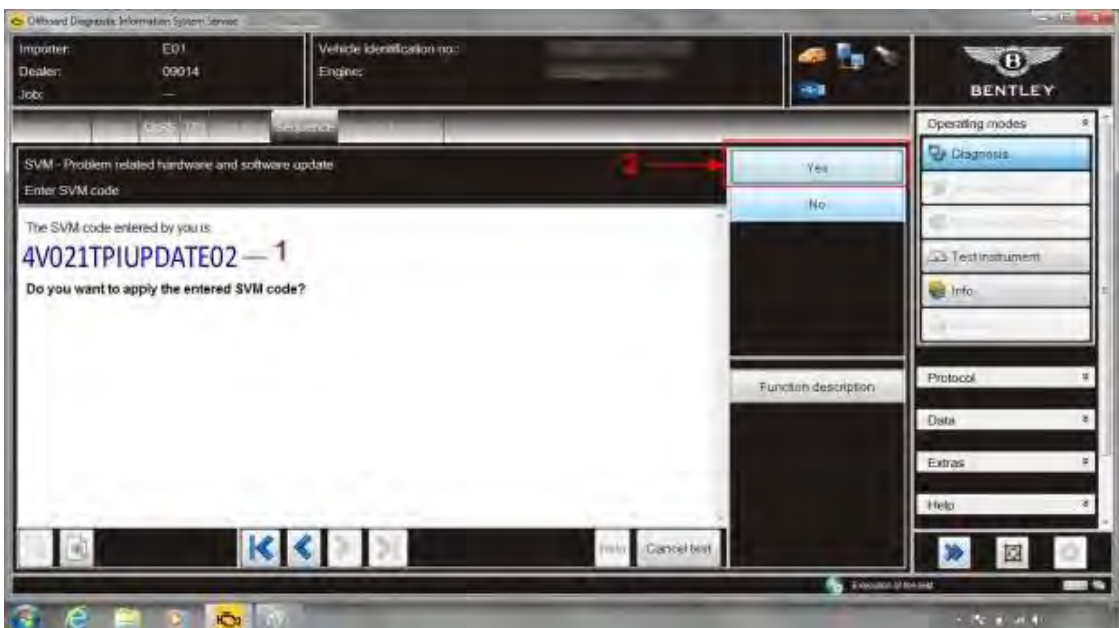
10. Referring to Figure 4, Check you have entered the correct SVM code (1) and select Yes (2)

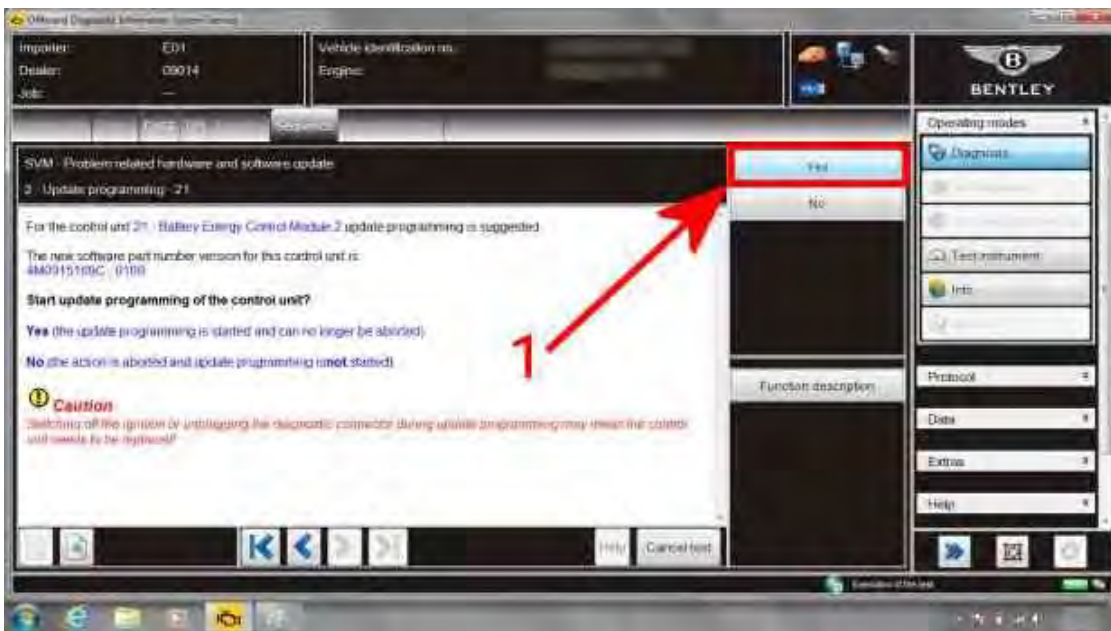
14. Select Yes at Update programming 21 to update 21 – Battery Energy Control Module 2 (see Figure 4 point 1)
15. During update a progress bar will be displayed
16. Once the battery energy control module 2 is updated an automatic SVM will take place

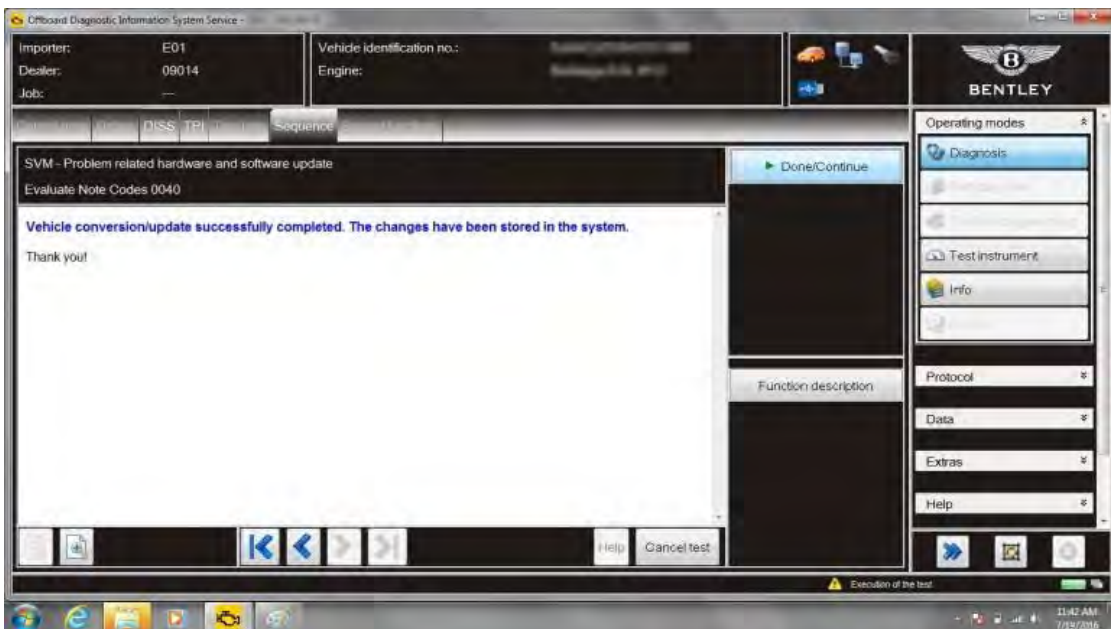
Figure 5

17. Select Done/Continue at successfully complete to finalise the update (see Figure 5)
18. Select Guided fault finding to check and clear the vehicle of any fault codes generated as a result of performing this campaign
 - Make a Target/Actual comparison - Follow on screen prompts
