### **✓ DTCs P0420 & P0421: PROPER CATALYST DIAGNOSIS AND PART IDENTIFICATION** – 2013-15 Outlander Sport/RVR.

### **TIN-18-13-002: ENGINE ECU SOFTWARE UPDATE IN TSB-18-13-001 & TSB-18-13-002 ADDRESSES BOTH DTC P0068 & P061A** – 2018 Eclipse Cross.

### **TIN-18-23-003: COOLANT LEAKING FROM CVT HOSES – COLLECTION OF PARTS COMPLETE**

### **TIN-18-35-001: BRAKE FLUID LEAK AT BRAKE MASTER CYLINDER**

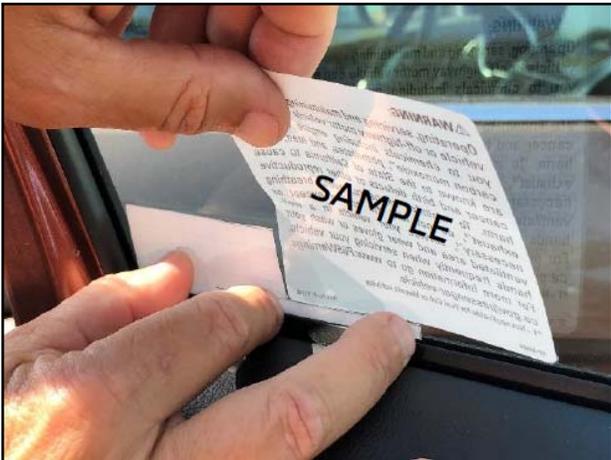
3. Apply label as shown. Label should be parallel to the bottom of the window (@ 5 mm above the rubber) and not cover any part of the DOT information etched into the glass.  
Gently push out any trapped air bubbles.

**NOTE: The label can be removed and reapplied if necessary.**

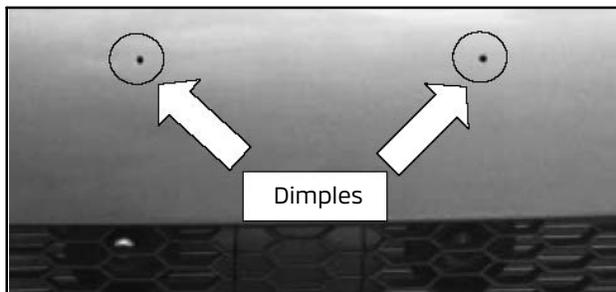
Most models 2013 and newer may not have license plate brackets/hardware shipped with the vehicle. For states that require front license plates, dealers are asked to use self-tapping screws for mounting the front license plate. License plates should be installed in the locations indicated by dimples in the front fascia. Dealers should use locally sourced, non-corroding M6 fasteners, 20 mm to 25 mm long. **Fasteners should be installed using hand tools only.**

**Do not submit any claims for missing front license plate hardware.**

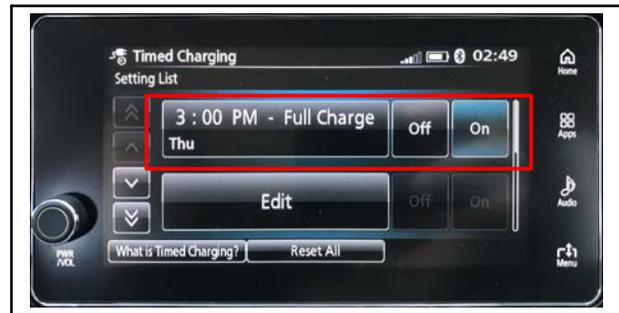
If a customer has set a delayed timed charging in the Smartphone Link Display Audio or in the PHEV II App, connecting the OEM Level 1 charge cable or a Level 2 charger outside the designated time will prevent the charge indicator in the combination meter from coming on and vehicle charging will not start. The "CHARGING" indicator light on the OEM Level 1 charger will be flashing green or the "charging" indicator (if applicable) on the Level 2 charger will be flashing. When checking the vehicle further, no vehicle warning lights come on after going into READY mode and no DTCs are found.

3. Confirm a set delay charging time. In this example, timed charging is set on Thursday at 3 PM.

4. Either press OFF or "Reset All" for Timed Charging. This operation can also be performed on the PHEV II App.
