## ENGINE CRANKS, NO START AND/OR ENGINE COOLANT TEMPERATURE FAULTS

This Service Information bulletin replaces SI M17 01 15 dated **March 2015**

R55 (Cooper S Clubman)	R56 (Cooper S)	R57 (Cooper S Convertible)	R58 (Cooper S Coupe)
R59 (Cooper S Roadster)	R60 (Cooper S Countryman)	R61 (Cooper S Paceman)

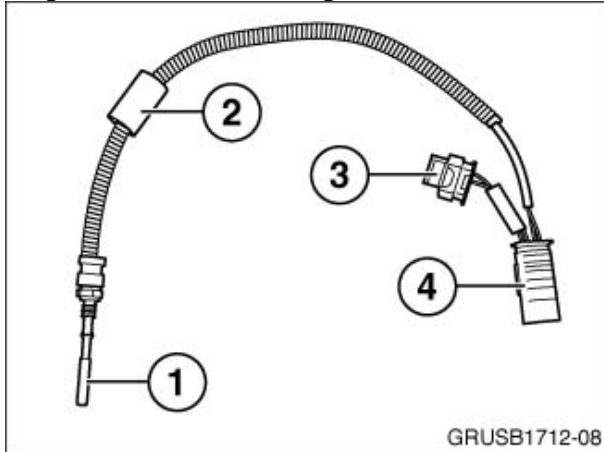
The improved sensor (P/N 13 62 8 603 908) includes the temperature probe (1) and insulating sleeve (2), a two-pin female connector (3) for the map thermostat, and a four-pin connector (4) for the engine harness.
