# **Emissions Recall Code: 23V2**

Subject	3.0L TDI Engine – Emissions System Modification
Release Date	July 26, 2018
Affected Vehicles	U.S.A.: 2011-2012 MY Audi Q7 3.0L TDI Generation 1.2
	Check Campaigns/Actions screen in Elsa on the day of repair to verify that a VIN qualifies for repair under this action. Elsa is the <u>only</u> valid campaign inquiry & verification source.
	✓ Campaign status must show "open."
	<ul> <li>If Elsa shows other open action(s), inform your customer so that the work can also be completed at the same time the vehicle is in the workshop for this campaign.</li> </ul>
Problem Description	3.0 TDI vehicles were equipped with undisclosed Auxiliary Emission Control Devices which are not permitted by emissions regulations.
Corrective Action	Install updated engine control module (ECM) software, transmission control module (TCM) software and hardware to bring affected vehicles into regulatory compliance.
Code Visibility	On or about July 26, 2018, affected vehicles will be listed on the Inventory Vehicle Open Campaign Action report under My Dealership Reports. A list will not be posted for dealers who do not have any affected vehicles. The campaign code will show

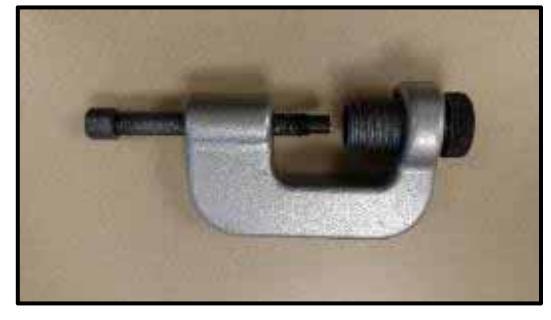
Due to corrosion, one or more of the mounting studs may break <arrows> when removing the SCR catalytic converter from the Diesel Particulate Filter (DPF) flange.

**<u>DO NOT</u>** use a hammer and punch, heat, torch, air hammer, or other method to remove the studs from the DPF flange.

- If stud replacement is necessary, <u>IT IS</u> <u>REQUIRED</u> to use a press tool such as the OTC 5057 clevis pin press (or equivalent), or other available screw or hydraulic type clevis/stud press tool to remove all necessary studs from the rear DPF flange.

- It is advised if one stud breaks that all three studs are pressed out and replaced with the bolts/nuts included in the parts kit.
  - Lubricate the OTC 5057 clevis/stud press tool threads and the press pin contact tip with hot bolt paste or anti-sieze lubricant before each use.

- For best results, cut any studs that do not break off as close to the flange as possible. Pressing a full length stud increases the chance of bending the stud, which may complicate the removal process.

- Use a cap from the VAS 6122 Engine Bung Set (or equivalent) to cover the hole in the DPF to eliminate the chance of contaminating of the DPF substrate with metallic particles when cutting the studs.

- Install the replacement bolts and corresponding nuts into the rear DPF flange.
