**Title:** Batt2 Load Shed Relay Failure

**Applies To:** LT's Without 16UZZL

This document will guide the user through identifying a failed relay and possibly a spread terminal resulting in loss of power to the sleeper.

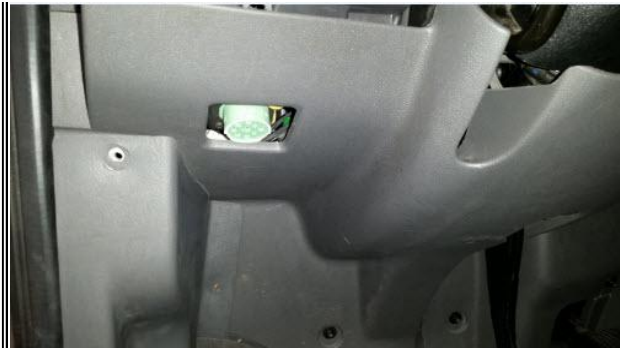
2. Remove Driver's side kickpanels for access to the bulkehead and wiring.

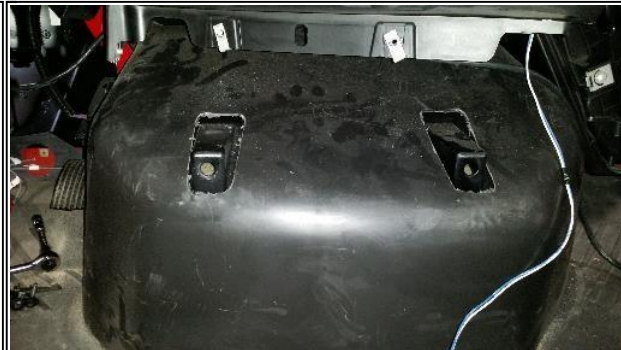
3. Remove dog house outer cover.

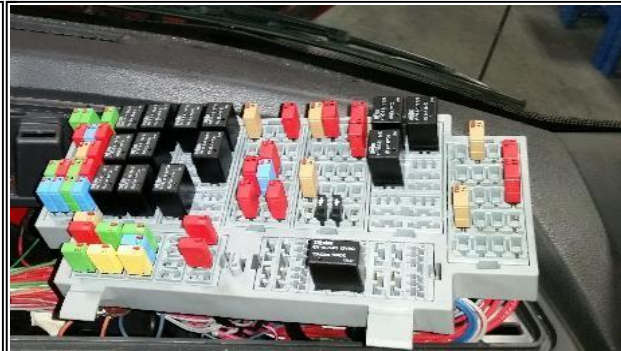
5. Loosen and set aside the PDM.

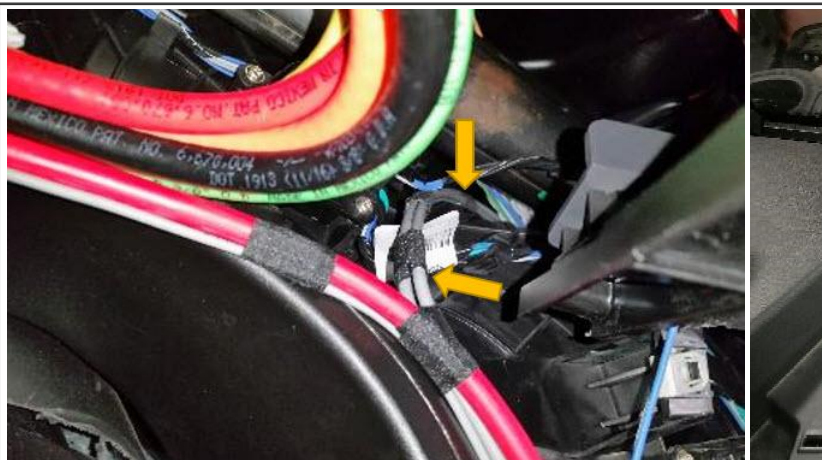
2. Feed the 3 blunt cut wires up labeled (A14XS, A14X and A14Y) up through the center console above the rear engine cover up to the fuse panel.

It may be helpful to insert a long screwdriver or some kind of stick from the top of the fuse panel so it would be possible to see it from underneath to help guide the routing of the wires up to the fuse block area.

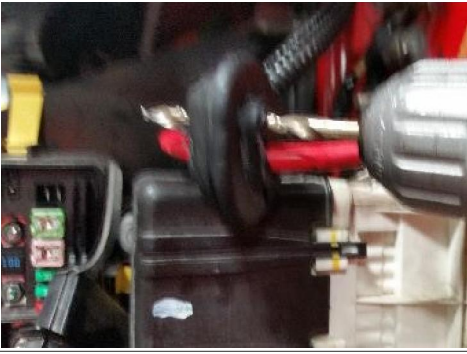
5. Drill a series of slightly increasing diameter, pilot holes into the grommet above the existing BCM power feed to carefully expand a hole thru the grommet to feed the red wire (A14A). Avoid contact between the drill bit and the BCM power feed cable. Center the drill bit so it is approximately 3/8" above the closest point of the BCM power feed cable.

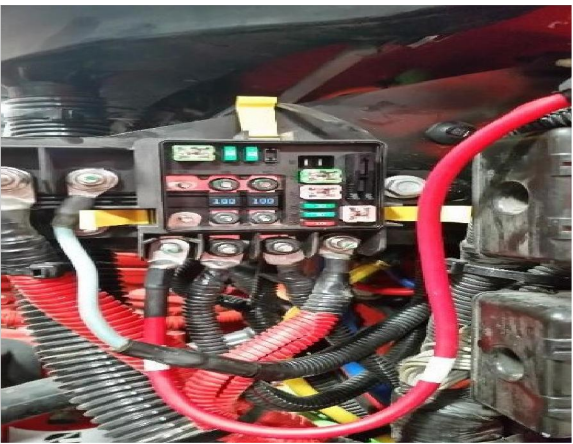
| <p>6. Feed the red wire (A14A) with ring terminal end thru the drilled hole in the grommet being careful not to tear the grommet. Pull approximately (1 to 1.5) feet of the red wire (A14A) thru the grommet.</p> <p>7. Reinsert the grommet back into the cab opening. Make sure that grommet is fully seated into the opening. It may be necessary to check the seating of the grommet from inside the cab as well.</p> <p>8. Connect the ring terminal to the same terminal that the body controller is currently receiving power from. Torque 15 +/- 1.5 N/M</p> <p>9. Install conduit and zip ties. Make sure there is a slight drip loop made with the body controller power and new harness power feed.</p> | |

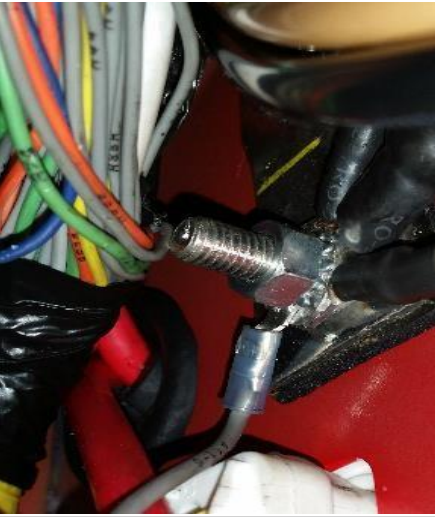
| <p>10. On the inside of the cab, connect the ground ring terminal (A111-g) to the cab ground stud.</p> <p>11. Install the plastic cap on the ground stud and ensure that the harness will not rub on the ground stud.</p> <p>12. Using the double sided adhesive and zip ties mount the fuse to the bulkhead and secure in place with the zip ties provided on any convenient location near the ground stud.</p> | |
