LTB01133NAS1

TECHNICAL BULLETIN

415-01: Information and Entertainment System

Voice Echo During In-Vehicle Hands-Free Call

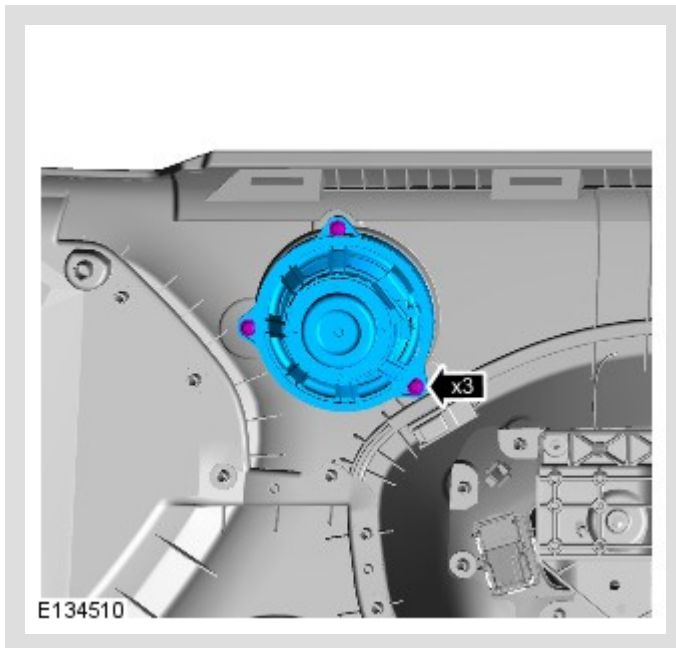
3

Possible damage to the mid-range speaker due to a weld tower present on the mid-range speaker grille.

Remove the mid-range speaker.
