## SERVICE BULLETIN

**APPLICABILITY:** 2017-2019MY Impreza  
 2018-19MY Crosstrek  
 2018-19MY Legacy and Outback  
 2019MY WRX and WRX STI  
 2019MY Ascent  
 2018-19MY BRZ

**NUMBER:** 15-221-18R  
**DATE:** 04/11/18  
**REVISED:** 09/05/18

**SUBJECT:** Harman Audio / Infotainment: Harman Generation 3.0 and 3.1 Operating Tips

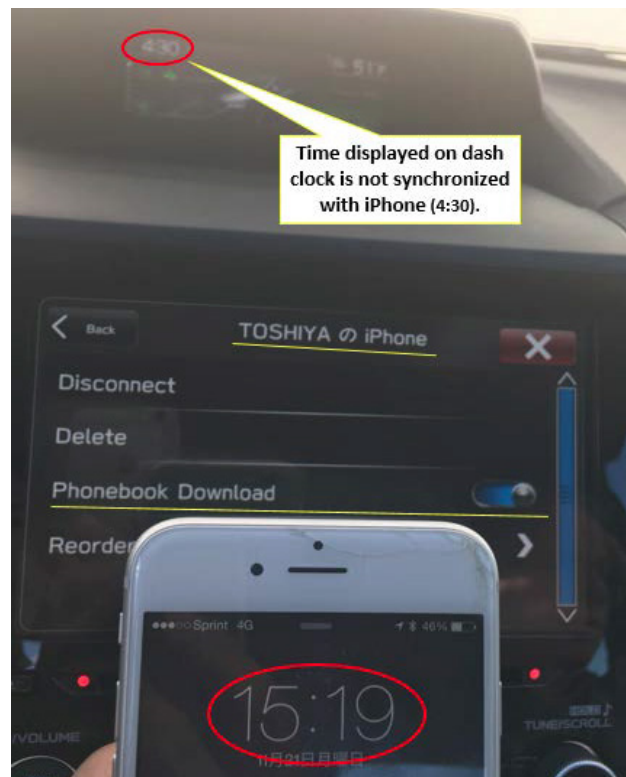
**CONDITION# 2:** Display Audio (non-navigation units), clock not synchronized with paired iPhone. (December 2016 TechTIPS).

**CAUSE: NOTE:** This information is applicable to iPhone (iOS) users only. If a customer states the time displayed on their iPhone is not synchronized with the instrument panel clock display, the information below provides an easy solution. Always ensure the latest software version is installed.

**RECOMMENDATIONS:** First, select the setting mode for the clock by following these steps:

- Press the “Home” button on the audio unit display.
- Press “Settings”.
- Press “Vehicle”.
- Select “Clock Adjustment”.
- Select “Auto”.
