Technical Service Bulletin

GROUP CAMPAIGN	NUMBER 18-01-032
DATE OCTOBER 2018	MODEL(S) SONATA (LF)

SUBJECT: SONATA ENGINE DTC P1326 - WIRING INSPECTION /
INSTALLATION AND ENGINE REPLACEMENT
(SERVICE CAMPAIGN T3G)

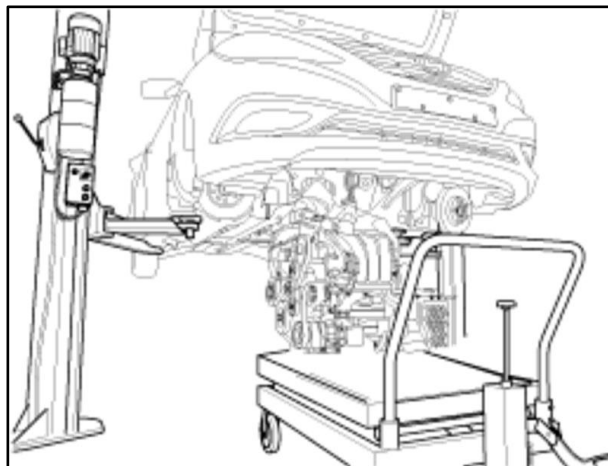
Shop Manual Section Location:

Engine Mechanical >
Engine And Transaxle Assembly >
Engine And Transaxle Assembly >
Repair Procedures

1. **If DTC P1326 is detected and the wiring signal interference inspection indicates engine replacement is required**, replace the Sub Engine Assembly (long block).
2. Follow the published Service Information from the applicable **Shop Manual** to remove the Sub Engine Assembly from the vehicle.

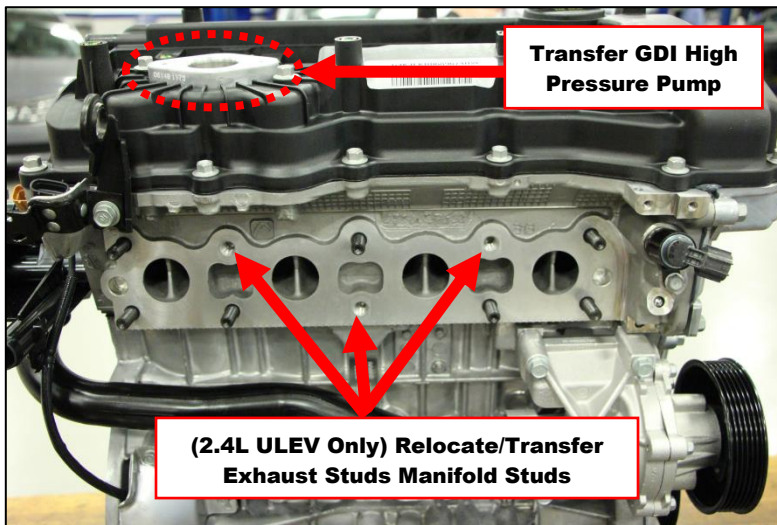
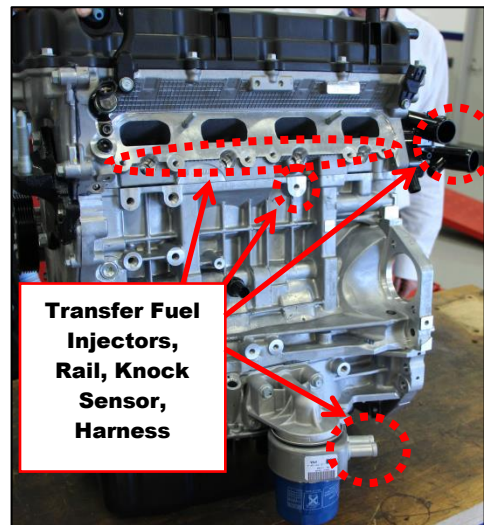
Be careful to preserve the vehicle's original parts for reinstallation on the replacement engine.

3. Replacement engines must be prepared prior to installation. Some components from the existing engine must be transferred to the new engine.
