**Campaign code:**  
L636-A.01.18

**Campaign description:**  
This campaign includes the MMI-Kombi-Gear Shifter Module update.

**Model:**  
Urus

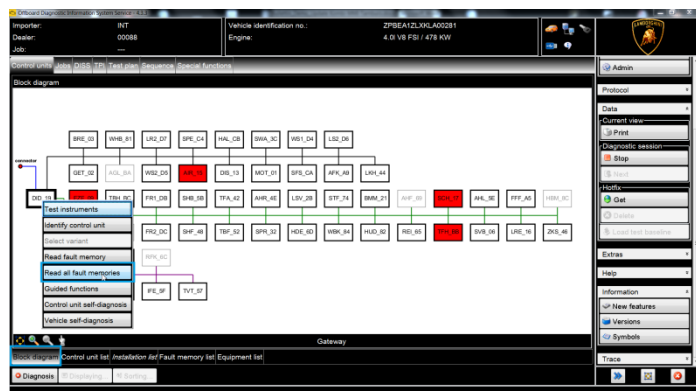
44. Go back to the "Block diagram" tab and select "Read all fault memories" from one of the ECUs of the vehicle.

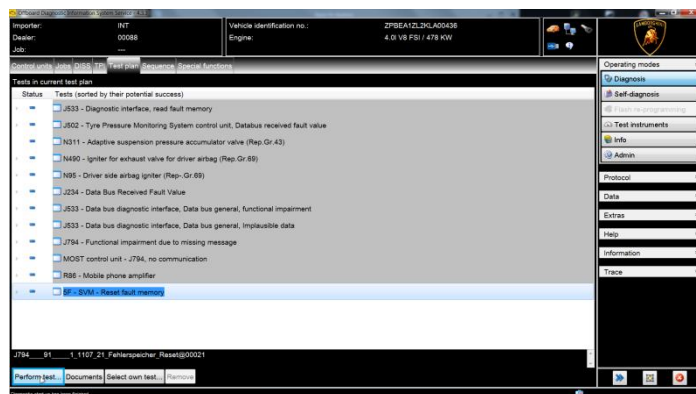
After the update of the 5F and the erase fault memories, the error “B201A00: Checking software version management” could occur.

45. If this error occurs, run the function that you find attached to the test plan: “5F –SVM – Reset fault memory”. Click “Perform test” to run the function.
