SERVICE BULLETIN

Classification: EC18-028a	Reference: NTB18-062a	Date: October 19, 2018
------------------------------	--------------------------	---------------------------

2018 ARMADA; MIL ON WITH DTC P0138 AND/OR P0158

APPLIED VEHICLES: 2018 Armada (Y62)

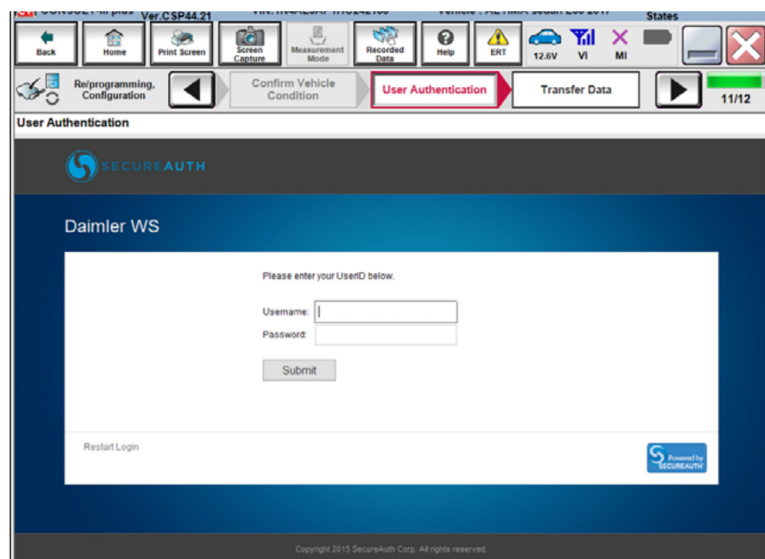
Figure 4

- Before reprogramming will start, you will be required to enter your User Name and Password.
 - The CONSULT PC must be connected to the Internet (Wi-Fi or cable).
 - If you do not know your **Username** and **Password**, contact your service manager.
