MODEL: Karma Revero**DATE:** October 2018**TITLE:** Cabin Temp Sensor Inspection**First Release****PRIORITY:** All**APPLICABILITY:** MY18 Revero vehicles from VIN 50GK41SA1JA000001- 50GK4LSA5JAA0005**MARKET REGION:** North America**PURPOSE:** To ensure proper function of cabin temp sensor motor**Overview:**

TITLE: Cabin Temp Sensor Inspection

CC-18-30-03

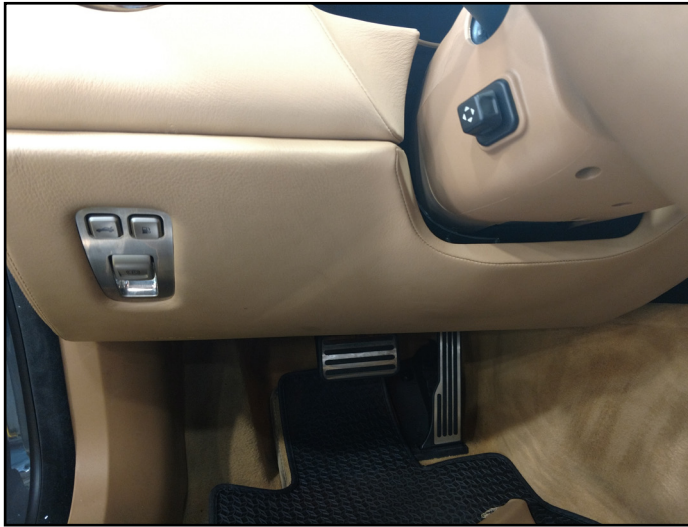
fig. 1a

1. The cabin air temp sensor is located behind the LH-knee bolster assembly (fig 1a). See Service Manual-“Sensor-Cabin Temp” for access instruction (fig. 1b).

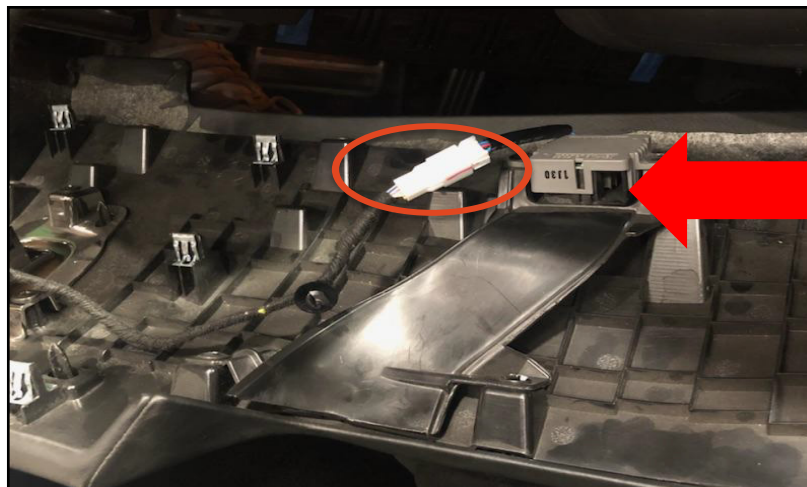
fig. 1c

Lower the panel exposing the harness and connector (circled) to the sensor and the small fan indicated with the arrow (fig. 1c).

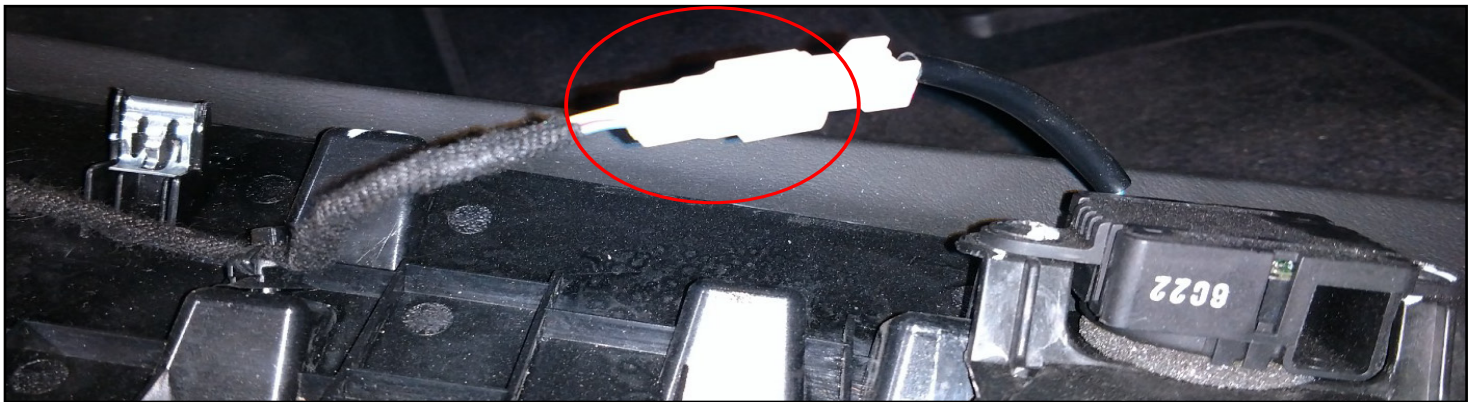
fig.7a

Check for continuity from the fan and temperature sensor connector (fig. 7a)

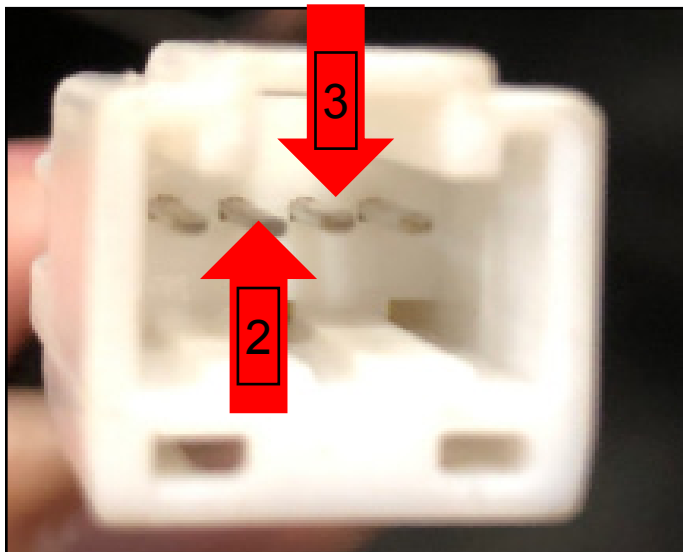
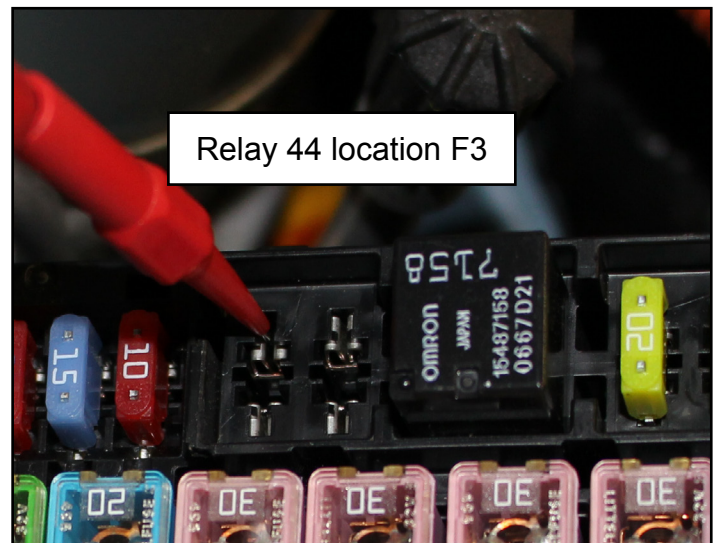
(D0601) pin 3 (fig.7b), on the harness side, to the fusebox at Relay 44 location F3 as shown in (fig. 7c).

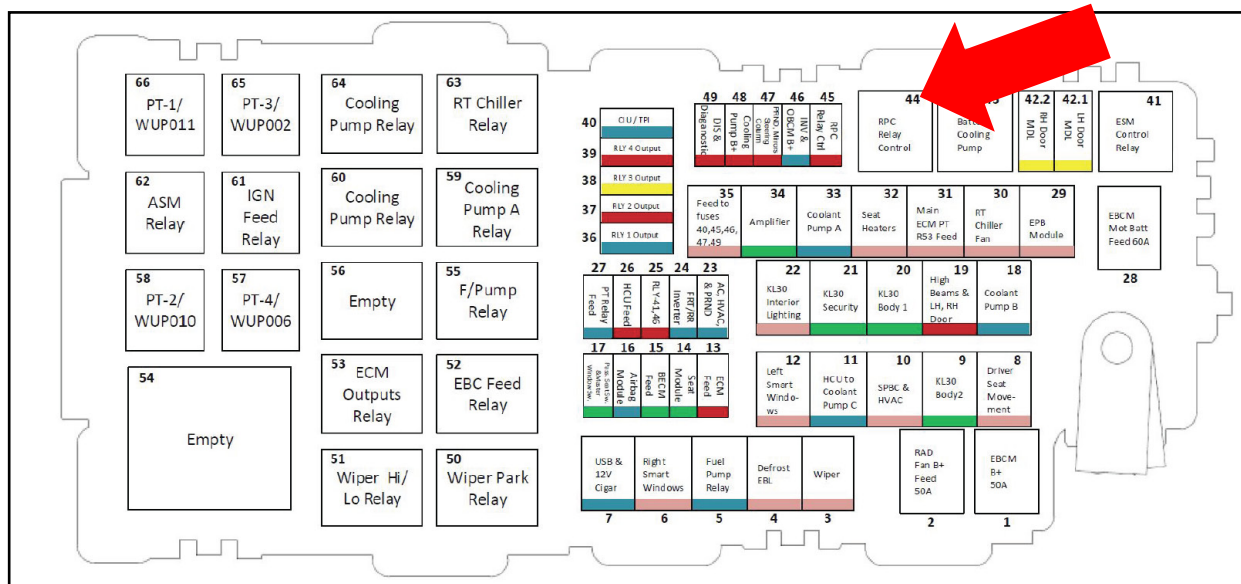
fig. 8c

The diagram in (fig. 8c) shows the relay number and location for reference.

IF installed correctly as per this bulletin and the fan/sensor is inoperative, then verify with TSS to get instructions on part replacement.
