## BR 190 - Worn seat cover in area of side bolster (code 555)

| Topic number | LI91.18-P-067198 |
| Validity | MODEL 190.3## (code 555) up to production date 12/2016 |

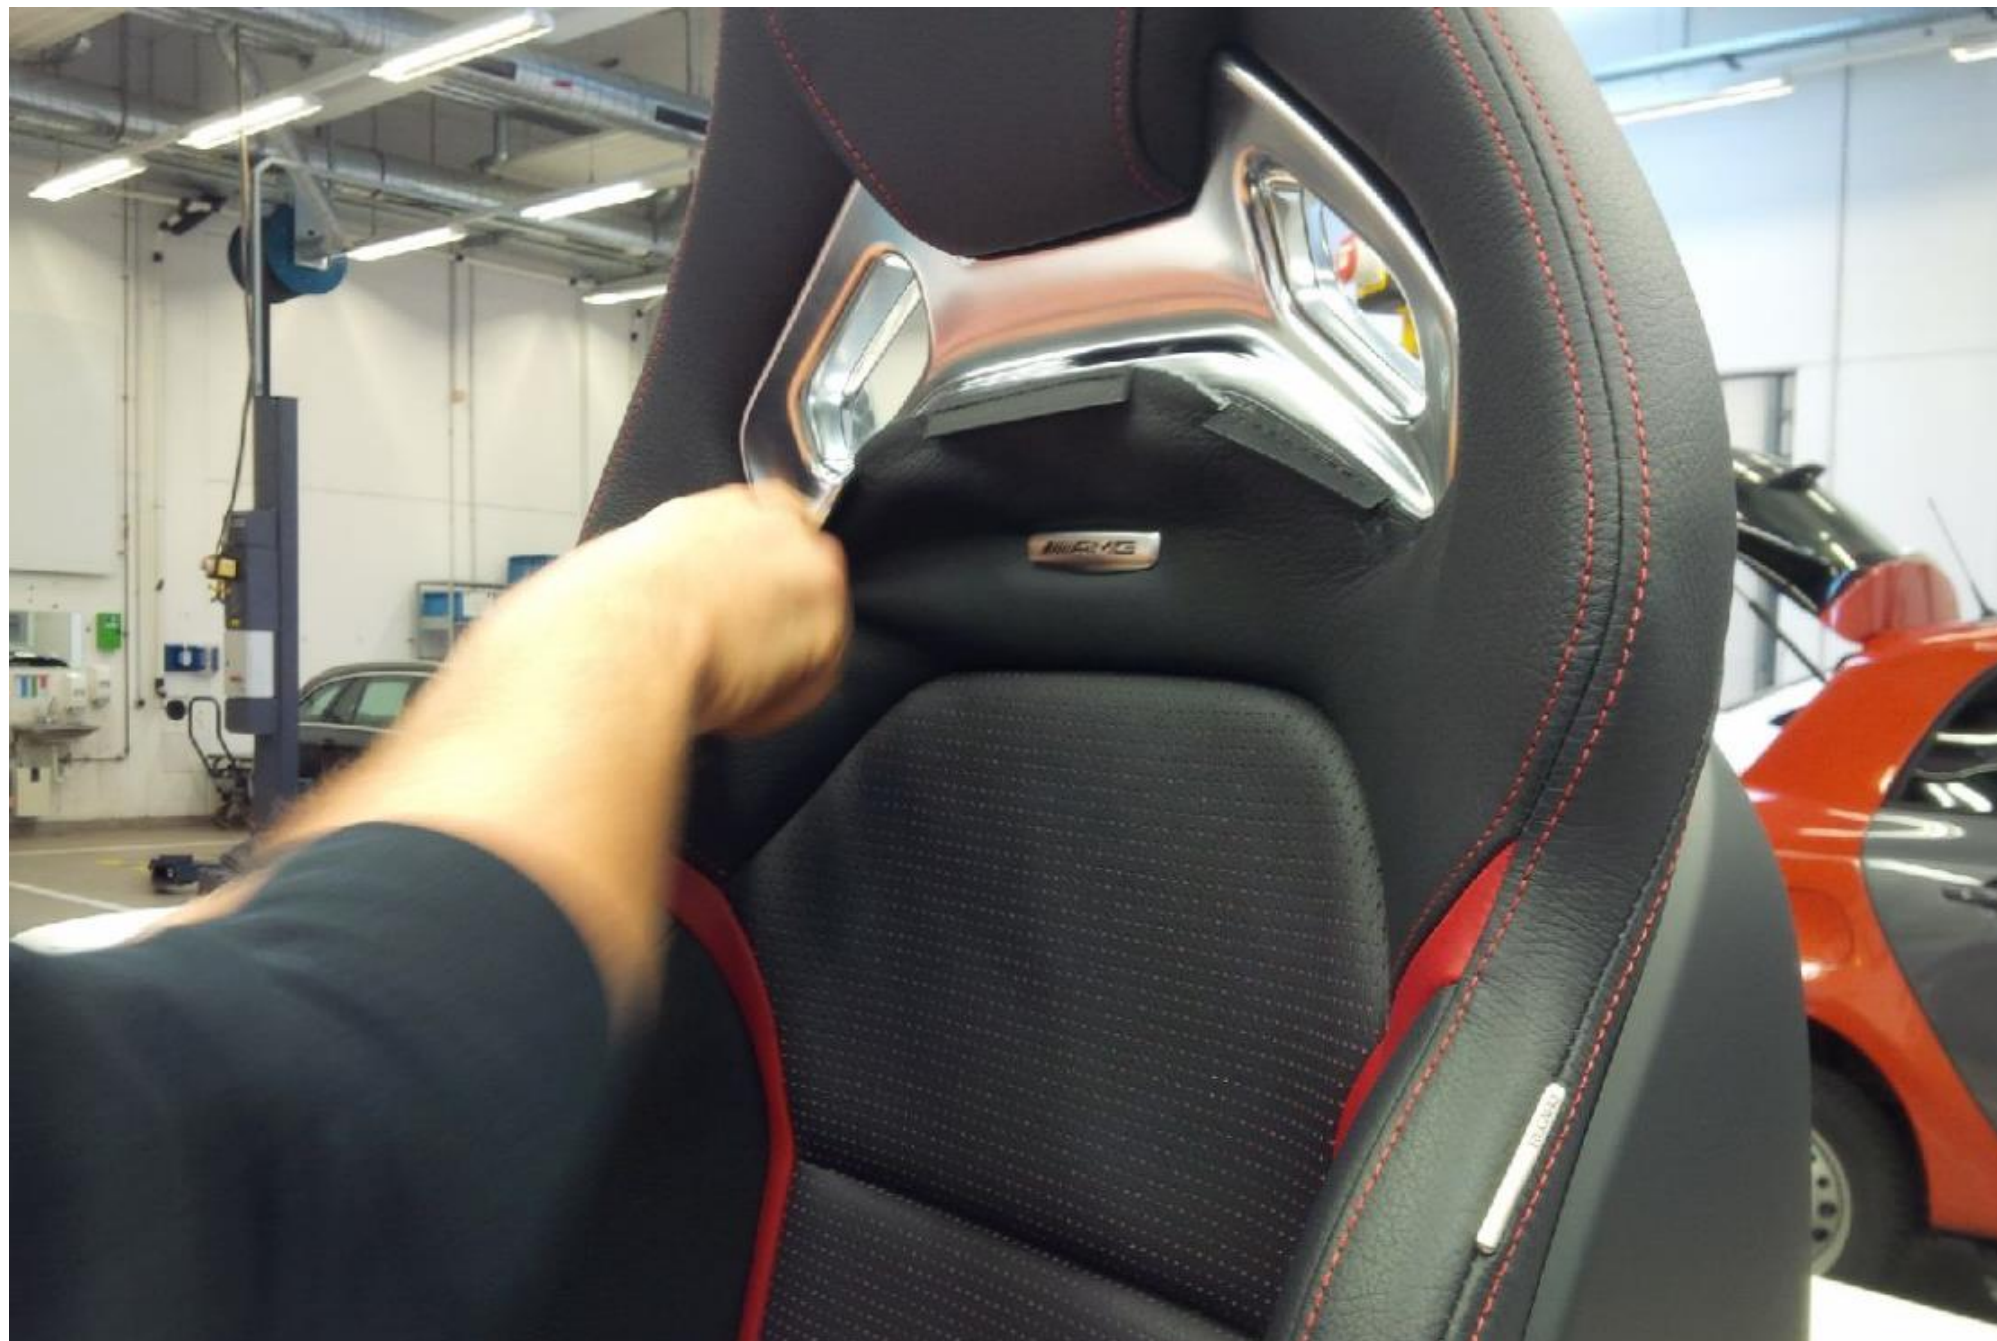
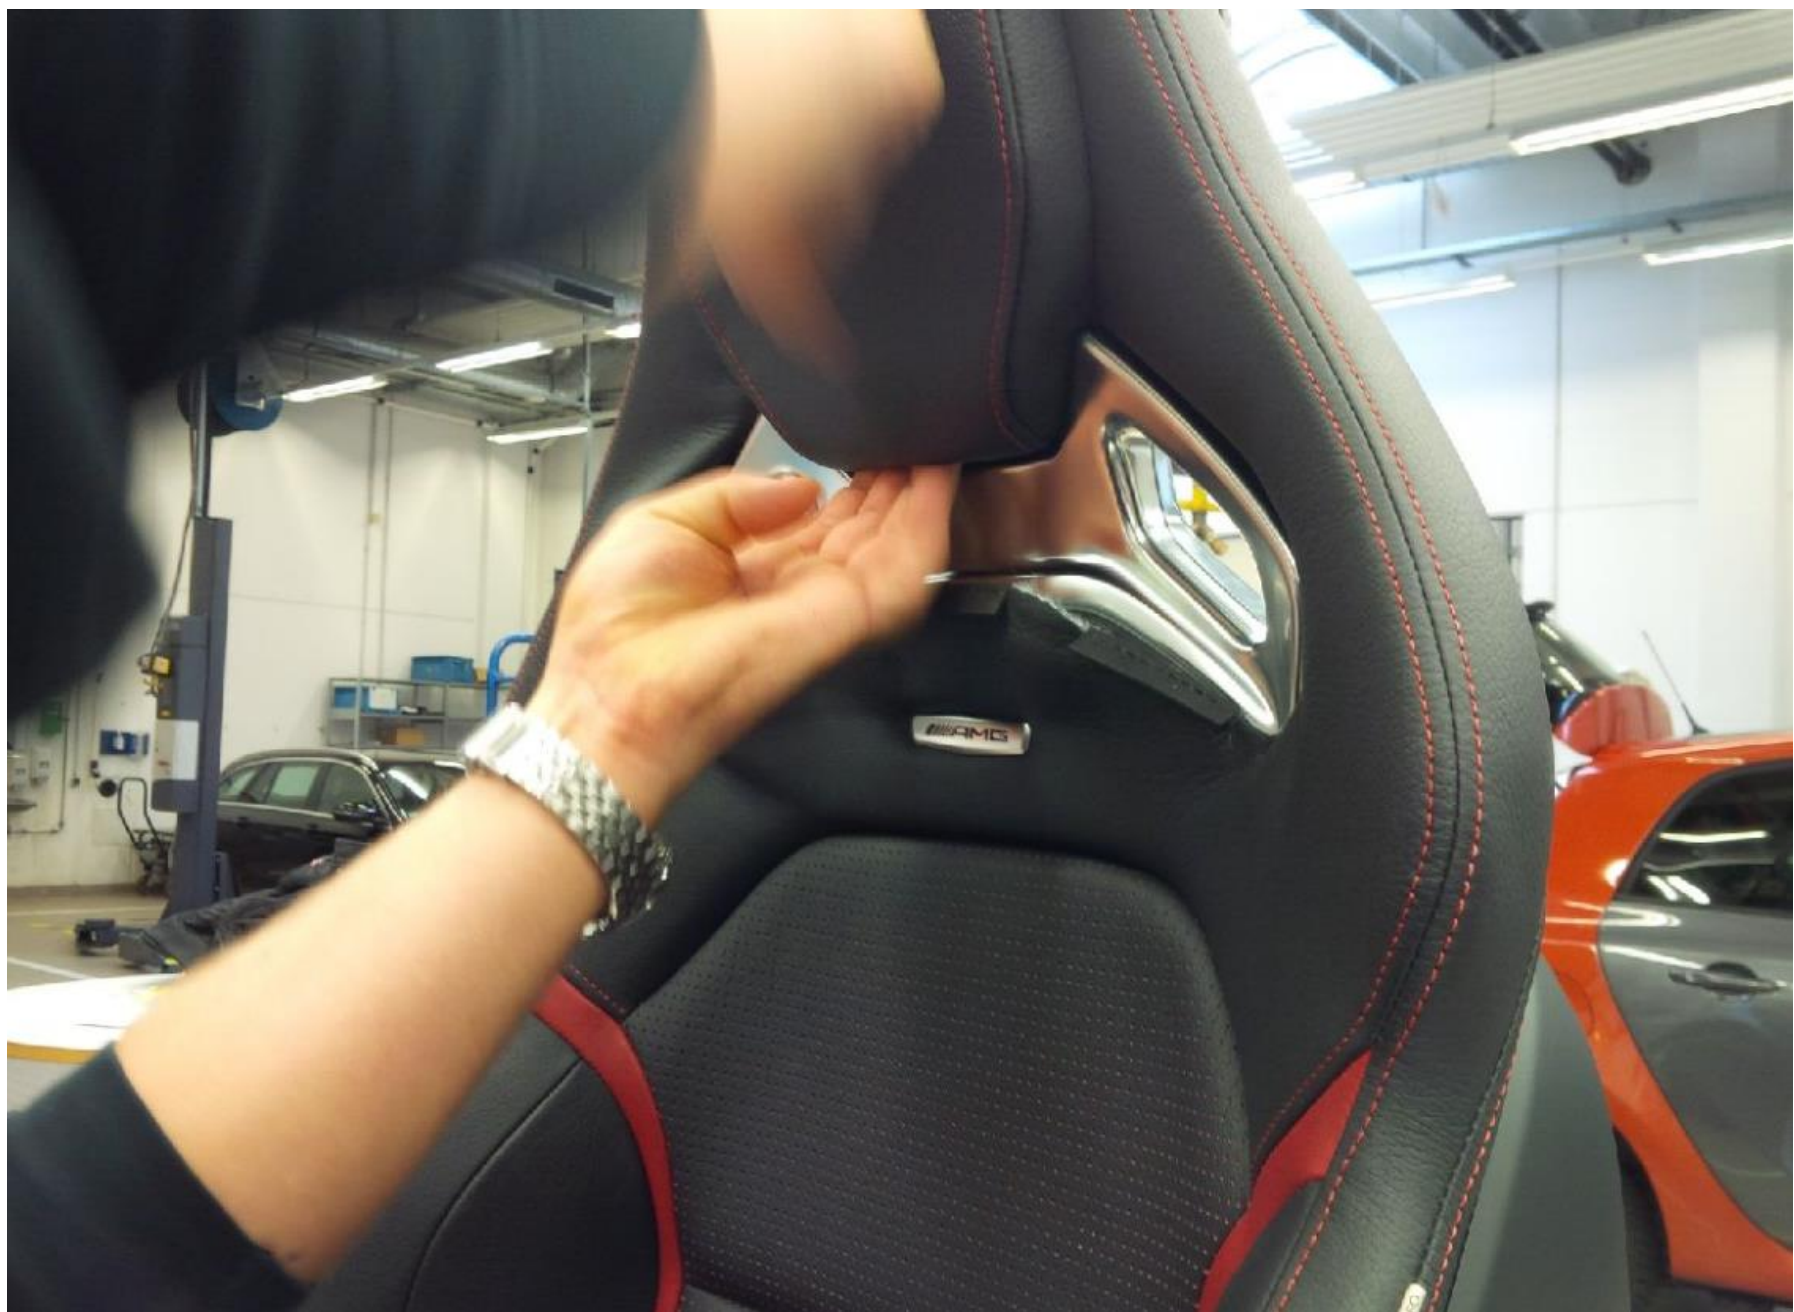
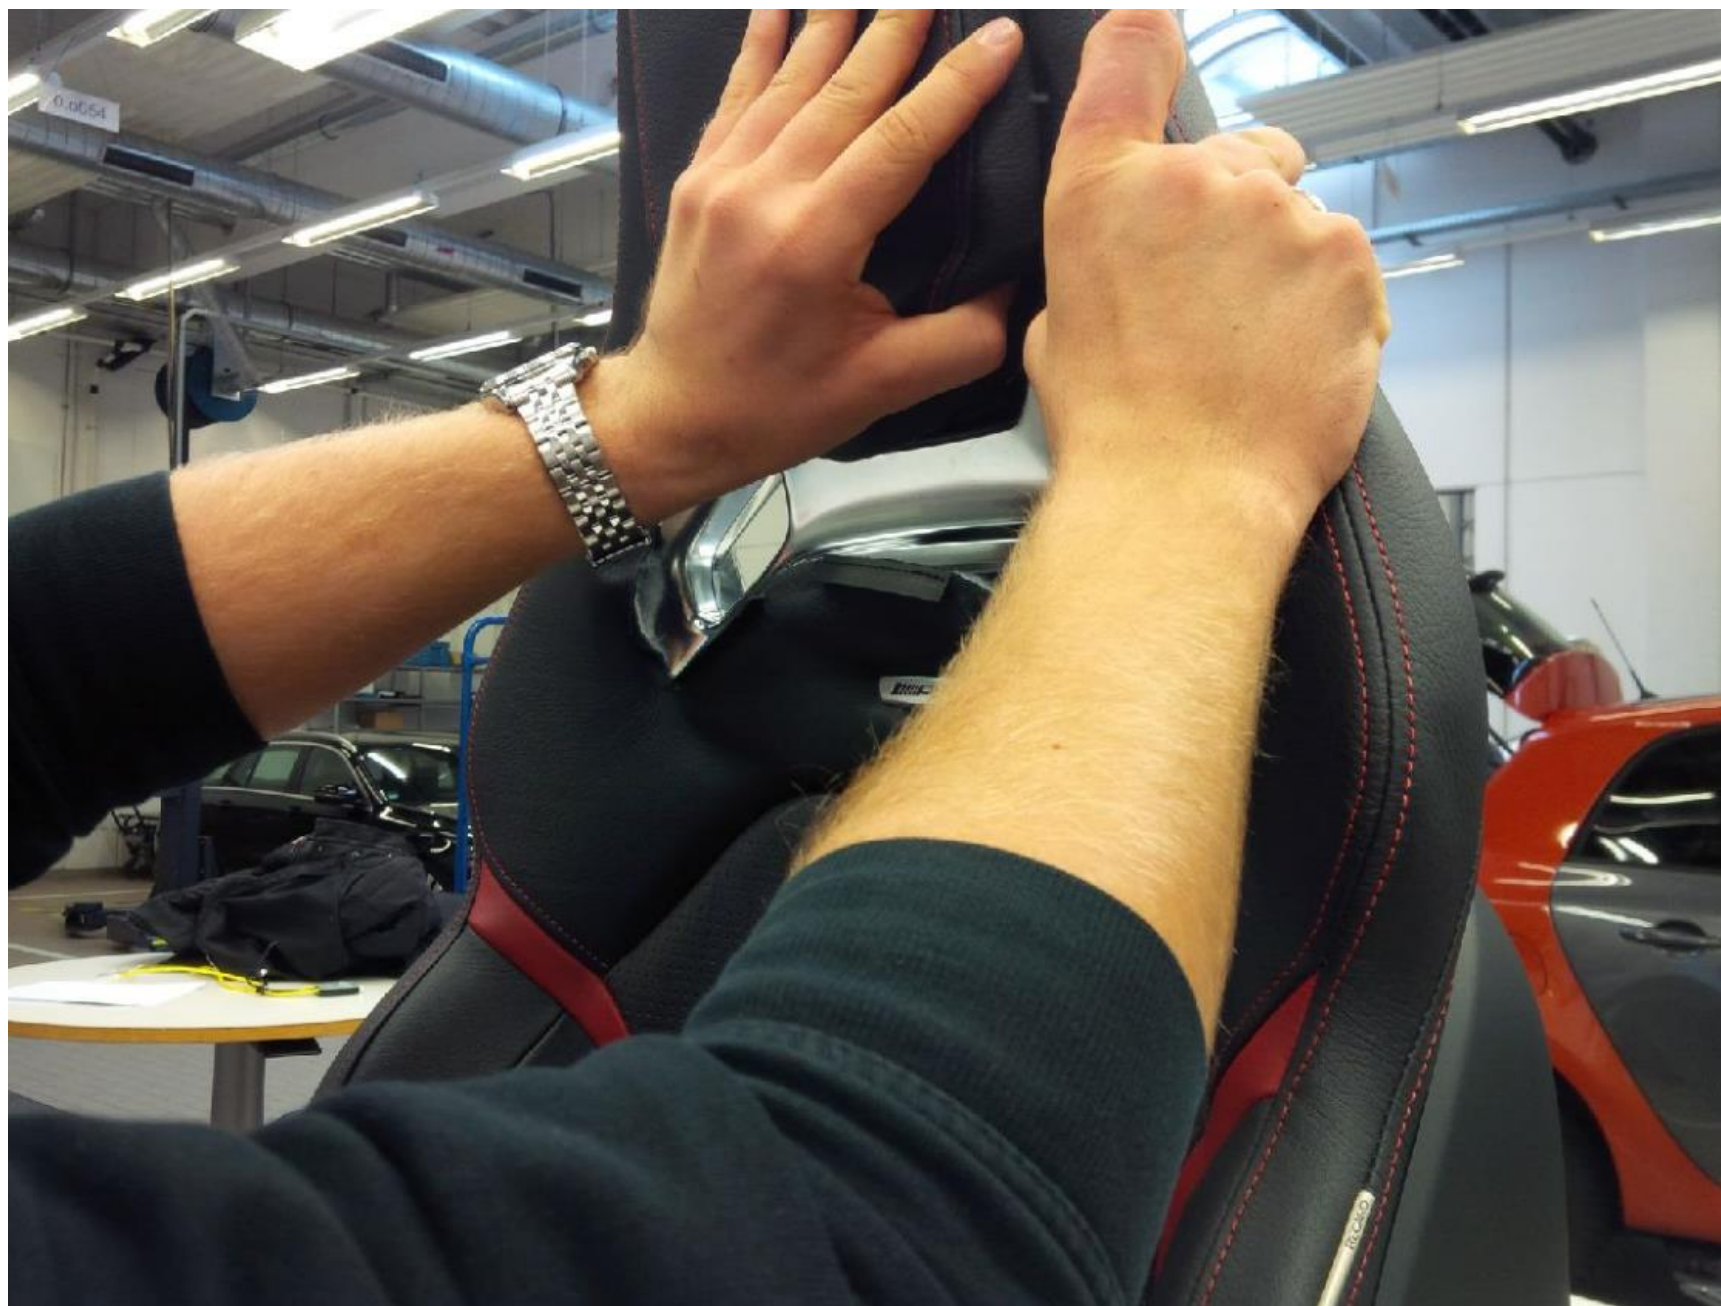
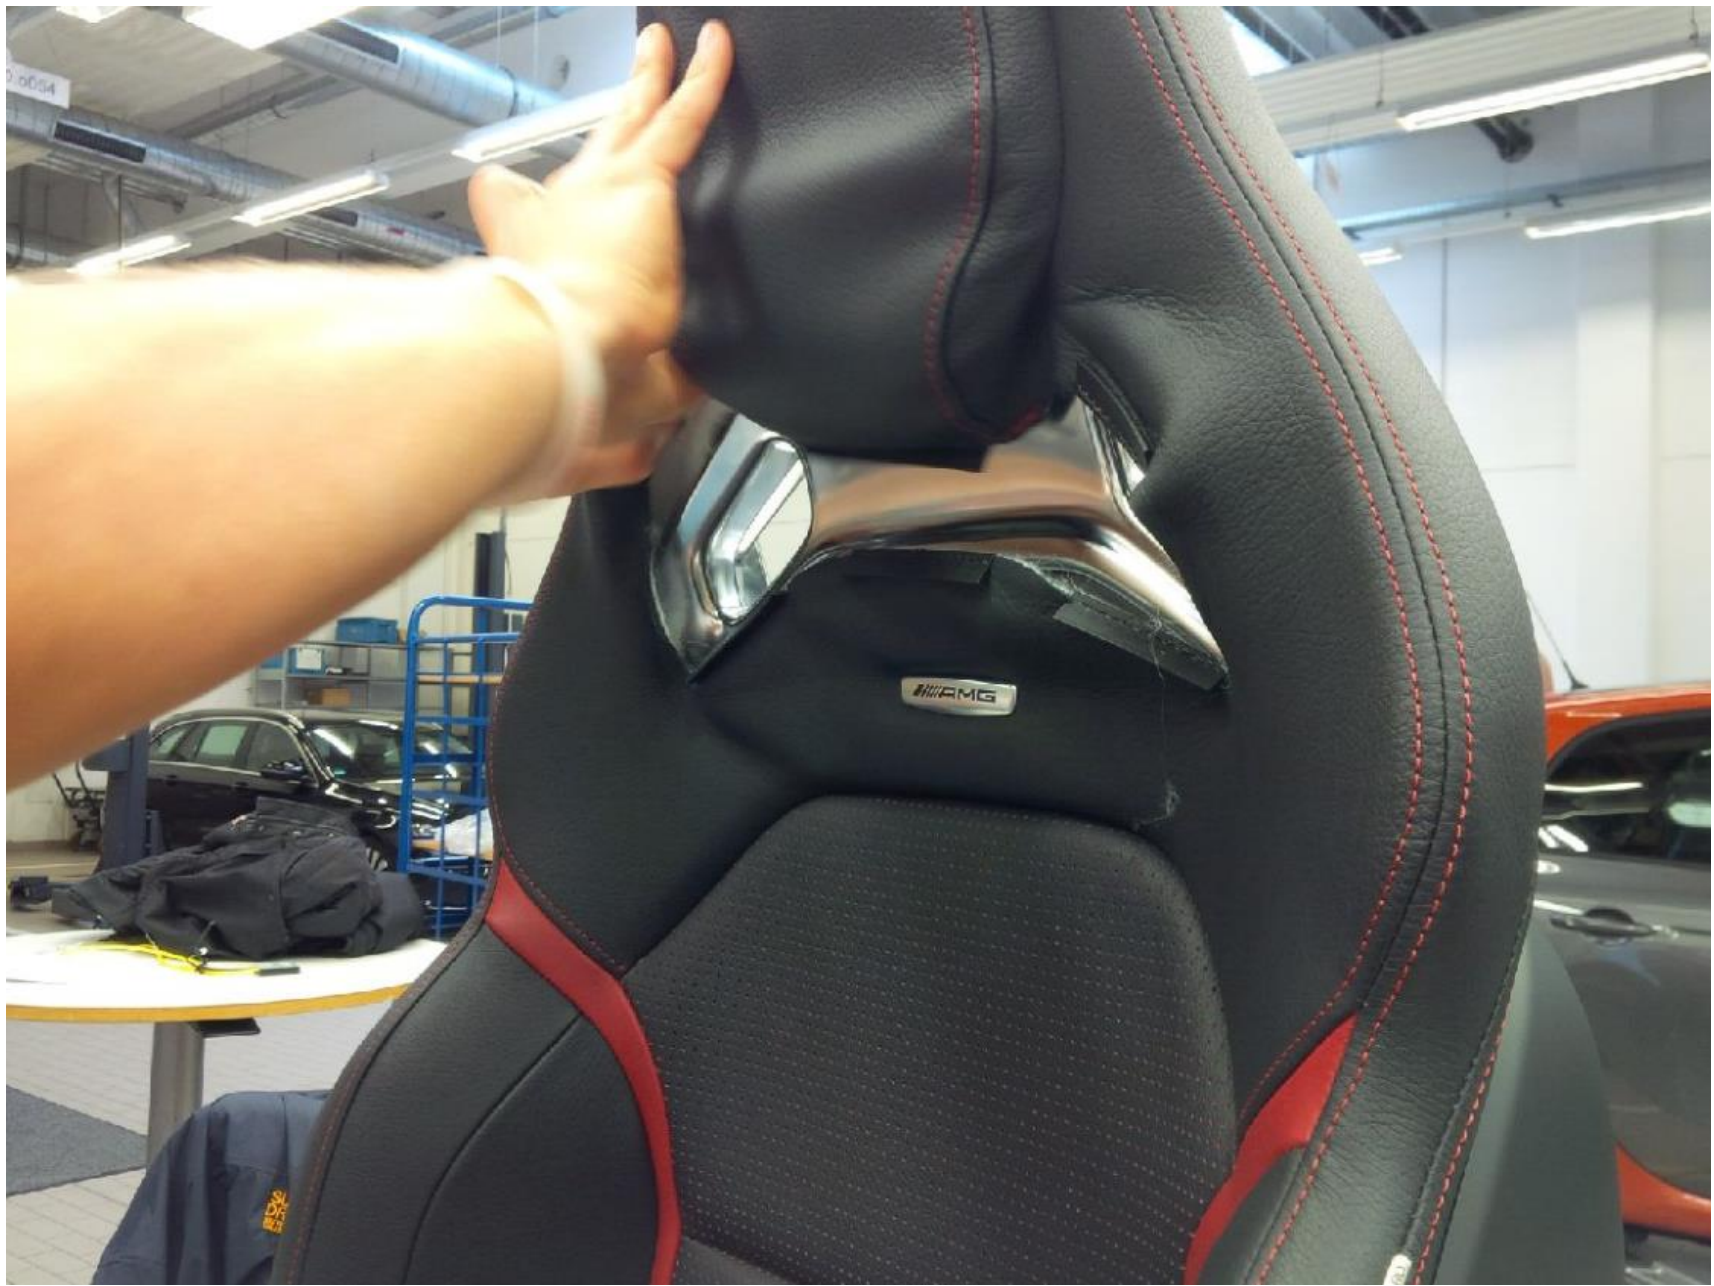
Beschädigung\_Abnutzung Sitzbezug.JPG:

Worn seat cover in area of side bolster.

| Attachments | |
|---|---|
| Beschädigung_Abnutzung Sitzbezug.JPG | Damage/wear on seat side bolster/seam |

Material wear in area of seat cushion and/or backrest.

Replace left and/or right front seat backrest cover.
