Technical Bulletin

Model(s)	Year	Eng. Code	Trans. Code	VIN Range From	VIN Range To
Tiguan LWB	2018	All	All	AX_JM000001	AX_JM158351

51 18 03 August 2, 2018 **2050753** Supersedes Technical Bulletin 51-18-02 (V511802) dated April 4, 2018 to update ending VIN range.

B-Pillar Noise while Driving

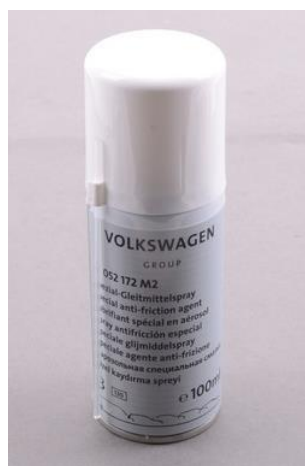
Krytox™ aerosol 100ml can.

- 3.1 Apply approximately 5 ml of Teflon (Krytox™) between the lower part of the bracket and cover sheet metal, apply in a uniform application on the entire contact zone of the bracket. See Figures 7 and 8.

Figures 7 -8 show use with Krytox™ syringe, however, use Part #G 052 172 M2 and apply with the supplied nozzle.
