## SERVICE BULLETIN

**APPLICABILITY:** 2017-18MY Impreza  
 2018MY Crosstrek  
 2018MY Legacy and Outback  
 2018MY BRZ

**NUMBER:** 15-211-17R

**SUBJECT:** Reprogramming File Availability for Additional Optimization of Harman Gen 3 Audio and Navigation Head Units

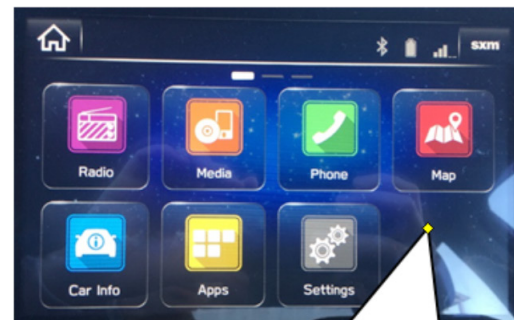
- Corrects for condition where only the star field background is displayed (without icons) after the HOME button is pressed.

**Background shown, but no icons**

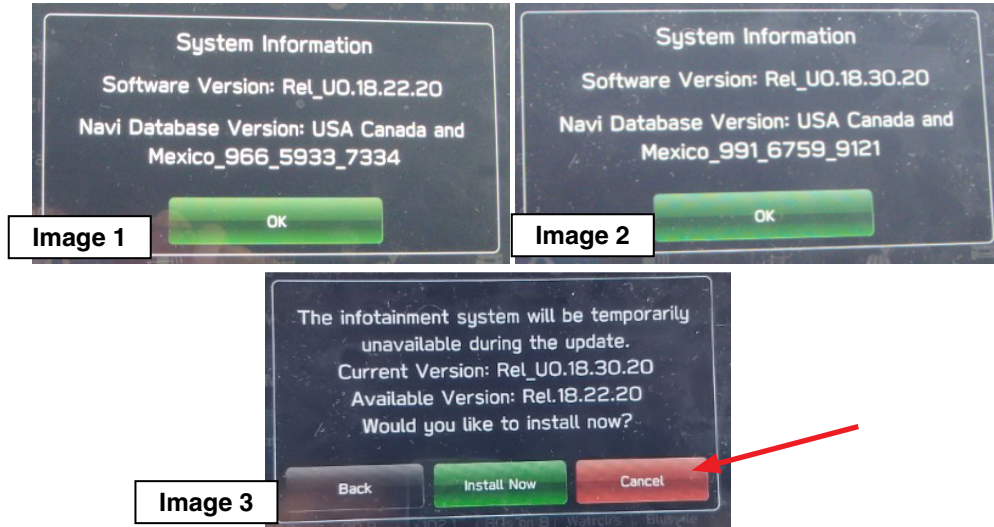
- Confirm the current Software Version ID. If the Current Version is **Rel\_U0.18.22.20 OR Rel\_U0.18.30.20** (Image 1 or Image 2 below), **STOP** as this latest update has already been installed. If a screen displays showing the Current Version as **Rel\_U0.18.30.20** and an Available Version: **Rel\_U0.18.22.20** Would you like to install now?" (Image 3 below), the answer is **NO. STOP** here and press **Cancel**. The **Rel\_U0.18.30.20** is a result of a customer-installed map update which included a slightly different strain of the Version 4 software. Contents of both strains are identical.

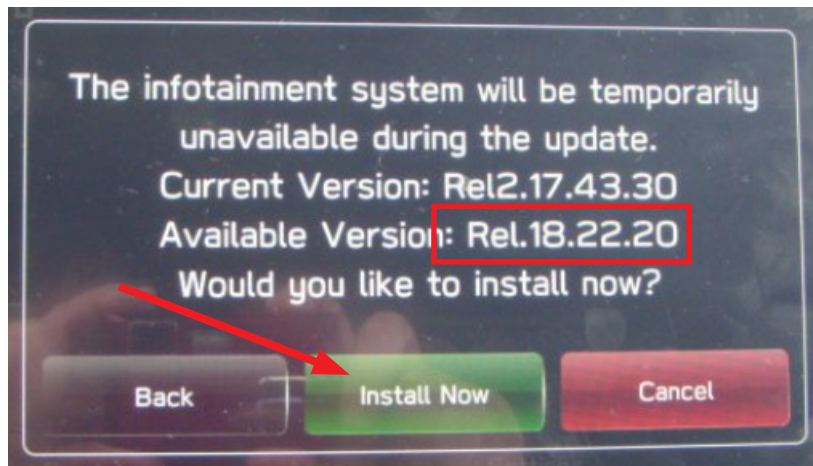
- The current and available software version information will be displayed. The Available Version I.D should be **Rel.18.22.20**.

**NOTE:** The displayed Available Version as shown below does not show the \_U0 after the Rel. This is normal.

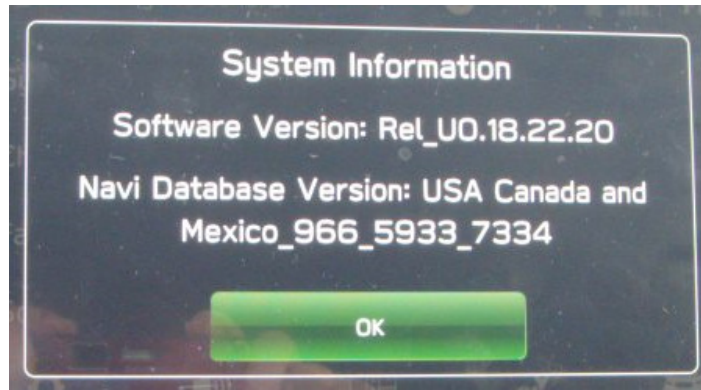
- Confirm Software Version is now “**Rel\_U0.18.22.20**”.
