## **SS 1033950 New Cascadia trailer receptacle back wall grounding stud**

New Cascadia

Some New Cascadia vehicles built with the seven way primary cable receptacle mounted at the lower left hand back of cab may have the trailer grounding circuit incorrectly attached to the interior back wall.

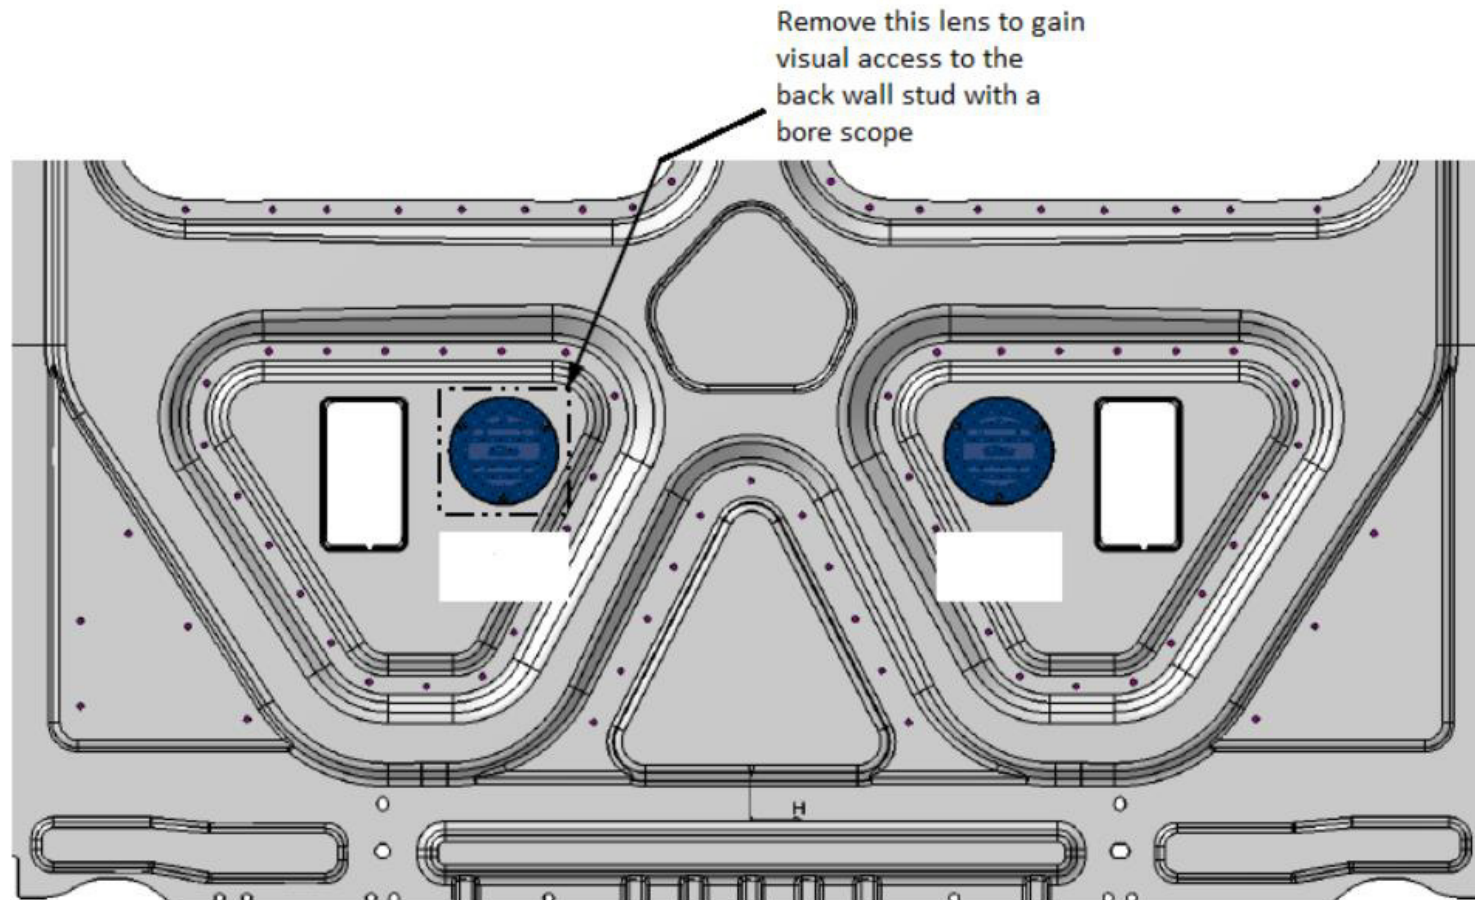
An initial determination of the back wall ground attachment strategy can be quickly determined with the use of a bore scope camera routed down through the driver's side utility light socket.
