**Bulletin No.:** PIC6293A **Published date:** 11/26/2018

# PIC6293A Installation of the GM Accessory Interior Spectrum Lighting Kit

Prand:	Model:	Model Years:	VIN:		Engino	Transmissions:
Brand:			from	to	Engine:	Transmissions.
Chevrolet	Camaro	2016 - 2019	All	All	All	All

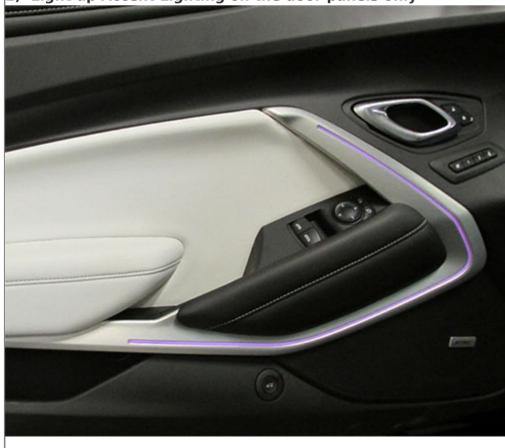
1) Light up Accent Lighting on the door panels only

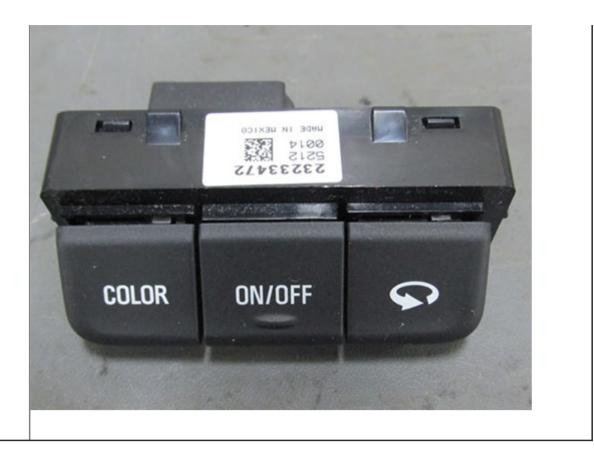
Vehicles equipped with the base radio (RPO IOB or IOR) do not require any programming. That is why the color selections are not available on the radio screen. This system uses a dashmounted switch to change the system's lighting colors. It is installed on the LH side of the steering column. This switch can be seen in the photo below.
