**HYUNDAI**  
**Technical Service Bulletin**

GROUP <b>BODY ELECTRICAL</b>	NUMBER <b>18-BE-015-1</b>
DATE <b>NOVEMBER, 2018</b>	MODEL(S) <b>Tucson (TL) Elantra GT (PD)</b>

**SUBJECT:** SOUND FADER SETTINGS CHANGE

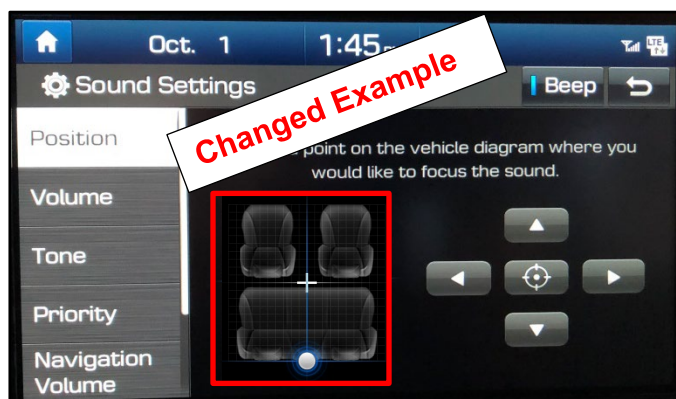
5. Confirm fader settings have changed without any user input.

**If yes, replace the Radio Assembly/Navigation Unit.**

For vehicles with mileage **below 500 miles, order a new radio.**  
*Part number examples are listed in the table on page 1.*

For vehicles with mileage **above 500 miles, order a remanufactured radio.**  
*Remanufactured radio Part numbers have FLT or FL at the end.*
