MODEL
2019MY
Optima (JFa)

NUMBER
153

TECHNICAL SERVICE BULLETIN

SUBJECT: SERVICE ACTION: POWER WINDOW SWITCH
ASSEMBLY REPLACEMENT (SA354)

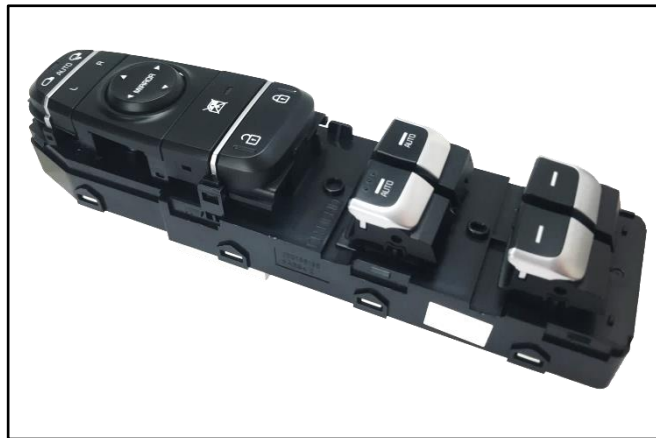
This bulletin provides the procedure to replace the main power window switch assembly on some 2019MY Optima (JFa) vehicles, produced from May 22, 2018 through August 30, 2018, which may experience a non-functioning “auto-up” window switch. Follow the procedure outlined in this bulletin to replace the main power window switch assembly.

Kia is requesting the completion of this Service Action on all affected vehicles in dealer stock, prior to delivery. Before conducting the procedure, verify that the vehicle is included in the list of affected VINs.
