MODEL: Karma Revero

TITLE: Downstream O2 Sensor Inspection

PURPOSE: To ensure correct routing of secondary oxygen sensor wiring

TB-18-12-05

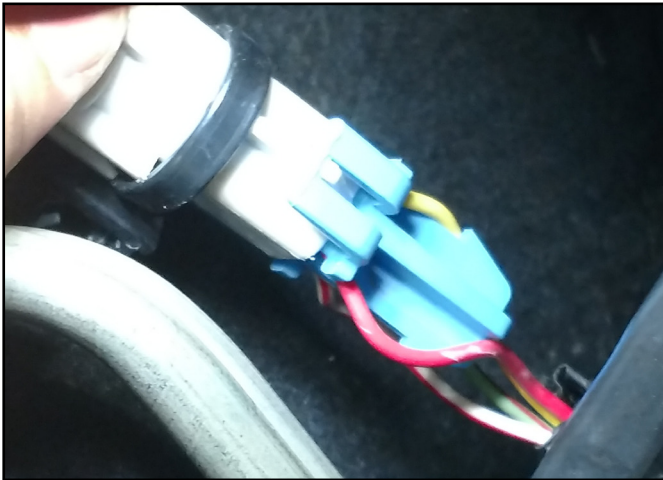
fig. 5a

Should any corrosion be found, replace the Oxygen sensor, and splice a new connector end on to the harness.

Remove the blue clip, and save to reuse on the spliced on connector, expose as much of the harness as possible. Use part number C161195900100, Pigtail - Engine Harness O2 Sensor (fig. 5b) to splice on to the harness. Be sure to connect the same wire colors to the existing ones in the harness (fig 5c), this is critical for proper operation. Use the extra length provided in the pigtail to create a drip loop, protecting the connector from future water ingress. Use zip-ties to secure the longer cable now, away from direct heat sources or sharp edges.
