GROUP TRA	MODEL 2019MY K900 (RJ)
	NUMBER 081	DATE December 2018
TECHNICAL SERVICE BULLETIN		
SUBJECT: SERVICE ACTION: TRANSMISSION FLUID COOLER HOSE INSPECTION (SA368)

SERVICE ACTION: TRANSMISSION FLUID COOLER HOSE INSPECTION (SA368)

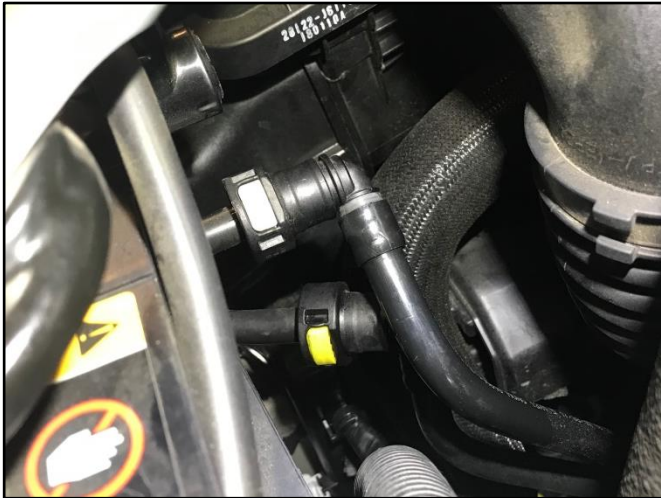
This bulletin provides the procedure to inspect the transmission fluid cooler hoses on certain 2019MY K900 (RJ) vehicles, produced from August 8, 2018 through November 1, 2018, which may experience a loose connection at the transmission cooler line quick disconnects. Follow the procedure in this bulletin to inspect the hoses. Before conducting the procedure, verify that the vehicle is included in the list of affected VINs.
