SERVICE BULLETIN

Classification: FA18-003	Reference: NTB18-083	Date: December 7, 2018
-----------------------------	-------------------------	---------------------------

2014 – 2019 ROGUE; SQUEAK/CREAK NOISE FROM FRONT SUSPENSION BOUND BUMPER DRIVING OVER BUMPS

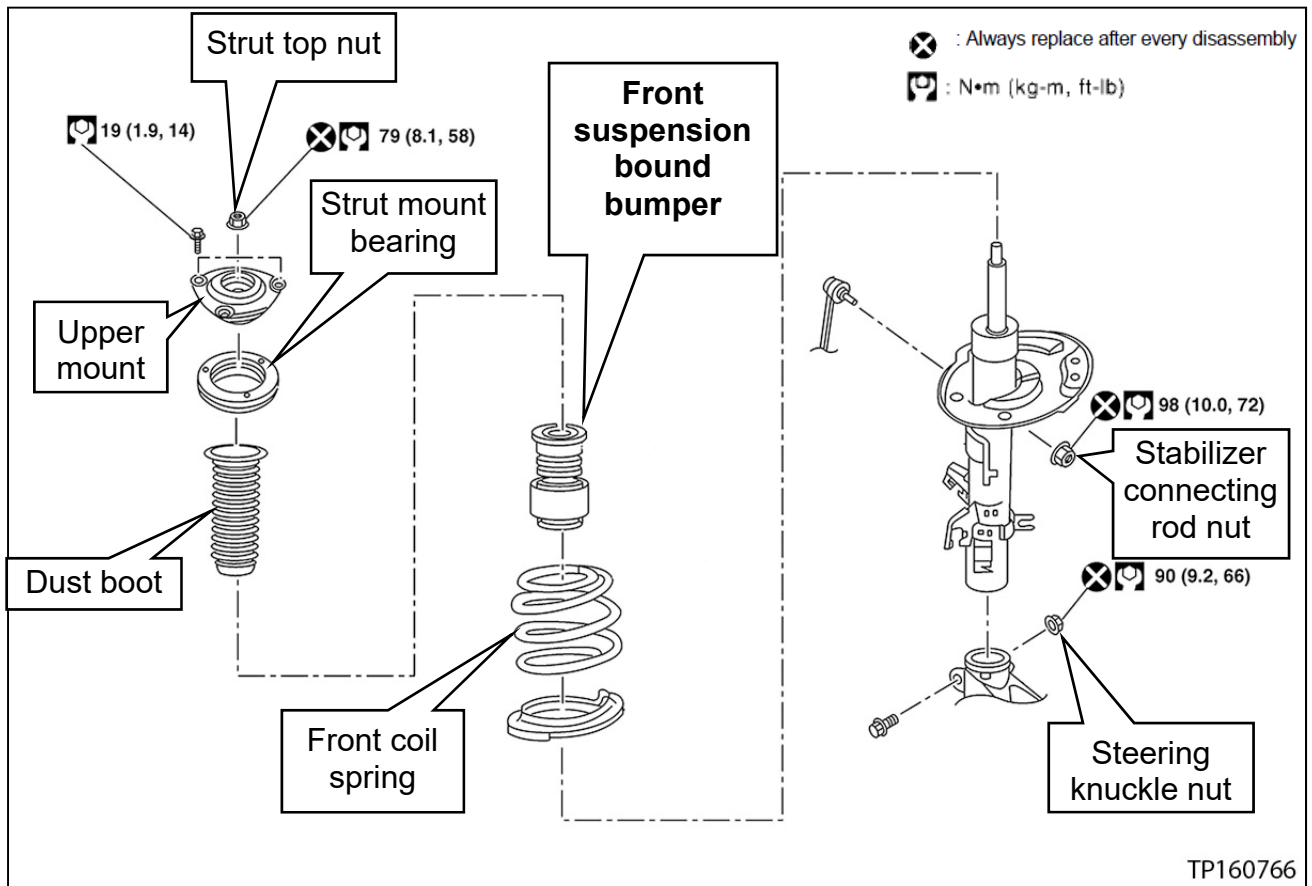
Figure 2

FRONT SUSPENSION BOUND BUMPER LOCATION

Replace the front suspension bound bumper, only on the side that is making noise.
