**PRODUCT CAMPAIGN BULLETIN**

**APPLICABILITY:** 2017MY Impreza

**NUMBER:** WTN-74R

**SUBJECT:** Reprogramming File Availability to Optimize Rear View Camera Operation on Harman Gen 3 Audio and Navigation Head Units

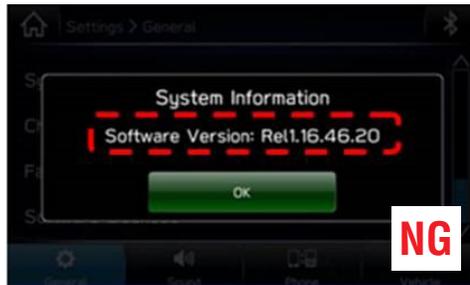
**NG-** Head Unit Must Be Updated, Proceed To Step 2.

- Confirm the Software Version ID.
  - If the Current Version is **Rel2.17.43.20** or newer (e.g. **Rel\_U0.18.30.20**), proceed to **Step 8. IMPORTANT: Step 8** contains critical additional checks and procedures required to complete this recall.
  - If the Current Version is prior to **Rel2.17.43.20**, continue to **Step 2**.

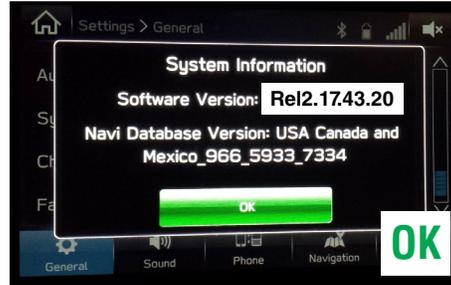
**OK-** Latest Version Installed, Proceed To Step 7.

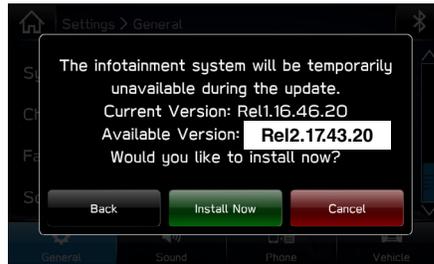
- The current and available software version information will be displayed. The **available** Version I.D should be “**Rel2.17.43.20**”. This version number is the same for all three levels of head unit.

**NOTE:** The version number may say Rel.17.43.20 (the 2 is missing after the Rel). This is OK.

- After confirming the Available Version, press “Install Now” to start the reprogramming process. **NOTE:** The screen will go blank (black) for a brief period after installation begins.
- Each of the updates (Base, Mid and High) should take less than 10 minutes to install.

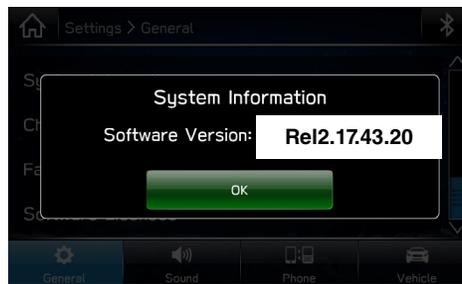
- Confirm Software Version is now “Rel2.17.43.20”.
