SUBJECT: **SPECIAL POLICY ADJUSTMENT FOR 1988 – EARLY 1990 TRUCK &
4RUNNER WITH 3VZ-E V6 ENGINES
AND
SPECIAL SERVICE CAMPAIGN (V06) FOR 1990 – EARLY 1995 TRUCK,
4RUNNER & T100 WITH 3VZ-E V6 ENGINES**

3VZ-E Head Gasket Special Policy Adjustment

3VZ-E Head Gasket Special Service Campaign (V06)

3VZ-E Cylinder Head/Block Inspection

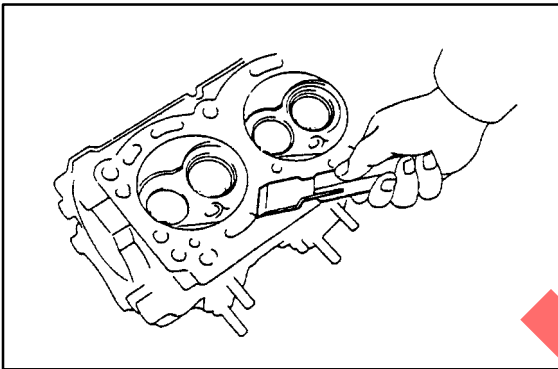
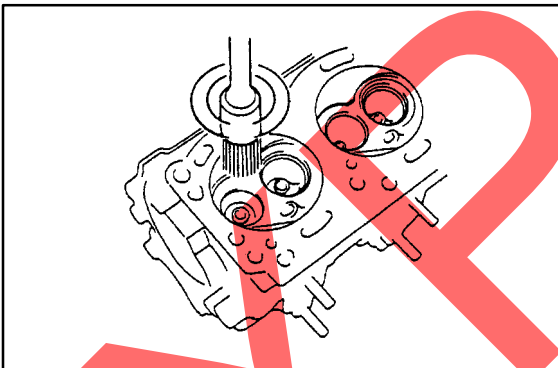
CYLINDER HEAD INSPECTION

When replacing cylinder head gaskets on the 3VZ-E engine, careful inspection of the cylinder head and block mating surfaces is necessary to ensure a complete and durable repair. If cylinder head or block mating surfaces are warped or eroded, they may be reconditioned using the following guidelines.

1. CLEAN CYLINDER HEAD

- (a). Using a gasket scraper, remove all the gasket material from the cylinder block contact surface.

- (b). Using a wire brush, remove all the carbon from the combustion chambers.
