# QUALITY ACTION

## CAMPAIGN BULLETIN

### Generator Harness Dealer Inventory

# PC673 – TITAN, TITAN XD GENERATOR (ENGINE NO. 2) HARNESS INSPECTION

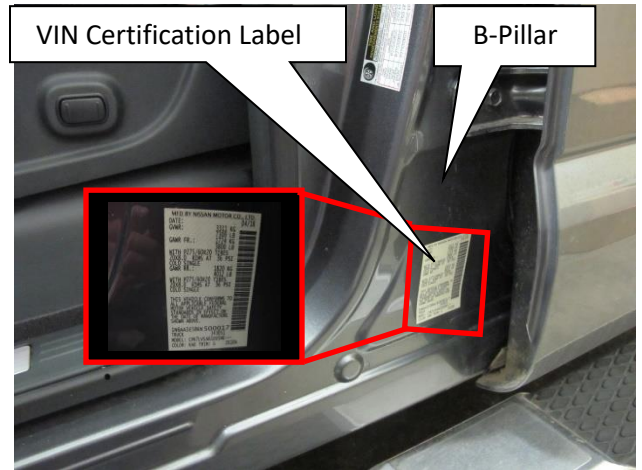
Figure 1

1. Verify the VIN of the affected Titan / Titan XD using the VIN Certification label. (Figure 1).

- VIN Certification label located on the Driver's Side Door B-Pillar.

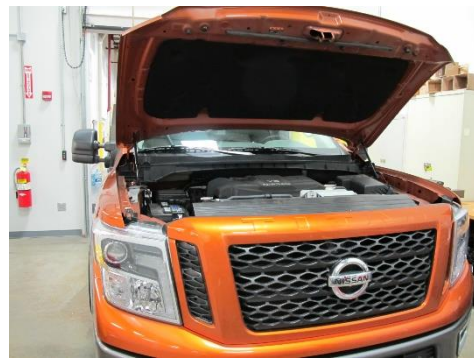
Figure 2

2. Open the hood.

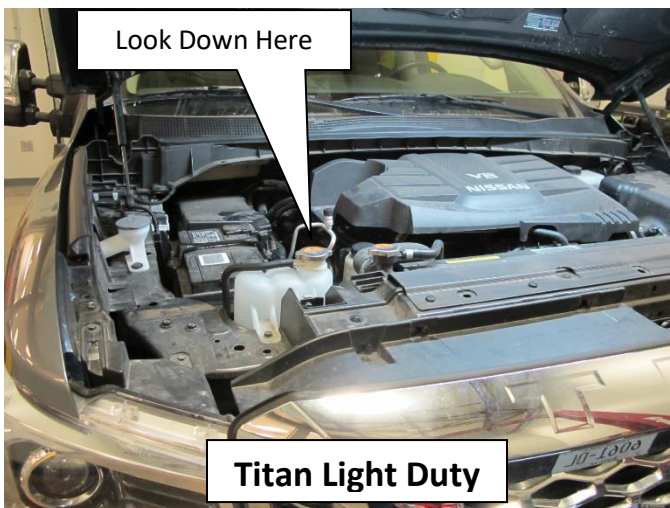
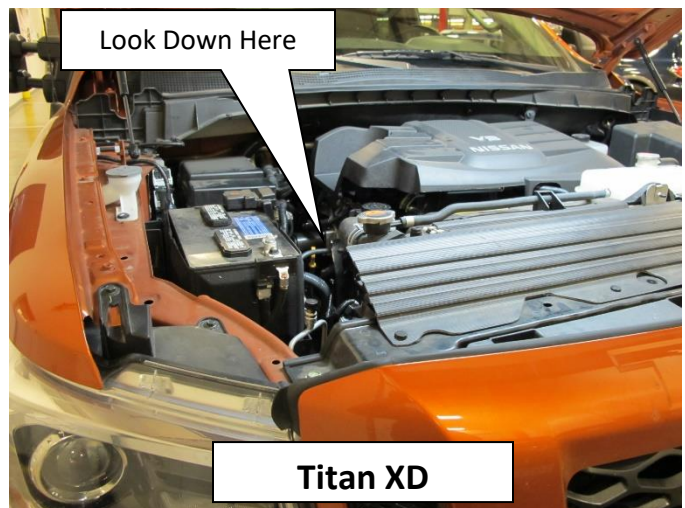
Figure 3

3. Look down in the area shown below (Figures 3 and 4). The generator harness is located between the yellow engine oil dipstick and the power steering pump.
