**Document ID:** IK1200163

**Title:** Updated I6 EVRT/VGT Diagnostics Check Sheet and Turbocharger Repair Procedures for engines that exhibit DTC 353 / 354

**Applies To:** 2004- 2006 MY EGR DT 466 and 570 with EVRT/VGT Turbos with ESN 2,000,001 - ESN 3,000,000

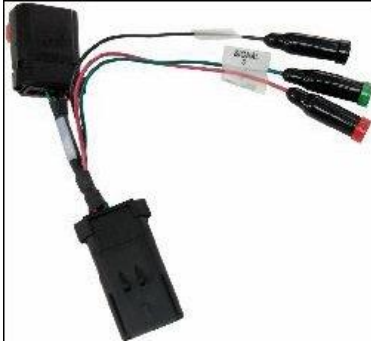
1. Connect the turbocharger breakout harness between the engine harness and the turbocharger actuator pigtail.

Note: The male/female connector has an additional retention locking feature that must be disengaged prior to separating the male/female connectors. This slide locking tab may be coated with paint that will be required to be scrapped off to ease disassembly.
