SI B01 21 18  
Warranties

## **UPDATE !** N63 ENGINE: OIL CONSUMPTION CLASS ACTION SETTLEMENT DIAGNOSIS AND REPAIR PROCEDURES (VERSION 7.0)

This Service Information bulletin supersedes SI B01 21 18 **dated December 2018**

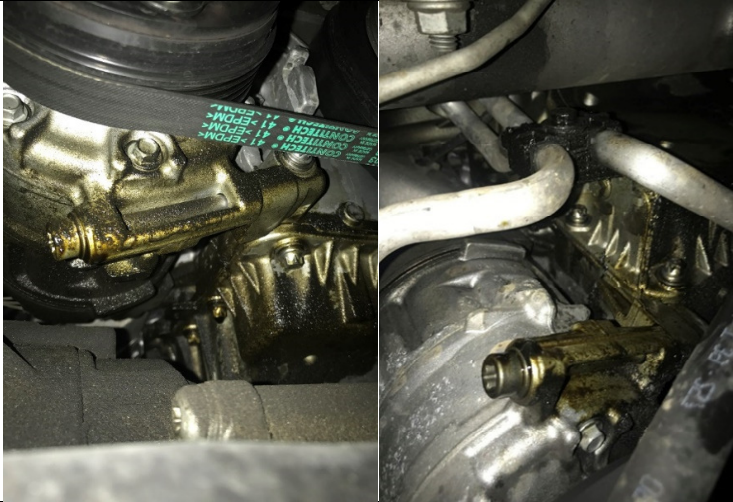
3. Inspect the front engine cover for engine oil leakage.

If the front timing cover is not leaking. Go to step 4.

If the front timing cover is leaking. Go to step 6.

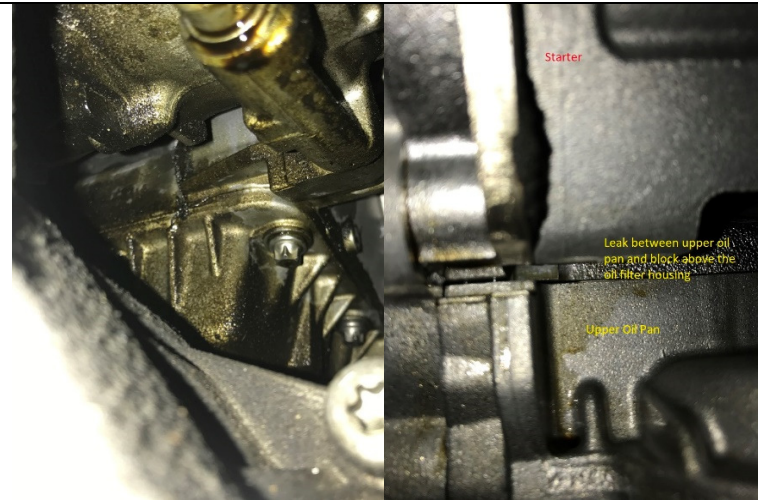
4. Inspect the upper engine oil pan for engine oil leakage.

| | <p>If the upper engine oil pan is not leaking.<br/>Go to step 5.</p> <p>If the upper engine oil pan is leaking.<br/>Go to step 6.</p> |

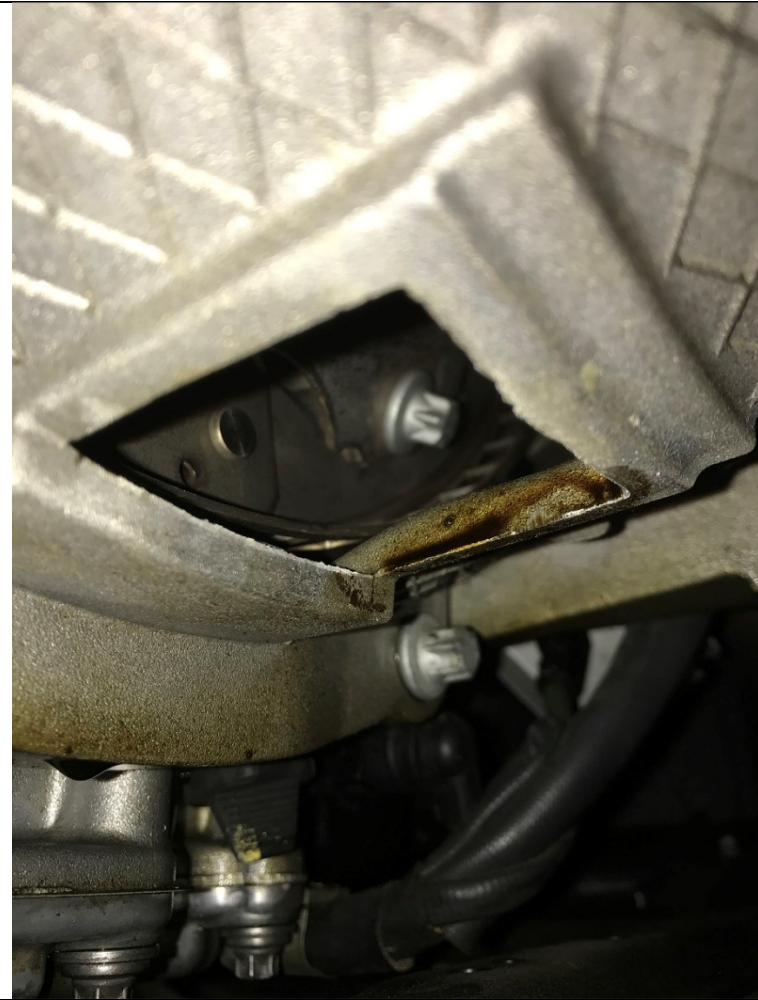
| 5. Inspect the lower bell housing for engine oil leakage | |
| | <p>The lower bell housing is not leaking. Go to step 7.</p> <p>The lower bell housing is leaking. Go to step 6.</p> |

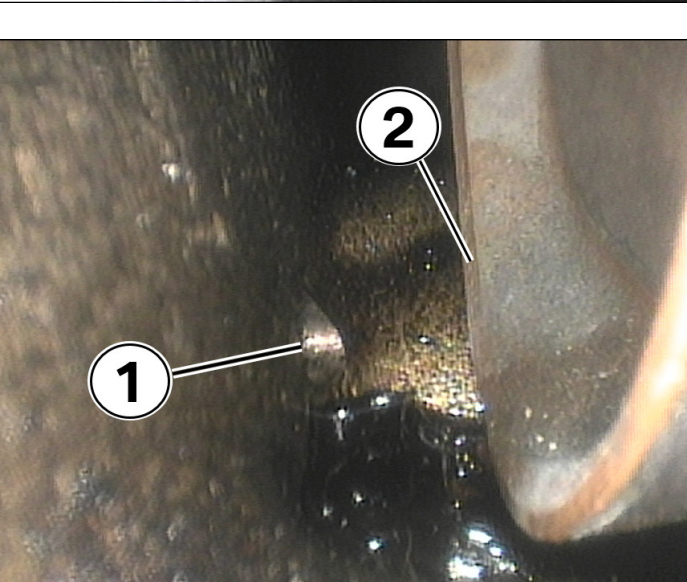
| | <p>Inspect the surrounding area of the engine valley drain hole (1).</p> <p>Engine valley drain hole (1)</p> <p>Metal vacuum reservoir (2) shown.</p> <p>This is a clean picture. No oil can be seen in the oil drain hole (1).</p> <p>The dark material at the bottom of the photo is dust and dirt. This material appears to be reflective but it is dry</p> |

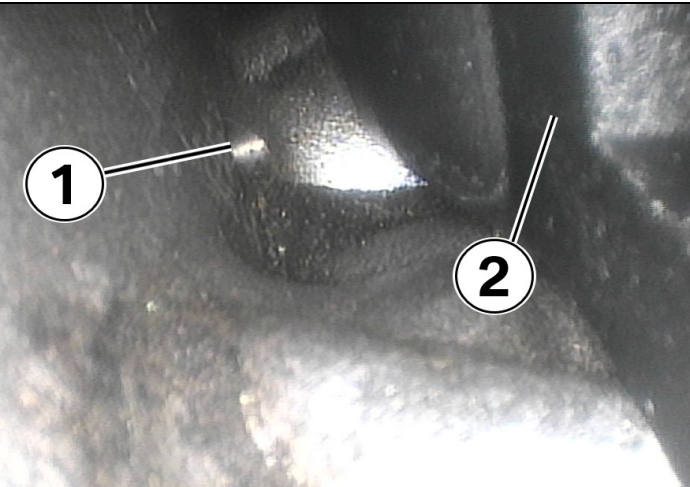
| | <p>Once the bore scope has gone under the plastic reservoir tab then the engine valley drain hole (1) and surrounding area can be clearly inspected.</p> <p>The dark material at the bottom of the photo is dust and dirt. This material appears to be reflective but it is dry.</p> <p>Engine valley drain hole (1)</p> <p>Plastic vacuum reservoir (2)</p> |

**If engine oil is found in the valley area, then the root cause of the engine oil leak resides in the components on top of the engine i.e. turbocharger oil line cover, turbo charger, etc. Further basic diagnosis will be needed to find the root cause this engine oil leak. Do not remove the transmission from the vehicle. Go to Step 7.**

**If NO engine oil residue is found at the engine valley drain hole, but an original visual inspection indicated leak in the bell housing area, the root cause of the engine leak resides in the rear main seal and rear engine cover. Do not remove transmission from the vehicle. Go to step 7.**

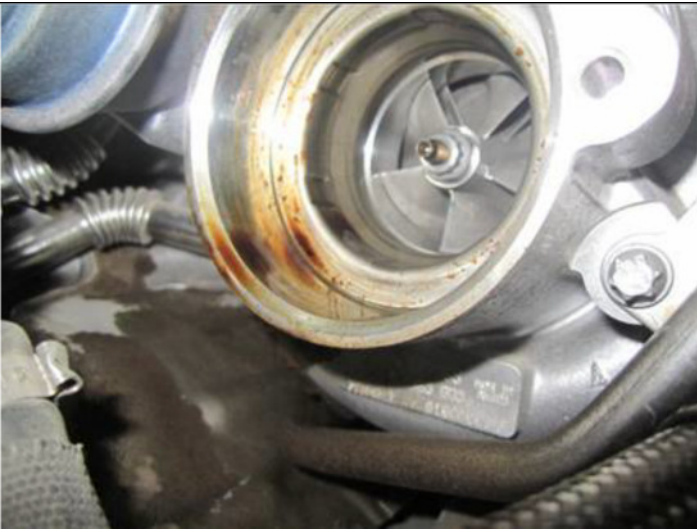
| | <p>The turbocharger is OK.</p> <p>No engine oil can be seen around the turbocharger impeller.</p> |

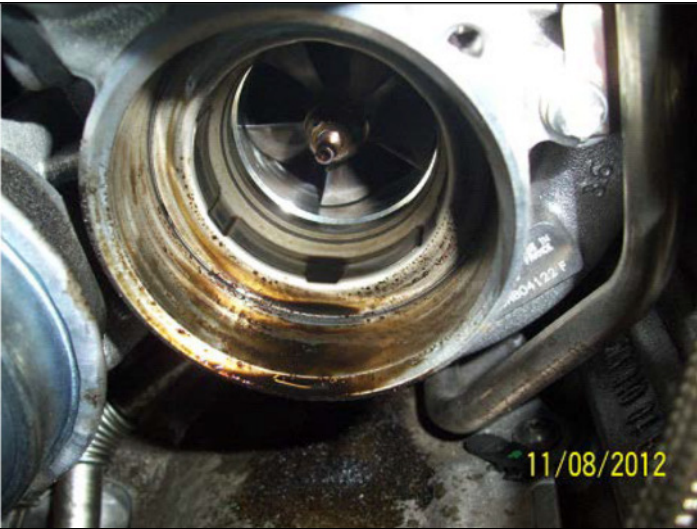
| | <p>The turbocharger is OK.</p> <p>No engine oil can be seen around the turbocharger impeller.</p> |

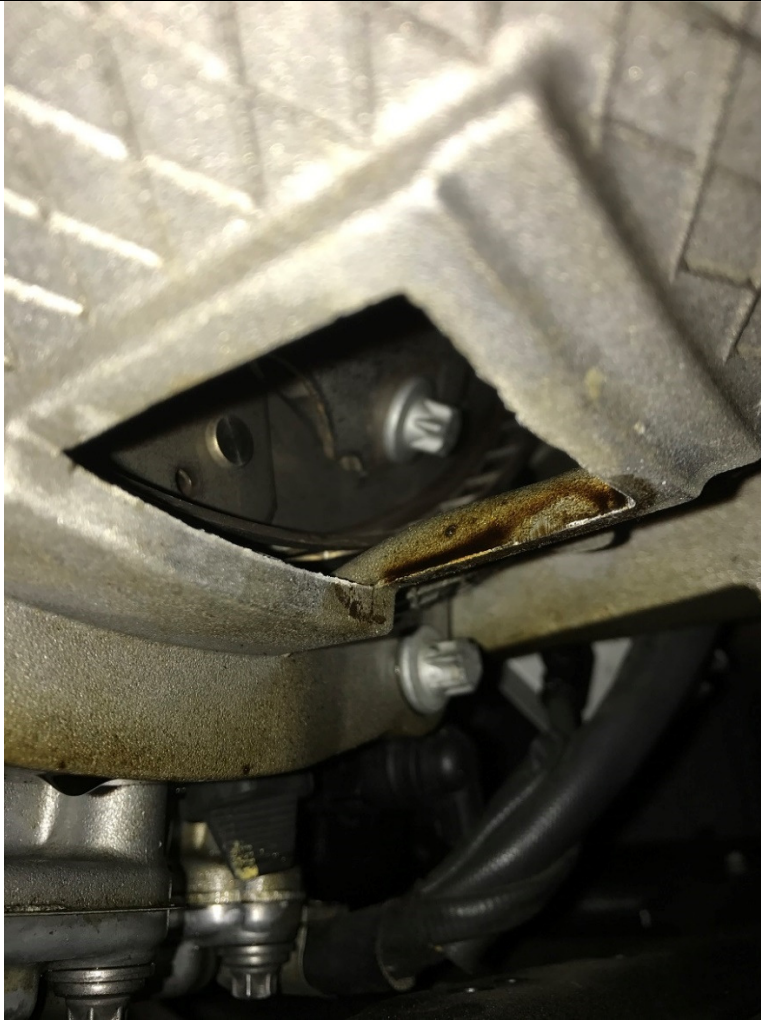
## 6. Inspect the lower bell housing for engine oil leakage

The lower bell housing is **not** leaking. Go to step 8.

The lower bell housing is leaking. Go to step 7.

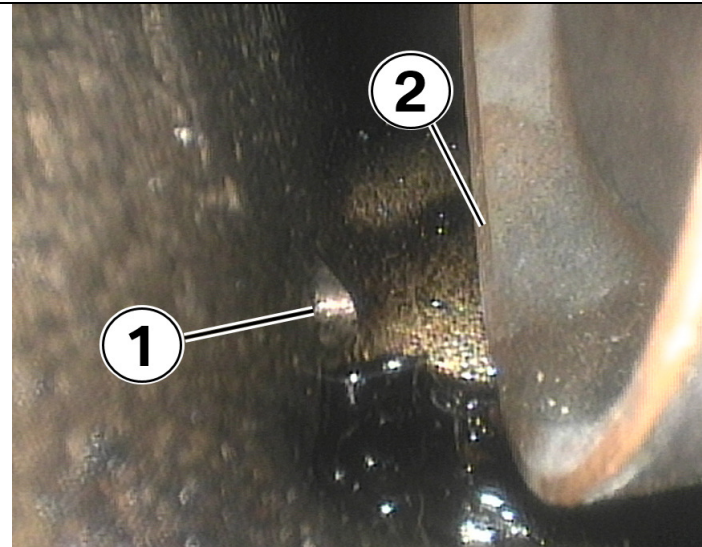
| | <p>Inspect the surrounding area of the engine valley drain hole (1).</p> <p>Engine valley drain hole (1)</p> <p>Metal vacuum reservoir (2) shown.</p> <p>This is a clean picture. No oil can be seen in the oil drain hole (1).</p> <p>The dark material at the bottom of the photo is dust and dirt. This material appears to be reflective but it is dry</p> |

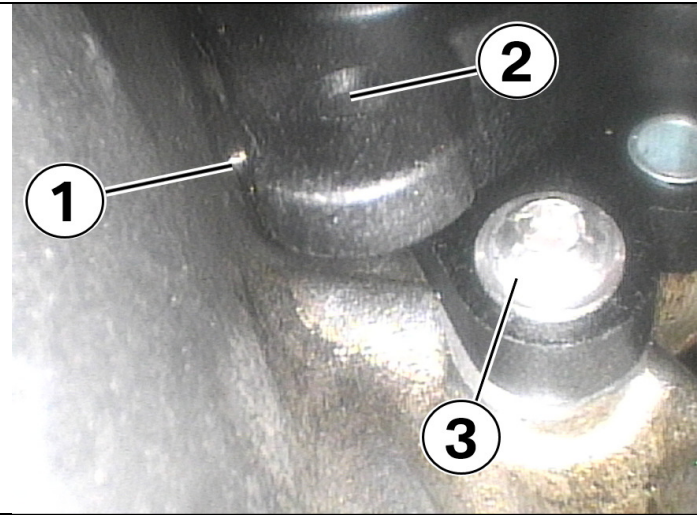
| | <p>Diagnosis in the vehicle:</p> <p>It may be more difficult to position the bore scope but it will only take a few minutes more to make the diagnosis.</p> <p>Engine valley drain hole (1)</p> <p>Plastic vacuum reservoir tab (2)</p> <p>Reservoir mounting screw (3)</p> |

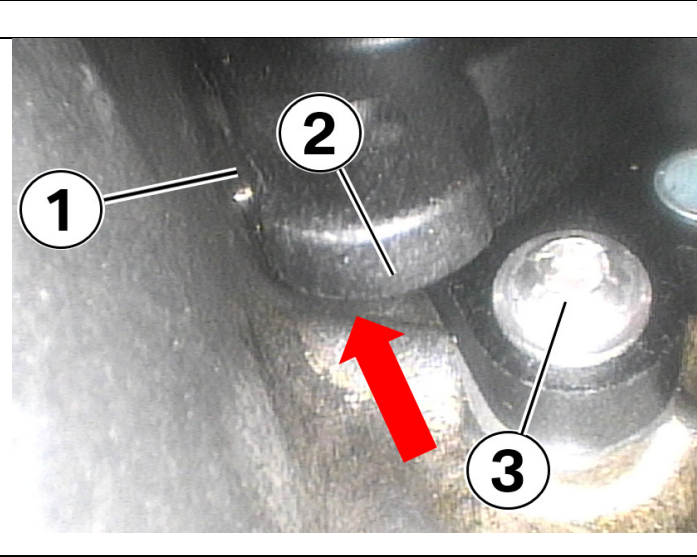
| | <p>Continue to push bore scope down ward towards the plastic vacuum reservoir tab (2).</p> <p>The bore scope needs to be moved towards the direction of the red arrow and under the tab (2) to have the best viewing angle of the engine valley drain hole (1).</p> <p>Engine valley drain hole (1)</p> <p>Plastic vacuum reservoir tab (2)</p> <p>Reservoir mounting screw (3)</p> |

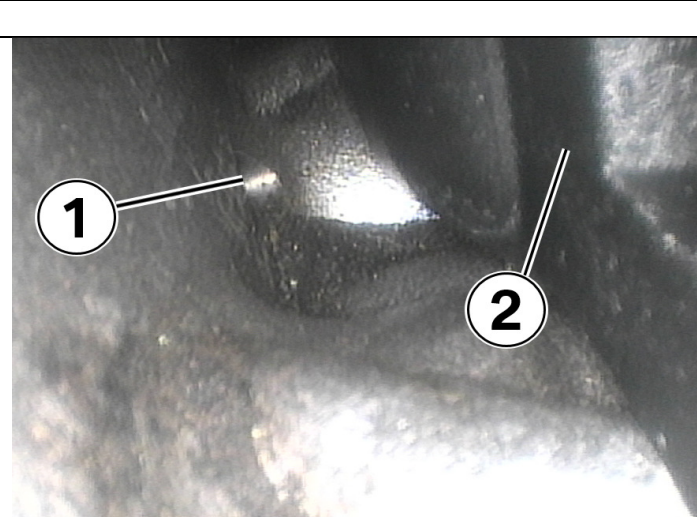
| | <p>Once the bore scope has gone under the plastic reservoir tab then the engine valley drain hole (1) and surrounding area can be clearly inspected.</p> <p>The dark material at the bottom of the photo is dust and dirt. This material appears to be reflective but it is dry.</p> <p>Engine valley drain hole (1)</p> <p>Plastic vacuum reservoir (2)</p> |

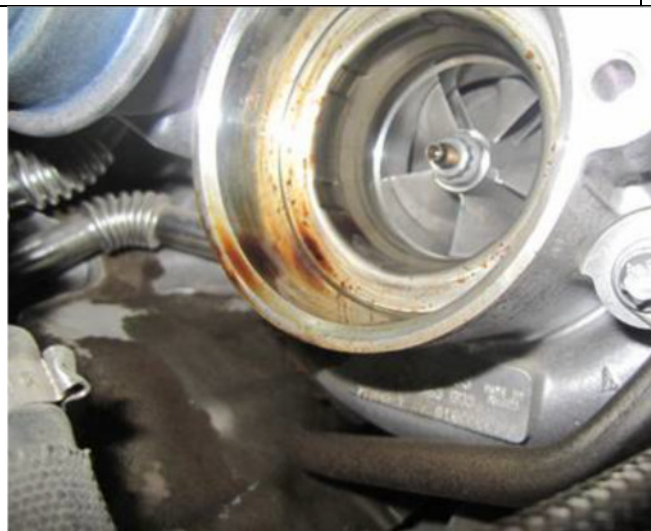
The turbocharger is OK.

No engine oil can be seen around the turbocharger impeller.

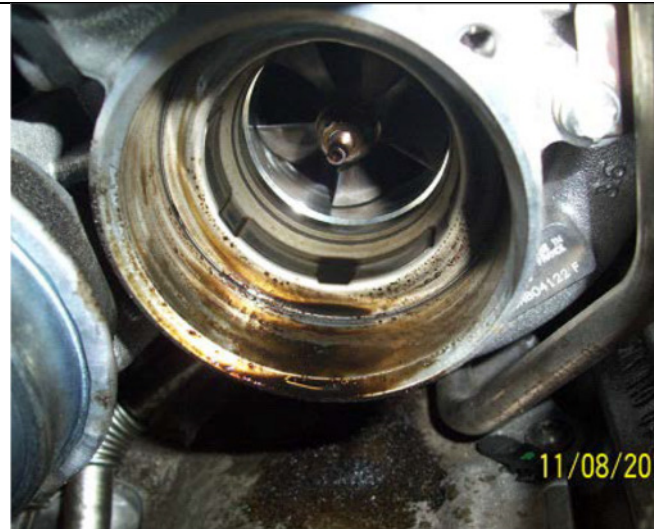
The turbocharger is OK.

No engine oil can be seen around the turbocharger impeller.

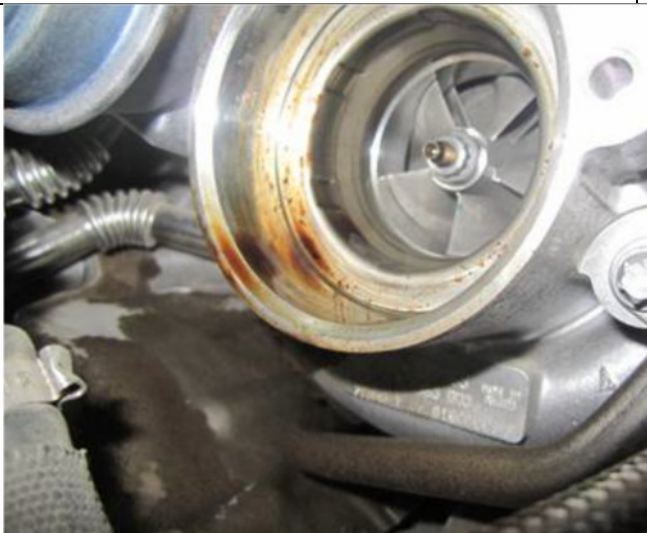
The turbocharger is OK.

No engine oil can be seen around the turbocharger impeller.

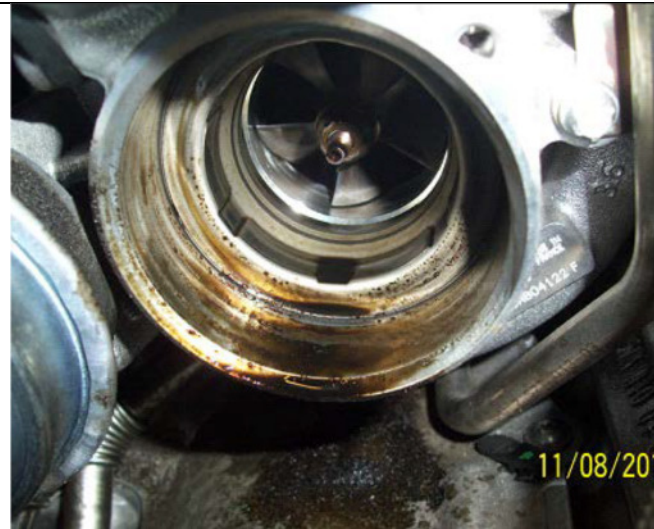
The turbocharger is OK.

No engine oil can be seen around the turbocharger impeller.
