# Inspect HV Battery Positive Contactor Fasteners

| <b>Classification</b> | Campaign Bulletin | <b>Section/Group</b> | 16 - HV Battery System | <b>Country/Region</b> | United States, Canada |
| <b>Year</b> | 2018 | <b>Model</b> | Model 3 | <b>Version</b> | All |

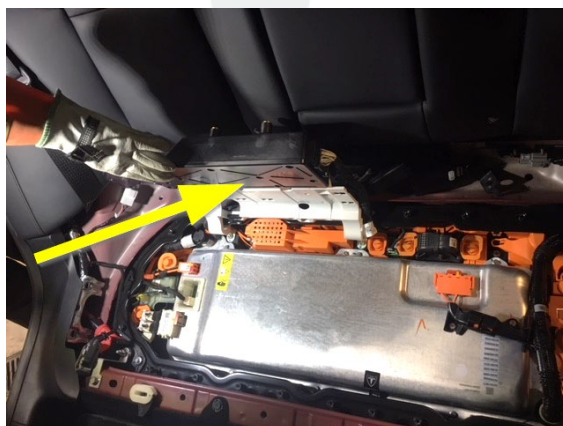
Figure 1

2. Raise the high voltage controller to a vertical position (Figure 1).

18. Install the insulator caps onto the HV battery positive contactor (Figure 2).
19. Lower the high voltage controller (Figure 1), and then skip to step 22.

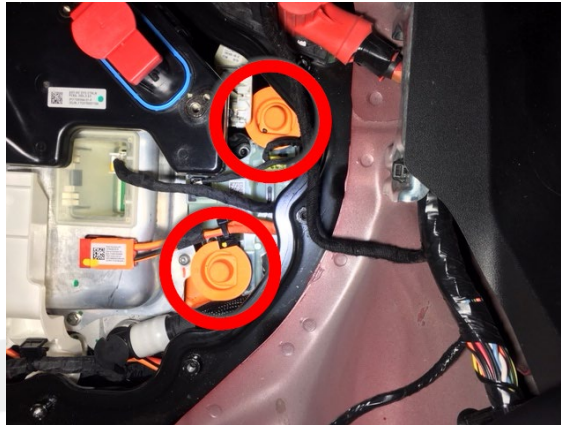
**Figure 2**

3. Remove the insulator caps from the HV battery positive contactor (Figure 2).
