December 2018  
SF558A

## Subject: Cascadia Front Suspension Crossmember Steel Sleeves

**Models Affected: Specific Freightliner Cascadia vehicles  
manufactured May 3, 2016, through October 13, 2017.**

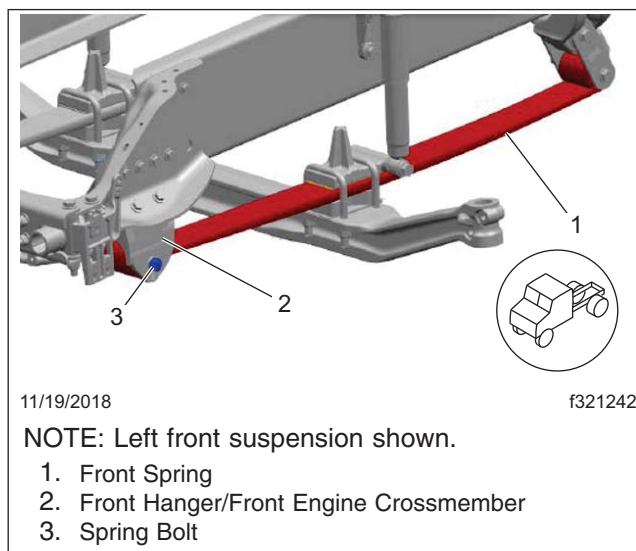
**Fig. 1, Front Suspension**

On specific Cascadia vehicles, a tolerance build up between the steel sleeve and casting on the front spring and engine crossmember can lead to the steel sleeve not seating properly against the spring bushing. This can lead to premature wear of the spring bushing.

The steel sleeve will be inspected and adjusted to seat against the spring bushing as needed.
