November 2018  
FL796A-F  
NHTSA #18V-699  
Transport Canada #2018-551

## Subject: Steering Wheel Fasteners

**Models Affected: Specific Freightliner Cascadia vehicles, and Western Star 5700 vehicles, manufactured July 31, 2018, through August 2, 2018.**

### Subject: Steering Wheel Fasteners

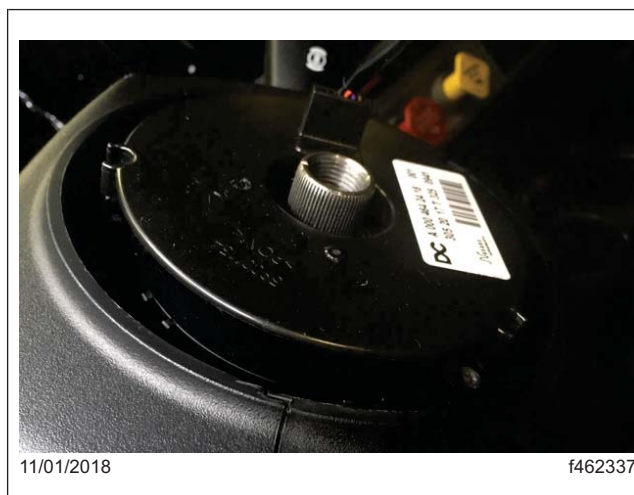
**Fig. 5, Steering Column Splines with Undamaged Grooves**

9. Inspect the steering column splines. There should be no wear or damage on the splines. See [Fig. 4](#) and [Fig. 5](#).
