Technical Journal

Wind noise, front and/or rear door areaREF NO:
TJ 34262.1.0ISSUING DEPARTMENT:
Technical ServiceCAR MARKET:
United States and CanadaPARTNER:
3 US 7510 Volvo Car USAISSUE DATE:
2018-12-10STATUS DATE:
2018-12-18FUNC GROUP:
8450FUNC DESC:
**Sealing and protect. moulding
for door**

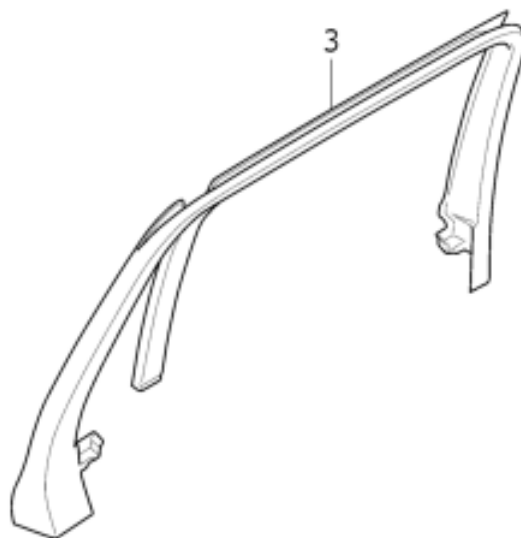
- 5. Rear Door weather strip with divider bar, see attachment 5 TJ34262.pdf (valid for vehicle type 224, 225, 256).**
Check if the weather strip ends are sealing against the door arch panel (see attached) and divider bar.
If not, re-assemble or replace part according to VIDA.
