TITLE:
C70 headliner hanging down, repair clip

REF NO: TJ 29245.2.2	ISSUING DEPARTMENT: Technical Service	CAR MARKET: United States and Canada	
PARTNER: 3 US 7510 Volvo Car USA		ISSUE DATE: 2018-08-24	STATUS DATE: 2018-08-29
FUNC GROUP: 8389	FUNC DESC: Miscellaneous	Page 1 of 9

TJ 29245

Title	Convertible Top Center Headliner	Page	1 (6)
Action	Product fix	Operation number:	98537-2

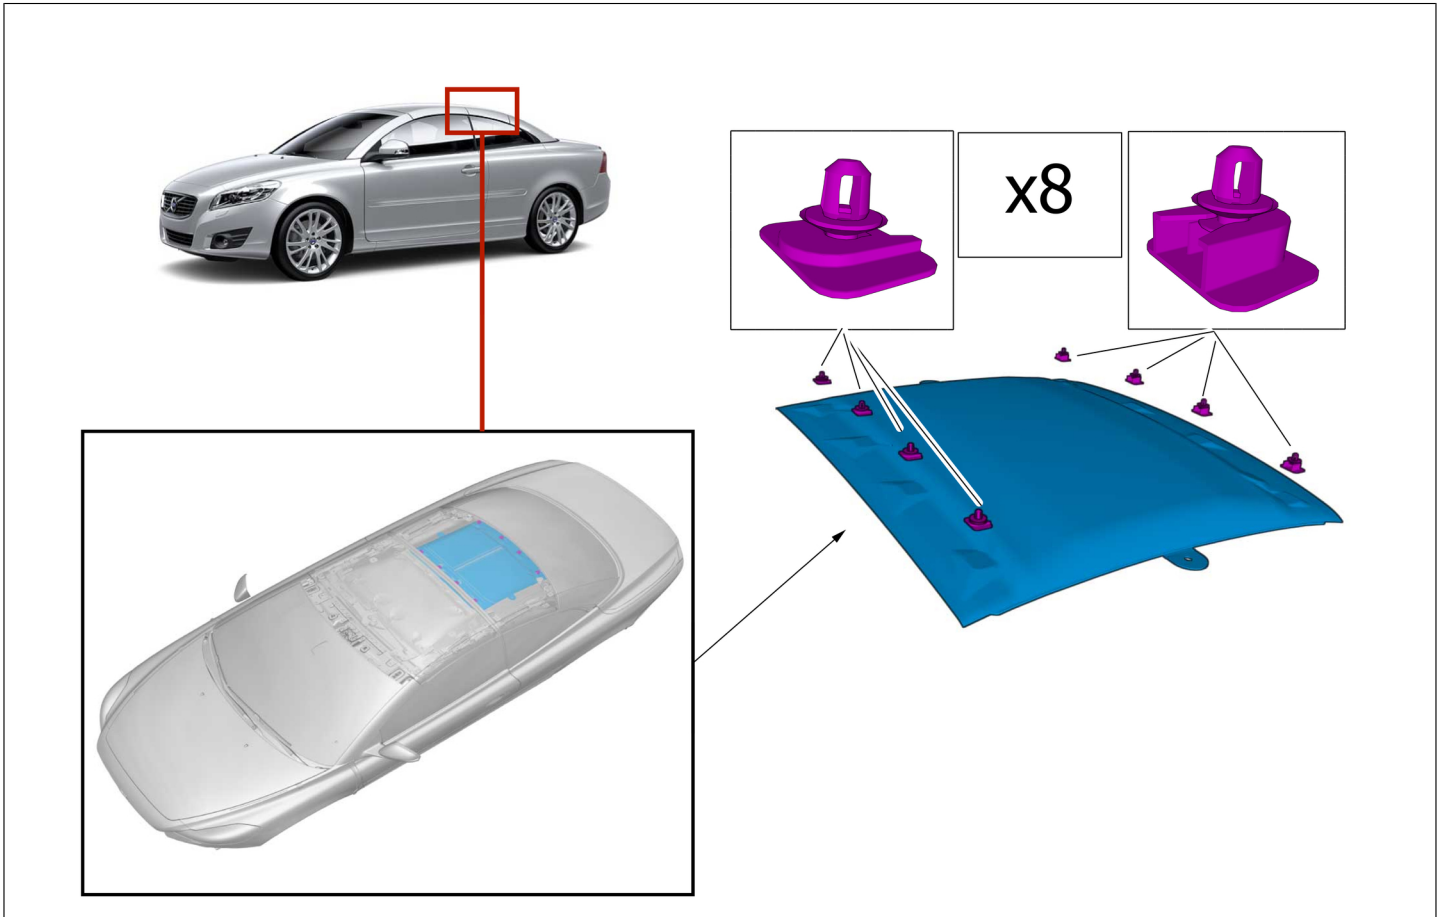
Orientation view

Clips on headlining may come loose, causing the headlining to hang down. This is more common in hot climate.

Headlining can be repaired by gluing the clips back on. See repair instruction TJ 29245.
