December 2018  
FL766A-C  
NHTSA #18V-191  
Transport Canada #18-190  
SECOND REVISED NOTICE

## **Subject: Western Star Power Cable Studs**

**Models Affected: Specific Western Star 4700, 4900, 5700, and 6900 model vehicles manufactured September 12, 2016, through February 6, 2018.**

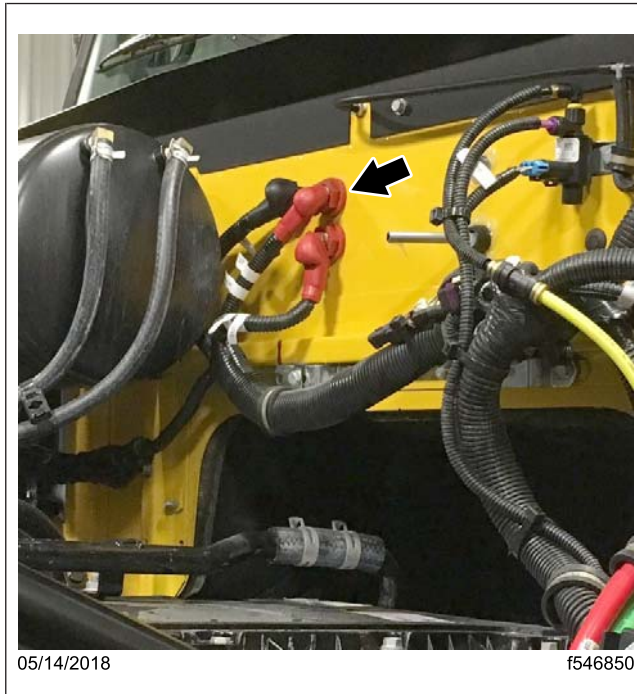
**Fig. 1, Power Cable Stud Connector Location**

1. Open the hood and locate the three or four power cable stud connectors on the front wall. See [Fig. 1](#).
2. Pull back the covers on the power cable stud connectors. See [Fig. 2](#). Inspect each cable stud to make sure at least one thread protrudes past the plastic nut. See [Fig. 3](#) and [Fig. 4](#).

1. Disconnect the batteries.
2. If not already done, open the hood and locate the three or four power cable stud connectors on the front wall, and pull back the cover on the power cable stud connector. See [Fig. 1](#) and [Fig. 2](#).
3. For parts ordering, check to see if the power studs size is 1/4 inch or 3/8 inch.
4. Loosen the dash, and move it back enough to access the front-wall power terminals. Refer to *Western Star Workshop Manual*, **Section 60.06, Subject 110**.

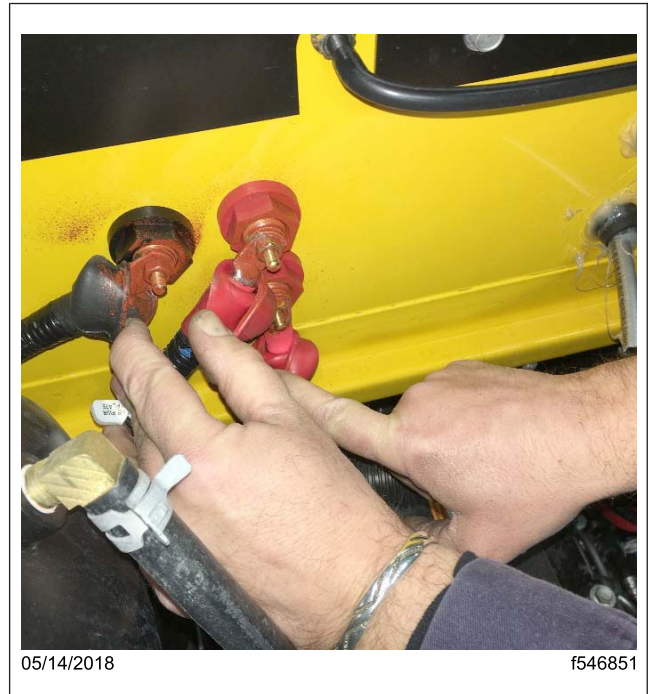
**Fig. 2, Removing Connector Protective Cover**

If at least one thread does **NOT** protrude past the plastic nut, the installation is **INCORRECT**. Proceed to "Power Cable Stud Replacement."
