To: All Subaru Retailers
From: Subaru of America, Inc. – Service
Date: July 2, 2018
Re: *Harman Gen 3 Audio and Navi Head Unit update - In-stock Vehicles*

SERVICE BULLETIN

NUMBER: 15-211-17R
DATE: 06/13/17
REVISED: 07/25/18

SUBJECT: Reprogramming File Availability for Additional Optimization of Harman Gen 3 Audio and Navigation Head Units

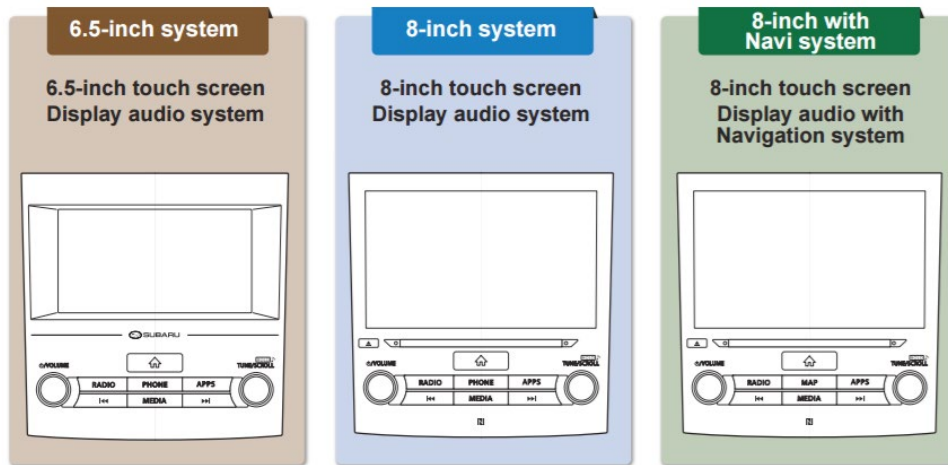
Multimedia System Type	Descriptive Features
6.5 Inch Display Audio System (Base)	No CD slot / Eject Button
8.0 Inch Display Audio System (Mid)	Phone Button
8.0 Inch Audio / Navigation System (High)	Map Button but no Phone Button

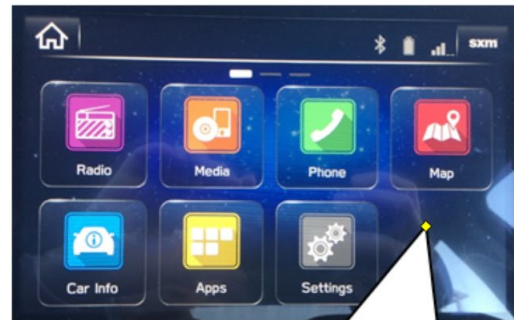
- Corrects for condition where only the star field background is displayed (without icons) after the HOME button is pressed.

Background shown, but no icons

Normal HOME screen with icons

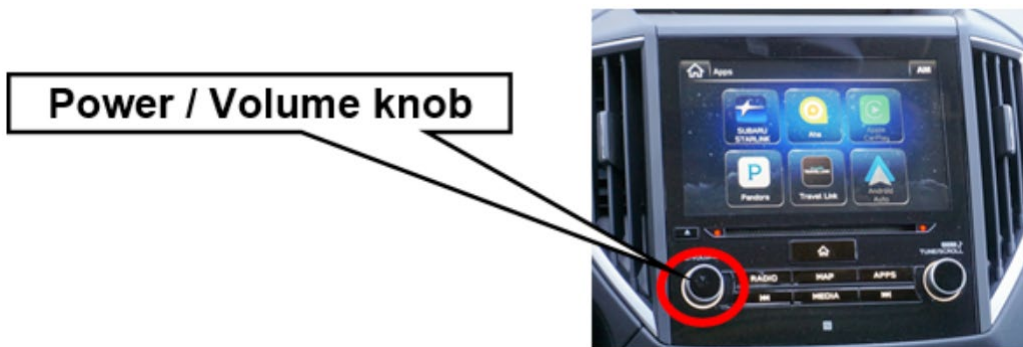
- Operation of the head unit after switching the ignition off and back on has been revised:

PREVIOUS Version: The head unit power is turned OFF by pressing the Power/Volume knob for 4 or more seconds. On the next ignition ON, the display remains OFF / black while the audio begins playing automatically. This was the prior characteristic operation.

NEW Version: The head unit power is turned OFF by pressing the Power/Volume knob for 4 or more seconds. On the next ignition ON, the display remains OFF / black and the audio will also be OFF until the Power/Volume knob is pressed to turn the head unit back ON.

- The Mute function of the Power / Volume knob (a brief press and release of the Power / Volume knob to mute audio output) is unchanged.
- A “system reboot” function is initiated by pressing and holding the Power / Volume button for 10 seconds. This feature was included as part of the previous (11/2017) software update.
