ITB17-042b

January 29, 2019

INFINITI; DTC P0456 CAUSED BY EVAP LEAK AT VENT CONTROL VALVE O-RING

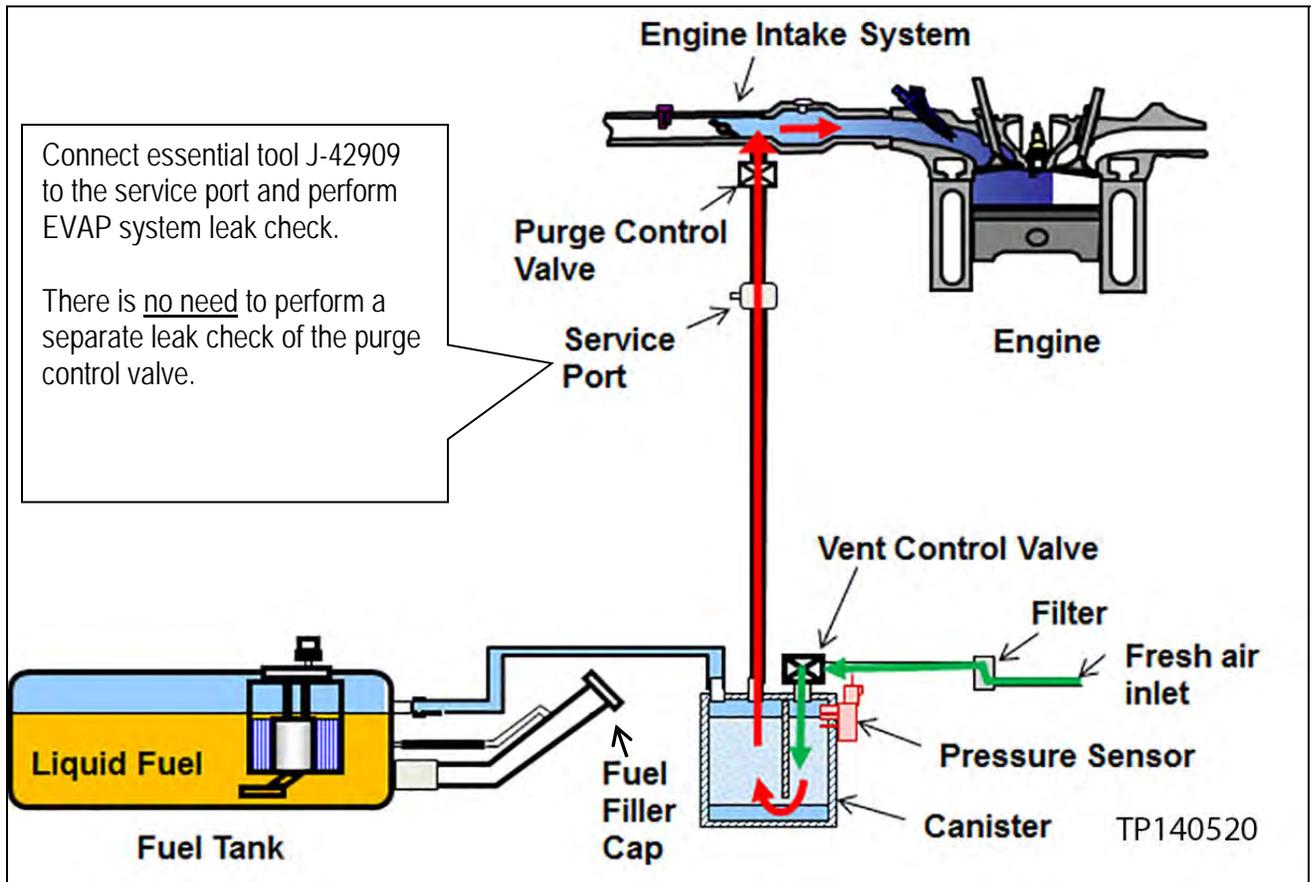
Figure 8

EVAP System Basic Operation

- Fuel vapor flows from fuel tank into canister (light blue area)
- Vapor flows from canister through purge control valve (red line)
- Fresh air flows into canister (green line)

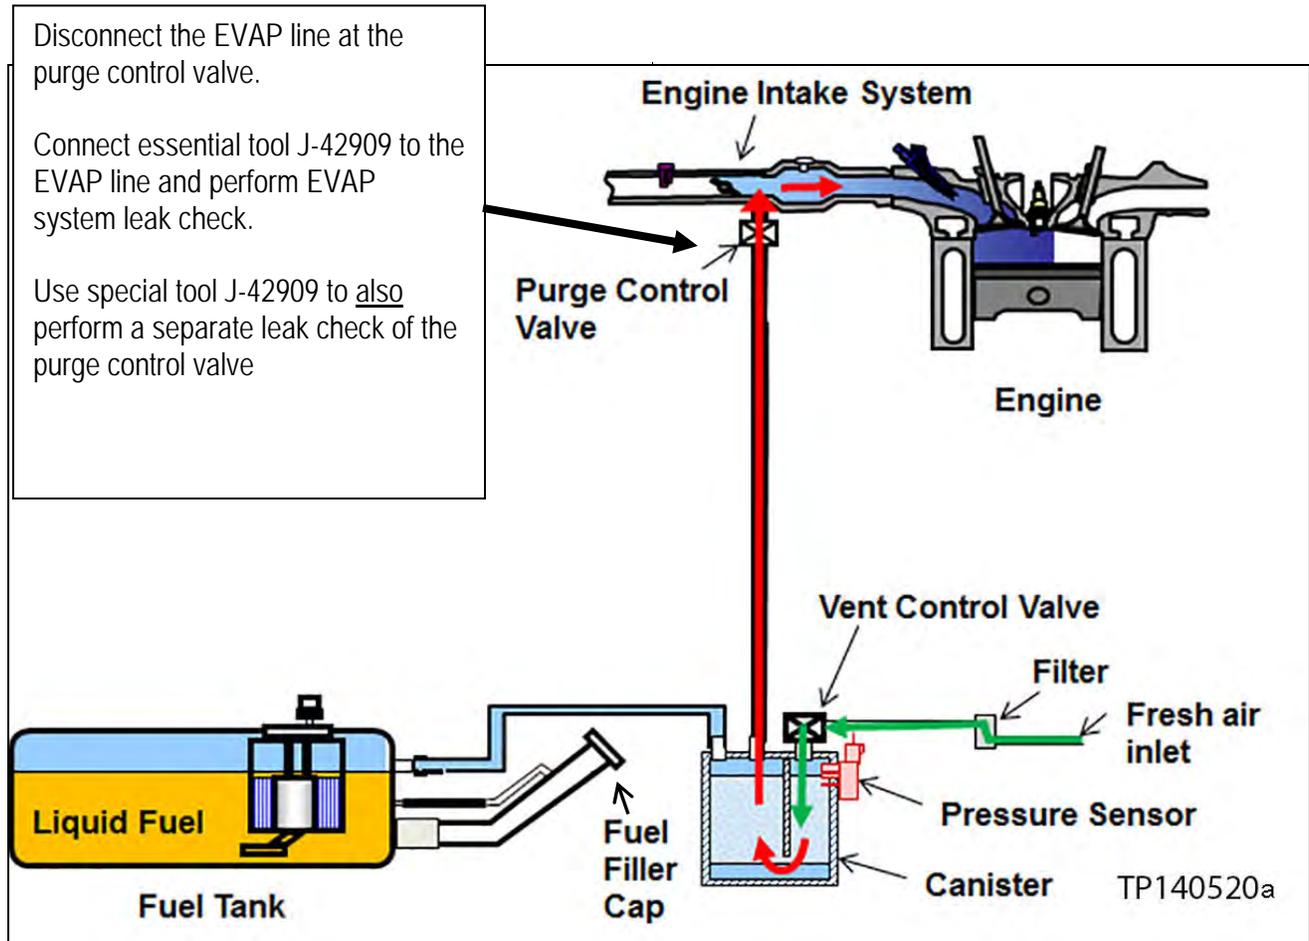
Figure 9

EVAP System Basic Operation
