Technical Service Bulletin

Subject: CONDENSATION / FOG IN FRONT AND REAR COMBINATION LAMPS (HEADLAMP AND TAILLAMP ASSEMBLIES)	Bulletin No.: 09-003/19
	Last Issued: 01/03/2019

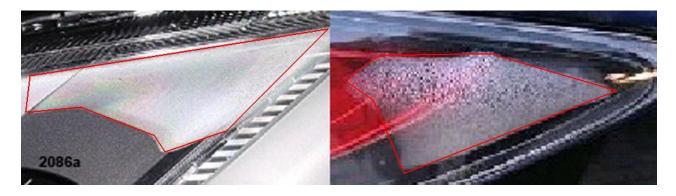
Halogen Headlamp + Bulb Type Turn Signal lamp Discharge Headlamp + Bulb Type Turn Signal lamp LED Headlamp + Bulb Type Turn Signal lamp

Replacement headlamp assembly applicable to this bulletin

Replacement headlamp assembly not applicable to this bulletin

LED Headlamp + LED Turn Signal lamp	SHO
---	-----
