# Replace Huck BOM Fastener on Front Seats

**Classification** Repair Bulletin    **Section/Group** 13 - Seats    **Country/Region** All

**Year** 2015-2018    **Model** Model S, Model X    **Version** All

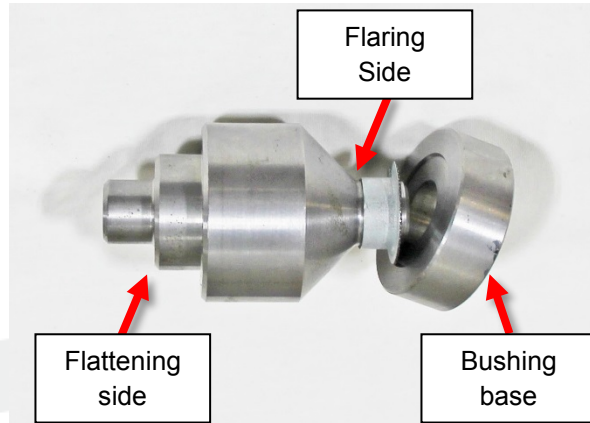
**Figure 7**

**NOTE:** The main parts of the flare tool (Figure 7) are:

- c. Remove the flare tool from the Huck BOM Replacement kit.

- d. Insert a new bushing with the flange on the inboard side of the seat track (Figure 8).
