SI B11 11 18
Engine

SERVICE ACTION: N63R ENGINE – CHECK AND REPLACE VANOS ACTUATORS, OIL FEED LINES, CHARGE AIR COOLERS AND THE MAP THERMOSTAT ELECTRICAL CONNECTOR

This Service Information bulletin replaces SI B11 11 18 **dated October 2018**

This Service Action involves G12 vehicles produced from May 2015 to July 2016.

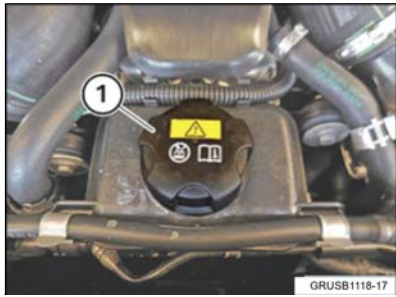
1. Locate and inspect the low temperature cooling system cap (1) for traces of overflowing.

If found overflowing, replace both charge air intercoolers.

If not leaking, do not replace any parts and do not drain the cooling system.
