Title: VIN Glare Remedy

Applicability: MY18 Revero

PURPOSE: This will mitigate a VIN reflection on the windshield from the drivers field of view.

Type: Technical Service Bulltein

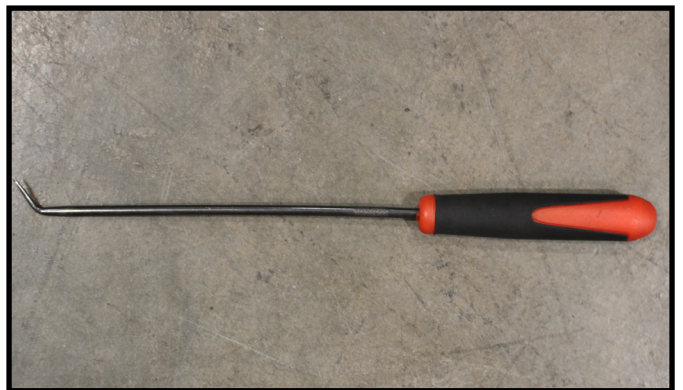
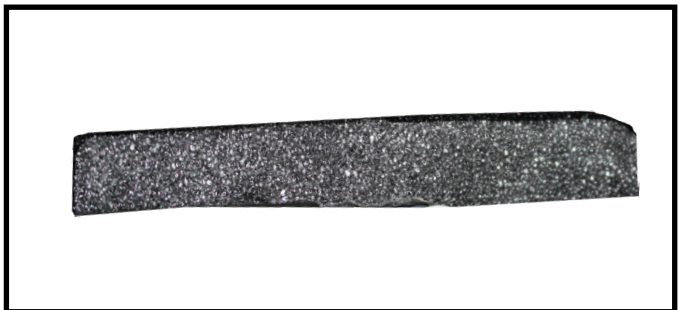
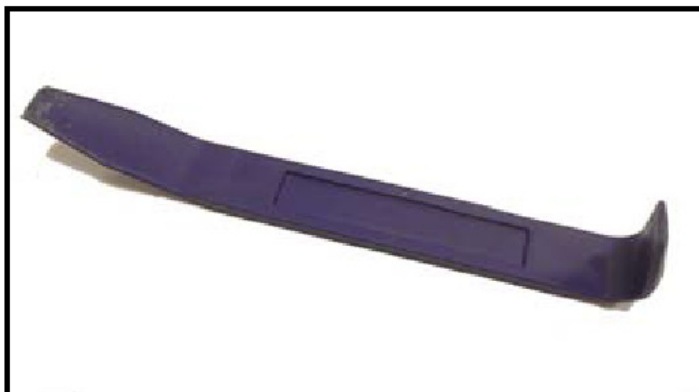
The tools as shown ,will be required to perform this set of inspections and adjustments.

- Panel tool
- Pick tool
- Foam Strip (C131140005300)
