## SERVICE BULLETIN

**APPLICABILITY:** All 2019MY Vehicles

**NUMBER:** 15-236-18R

**SUBJECT:** Reprogramming File Availability for Optimization of Harman Gen 3.1 Audio and Navigation Head Units

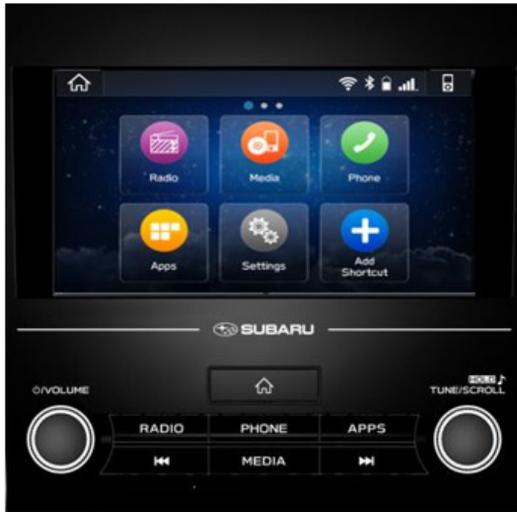
**BASE**

Multimedia System Type	Descriptive Features
6.5 Inch Display Audio System (Base)	No CD slot / Eject Button
6.5 Inch Display Audio System (Base +)	Equipped with CD Player and Eject Button
8.0 Inch Display Audio System (Mid)	Phone Button
8.0 Inch Audio / Navigation System (High)	Map Button but no Phone Button
